Asbestos Refurbishment Survey At Woodfield School, Stoneleigh Road Site, Coventry

Project No: W16-00408

Report Issue Date: 3 November 2016

Site: Woodfield School

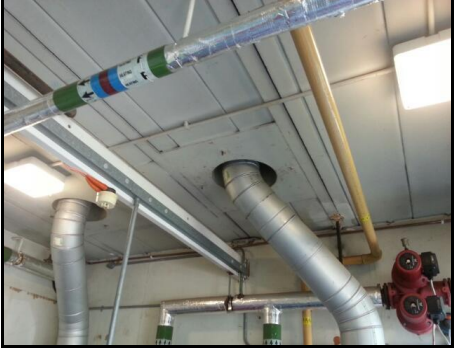
Building ID	Woodfield School
Sample No.	S0003
Floor	Ground Floor
Room No.	001
Room ID	Boiler Room

Item Description	Ceiling
Material	Cement Product
Asbestos Type	Chrysotile
Extent	32m2
Notes: Timber soffit. Plasterboard walls. Concrete floor. UPVC windows, doors and frame. MMMF insulation to pipework and internal replacement boiler. Limited access around boilers.	
Surveyor:	Paul Sidebotham
Recommendation:	Remove

HSG 264 Material Assessment Scores				Priority Assessment Scores				Risk Priority Rating:
Product:	1	Condition:	2	Occupant Activity:	0	Likelihood of Disturbance:	2	3
Surface Treatment:	2	Asbestos Type:	1	Potential of Human Exposure:	1	Maintenance Activity:	1	
Material Score:	6	Material Category:	C	Priority Score:	4	Total Score (Overall):	10

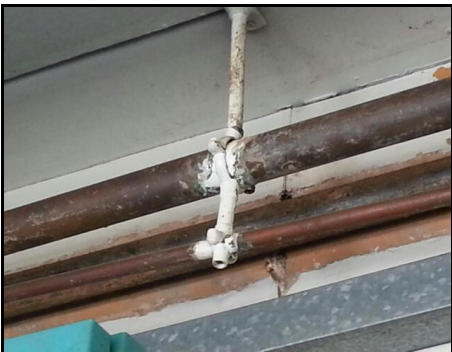
Building ID	Woodfield School
Sample No.	S0006
Floor	Ground Floor
Room No.	001
Room ID	Boiler Room

Item Description	Residue
Material	Debris
Asbestos Type	Amosite, Chrysotile
Extent	1m2
Notes: Timber soffit. Plasterboard walls. Concrete floor. UPVC windows, doors and frame. MMMF insulation to pipework and internal replacement boiler. Limited access around boilers.	
Surveyor:	Paul Sidebotham
Recommendation:	Remove

HSG 264 Material Assessment Scores				Priority Assessment Scores				Risk Priority Rating:
Product:	2	Condition:	3	Occupant Activity:	0	Likelihood of Disturbance:	1	2
Surface Treatment:	3	Asbestos Type:	2	Potential of Human Exposure:	2	Maintenance Activity:	1	
Material Score:	10	Material Category:	A	Priority Score:	4	Total Score (Overall):	14

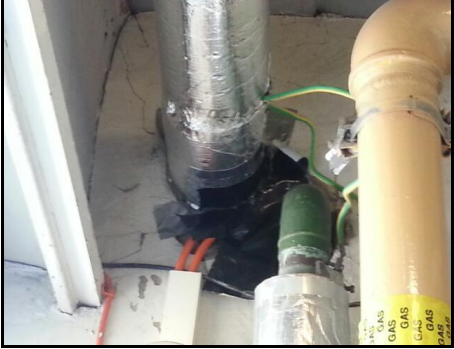
Building ID	Woodfield School	Item Description	Wall void
Sample No.	S0007	Material	Debris
Floor	Ground Floor	Asbestos Type	Amosite, Chrysotile
Room No.	001	Extent	1no
Room ID	Boiler Room	Notes:	Timber soffit. Plasterboard walls. Concrete floor. UPVC windows, doors and frame. MMMF insulation to pipework and internal replacement boiler. Limited access around boilers.

Surveyor:	Paul Sidebotham
		Recommendation:	Remove

HSG 264 Material Assessment Scores				Priority Assessment Scores				Risk Priority Rating:
Product:	3	Condition:	3	Occupant Activity:	0	Likelihood of Disturbance:	1	2
Surface Treatment:	3	Asbestos Type:	2	Potential of Human Exposure:	2	Maintenance Activity:	1	
Material Score:	11	Material Category:	A	Priority Score:	4	Total Score (Overall):	15

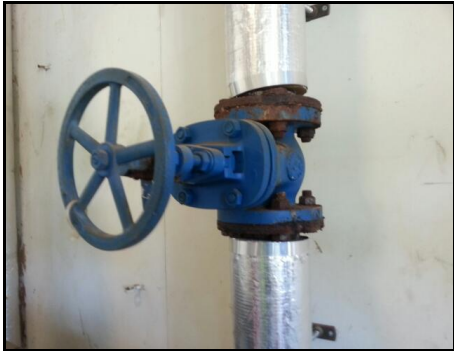
Building ID	Woodfield School
Sample No.	S0009
Floor	Ground Floor
Room No.	001
Room ID	Boiler Room

Item Description	Gasket
Material	Gasket
Asbestos Type	Chrysotile
Extent	14no
Notes: Timber soffit. Plasterboard walls. Concrete floor. UPVC windows, doors and frame. MMMF insulation to pipework and internal replacement boiler. Limited access around boilers.	
Surveyor:	Paul Sidebotham
Recommendation:	Remedial Work Required

HSG 264 Material Assessment Scores				Priority Assessment Scores				Risk Priority Rating:
Product:	2	Condition:	0	Occupant Activity:	0	Likelihood of Disturbance:	1	3
Surface Treatment:	1	Asbestos Type:	1	Potential of Human Exposure:	2	Maintenance Activity:	1	
Material Score:	4	Material Category:	D	Priority Score:	4	Total Score (Overall):	8

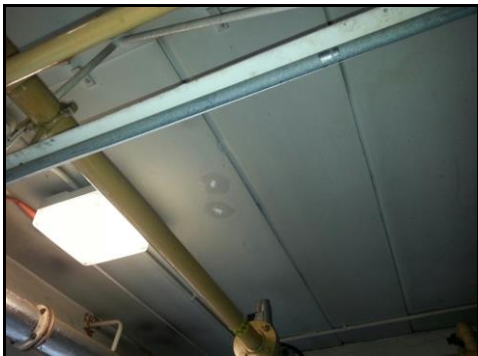
Building ID	Woodfield School
Sample No.	S0010
Floor	Ground Floor
Room No.	001
Room ID	Boiler Room (064)

Item Description	Thermal residue to cement ceiling.
Material	Insulation
Asbestos Type	Chrysotile
Extent	2m ²
Notes: Timber soffit. Plasterboard walls. Concrete floor. UPVC windows, doors and frame. MMMF insulation to pipework and internal replacement boiler. Limited access around boilers.	
Surveyor:	Steven Jones
Recommendation:	Remove

HSG 264 Material Assessment Scores				Priority Assessment Scores				Risk Priority Rating:
Product:	3	Condition:	1	Occupant Activity:	1	Likelihood of Disturbance:	2	2
Surface Treatment:	3	Asbestos Type:	1	Potential of Human Exposure:	2	Maintenance Activity:	1	
Material Score:	8	Material Category:	B	Priority Score:	6	Total Score (Overall):	14

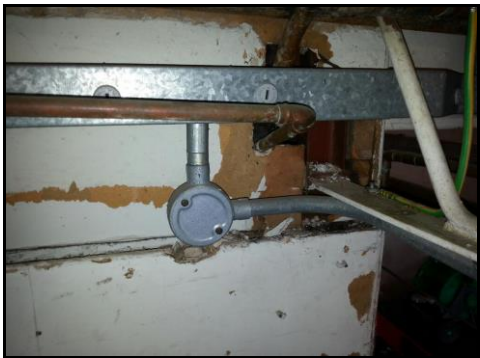
Building ID	Woodfield School
Sample No.	S0011
Floor	Ground Floor
Room No.	001
Room ID	Boiler Room (064)

Item Description	Thermal debris to wall top and framework.
Material	Insulation
Asbestos Type	Amosite, Chrysotile
Extent	2m ²
Notes: Timber soffit. Plasterboard walls. Concrete floor. UPVC windows, doors and frame. MMMF insulation to pipework and internal replacement boiler. Limited access around boilers.	
Surveyor:	Steven Jones
Recommendation:	Remove

HSG 264 Material Assessment Scores				Priority Assessment Scores				Risk Priority Rating:
Product:	3	Condition:	3	Occupant Activity:	1	Likelihood of Disturbance:	2	2
Surface Treatment:	3	Asbestos Type:	2	Potential of Human Exposure:	2	Maintenance Activity:	1	
Material Score:	11	Material Category:	A	Priority Score:	6	Total Score (Overall):	17

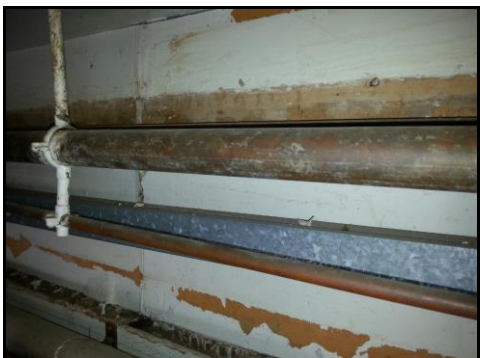
Building ID	Woodfield School
Sample No.	S0012
Floor	Ground Floor
Room No.	001
Room ID	Boiler Room (064)

Sample No.	Room No.	Room ID	Item Description	Extent	Surface Treatment	Condition	Material Assessment Score	Priority Assessment Score	Total Score	Asbestos Type
S0012	001	Ground Floor Boiler Room (064)	Thermal debris to top of conduit.	1m ²	3	3	12	6	18	Amosite, Chrysotile, Crocidolite

Item Description	Thermal debris to top of conduit.
Material	Insulation
Asbestos Type	Amosite, Chrysotile, Crocidolite
Extent	1m ²
Notes: Timber soffit. Plasterboard walls. Concrete floor. UPVC windows, doors and frame. MMMF insulation to pipework and internal replacement boiler. Limited access around boilers.	
Surveyor:	Steven Jones
Recommendation:	Remove

HSG 264 Material Assessment Scores				Priority Assessment Scores				Risk Priority Rating:
Product:	3	Condition:	3	Occupant Activity:	1	Likelihood of Disturbance:	2	1
Surface Treatment:	3	Asbestos Type:	3	Potential of Human Exposure:	2	Maintenance Activity:	1	
Material Score:	12	Material Category:	A	Priority Score:	6	Total Score (Overall):	18

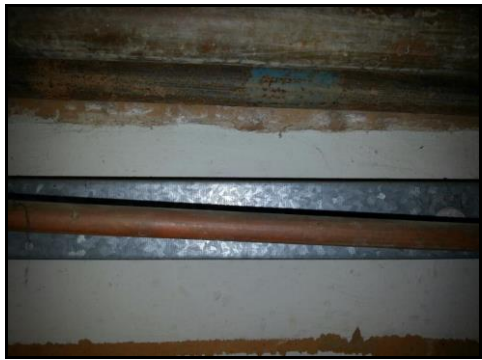
Building ID	Woodfield School		
Sample No.	S0013		
Floor	Ground Floor		
Room No.	001		
Room ID	Boiler Room (064)

Item Description	Thermal residue to wall paint lines behind pipes. Left side back wall.
		Material	Insulation
		Asbestos Type	Amosite, Chrysotile
		Extent	2m ²
		Notes: Timber soffit. Plasterboard walls. Concrete floor. UPVC windows, doors and frame. MMMF insulation to pipework and internal replacement boiler. Limited access around boilers.	
		Surveyor:	Steven Jones
		Recommendation:	Remove

HSG 264 Material Assessment Scores				Priority Assessment Scores				Risk Priority Rating:
Product:	3	Condition:	3	Occupant Activity:	1	Likelihood of Disturbance:	2	2
Surface Treatment:	3	Asbestos Type:	2	Potential of Human Exposure:	2	Maintenance Activity:	1	
Material Score:	11	Material Category:	A	Priority Score:	6	Total Score (Overall):	17

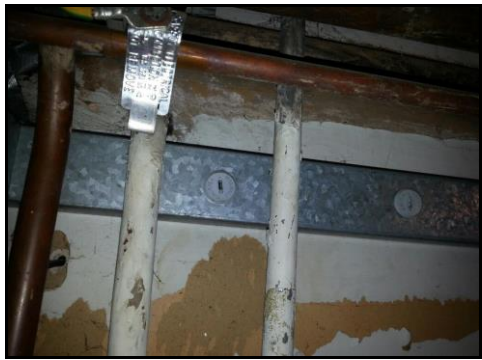
Building ID	Woodfield School		
Sample No.	S0014		
Floor	Ground Floor		
Room No.	001		
Room ID	Boiler Room (064)

Item Description	Thermal residue to electrical conduit.
		Material	Insulation
		Asbestos Type	Amosite, Chrysotile
		Extent	1m ²
		Notes: Timber soffit. Plasterboard walls. Concrete floor. UPVC windows, doors and frame. MMMF insulation to pipework and internal replacement boiler. Limited access around boilers.	
		Surveyor:	Steven Jones
		Recommendation:	Remove

HSG 264 Material Assessment Scores				Priority Assessment Scores				Risk Priority Rating:
Product:	3	Condition:	2	Occupant Activity:	1	Likelihood of Disturbance:	2	2
Surface Treatment:	3	Asbestos Type:	2	Potential of Human Exposure:	2	Maintenance Activity:	1	
Material Score:	10	Material Category:	A	Priority Score:	6	Total Score (Overall):	16

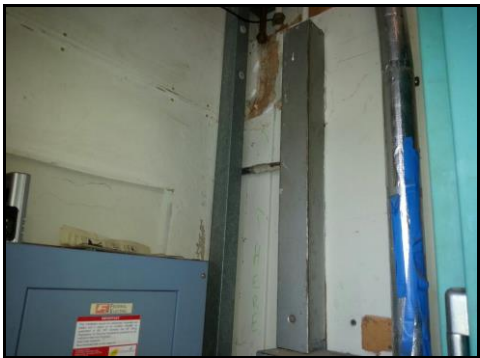
Building ID	Woodfield School	
Sample No.	S0015	
Floor	Ground Floor	
Room No.	001	
Room ID	Boiler Room (064)

Item Description Insulating board strip/panel to wall corner.
		Material Board
		Asbestos Type Amosite, Chrysotile
		Extent 2m ²
		Notes: Timber soffit. Plasterboard walls. Concrete floor. UPVC windows, doors and frame. MMMF insulation to pipework and internal replacement boiler. Limited access around boilers.
		Surveyor: Steven Jones
		Recommendation: Remove

HSG 264 Material Assessment Scores				Priority Assessment Scores				Risk Priority Rating:
Product:	2	Condition:	2	Occupant Activity:	1	Likelihood of Disturbance:	2	2
Surface Treatment:	1	Asbestos Type:	2	Potential of Human Exposure:	2	Maintenance Activity:	1	
Material Score:	7	Material Category:	B	Priority Score:	6	Total Score (Overall):	13

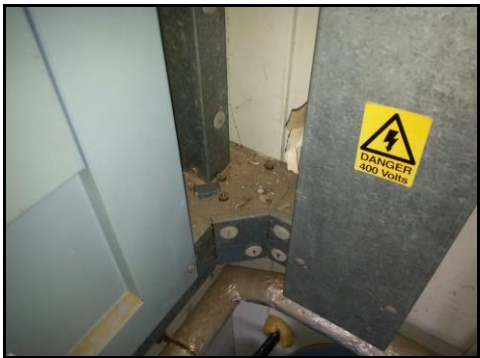
Building ID	Woodfield School	
Sample No.	S0016	
Floor	Ground Floor	
Room No.	001	
Room ID	Boiler Room (064)

Item Description Thermal residue/debris to electrical corner conduit
		Material Insulation
		Asbestos Type Amosite, Chrysotile
		Extent 1m ²
		Notes: Timber soffit. Plasterboard walls. Concrete floor. UPVC windows, doors and frame. MMMF insulation to pipework and internal replacement boiler. Limited access around boilers.
		Surveyor: Steven Jones
		Recommendation: Remove

HSG 264 Material Assessment Scores				Priority Assessment Scores				Risk Priority Rating:
Product:	3	Condition:	3	Occupant Activity:	1	Likelihood of Disturbance:	2	2
Surface Treatment:	3	Asbestos Type:	2	Potential of Human Exposure:	2	Maintenance Activity:	1	
Material Score:	11	Material Category:	A	Priority Score:	6	Total Score (Overall):	17

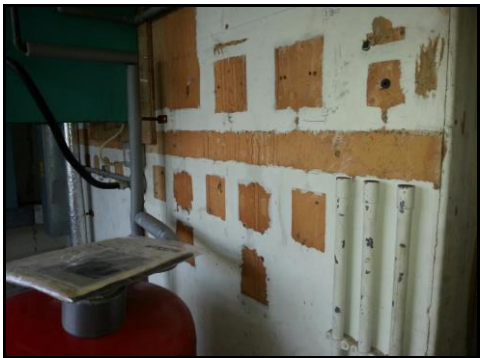
Building ID	Woodfield School
Sample No.	S0017
Floor	Ground Floor
Room No.	001
Room ID	Boiler Room (064)

Item Description	Thermal residue to wall paint lines. Left side back wall.
Material	Insulation
Asbestos Type	Amosite, Chrysotile
Extent	2m ²
Notes: Timber soffit. Plasterboard walls. Concrete floor. UPVC windows, doors and frame. MMMF insulation to pipework and internal replacement boiler. Limited access around boilers.	
Surveyor:	Steven Jones
Recommendation:	Remove

HSG 264 Material Assessment Scores				Priority Assessment Scores				Risk Priority Rating:
Product:	3	Condition:	3	Occupant Activity:	1	Likelihood of Disturbance:	2	2
Surface Treatment:	3	Asbestos Type:	2	Potential of Human Exposure:	2	Maintenance Activity:	1	
Material Score:	11	Material Category:	A	Priority Score:	6	Total Score (Overall):	17

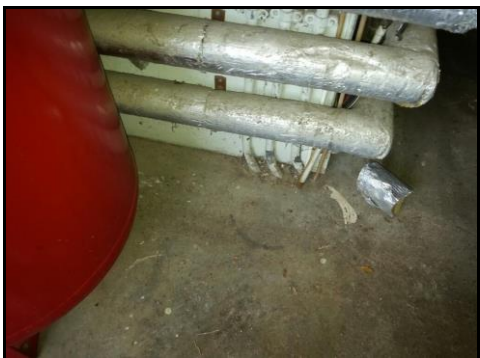
Building ID	Woodfield School
Sample No.	S0018
Floor	Ground Floor
Room No.	001
Room ID	Boiler Room (064)

Item Description	Debris to floor.
Material	Insulation
Asbestos Type	Amosite, Chrysotile
Extent	1m ²
Notes: Timber soffit. Plasterboard walls. Concrete floor. UPVC windows, doors and frame. MMMF insulation to pipework and internal replacement boiler. Limited access around boilers.	
Surveyor:	Steven Jones
Recommendation:	Remove

HSG 264 Material Assessment Scores				Priority Assessment Scores				Risk Priority Rating:
Product:	3	Condition:	3	Occupant Activity:	1	Likelihood of Disturbance:	2	2
Surface Treatment:	3	Asbestos Type:	2	Potential of Human Exposure:	2	Maintenance Activity:	1	
Material Score:	11	Material Category:	A	Priority Score:	6	Total Score (Overall):	17

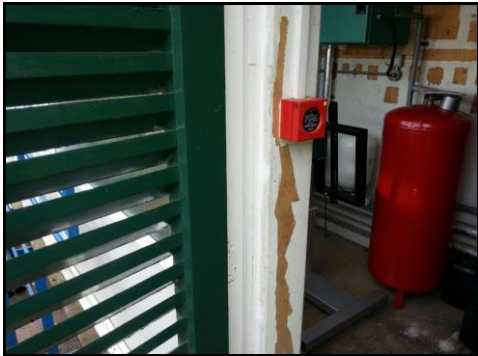
Building ID	Woodfield School
Sample No.	S0019
Floor	Ground Floor
Room No.	001
Room ID	Boiler Room (064)

Item Description	Insulating board to column casing adjacent to left door.
Material	Board
Asbestos Type	Amosite, Chrysotile
Extent	2m ²
Notes: Timber soffit. Plasterboard walls. Concrete floor. UPVC windows, doors and frame. MMMF insulation to pipework and internal replacement boiler. Limited access around boilers.	
Surveyor:	Steven Jones
Recommendation:	Remove

HSG 264 Material Assessment Scores				Priority Assessment Scores				Risk Priority Rating:
Product:	2	Condition:	1	Occupant Activity:	1	Likelihood of Disturbance:	2	2
Surface Treatment:	1	Asbestos Type:	2	Potential of Human Exposure:	2	Maintenance Activity:	1	
Material Score:	6	Material Category:	C	Priority Score:	6	Total Score (Overall):	12

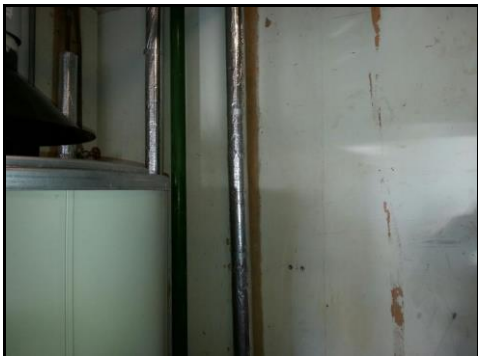
Building ID	Woodfield School
Sample No.	S0020
Floor	Ground Floor
Room No.	001
Room ID	Boiler Room (064)

Item Description	Thermal residue to wall paint lines behind pipework. Furthest back wall.
Material	Insulation
Asbestos Type	Amosite, Chrysotile
Extent	2m ²
Notes: Timber soffit. Plasterboard walls. Concrete floor. UPVC windows, doors and frame. MMMF insulation to pipework and internal replacement boiler. Limited access around boilers.	
Surveyor:	Steven Jones
Recommendation:	Remove

HSG 264 Material Assessment Scores				Priority Assessment Scores				Risk Priority Rating:
Product:	3	Condition:	2	Occupant Activity:	1	Likelihood of Disturbance:	2	2
Surface Treatment:	3	Asbestos Type:	2	Potential of Human Exposure:	2	Maintenance Activity:	1	
Material Score:	10	Material Category:	A	Priority Score:	6	Total Score (Overall):	16

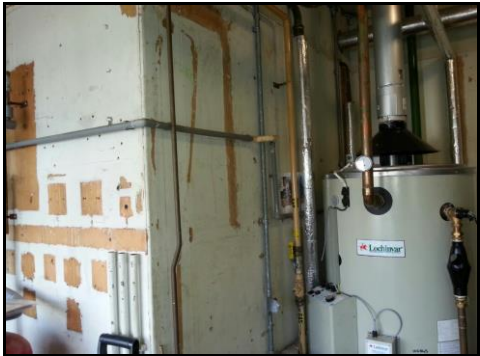
Building ID	Woodfield School
Sample No.	S0021
Floor	Ground Floor
Room No.	001
Room ID	Boiler Room (064)

Item Description	Thermal residue to wall paint lines. Left wall
Material	Insulation
Asbestos Type	Amosite, Chrysotile
Extent	2m ²
Notes: Timber soffit. Plasterboard walls. Concrete floor. UPVC windows, doors and frame. MMMF insulation to pipework and internal replacement boiler. Limited access around boilers.	
Surveyor:	Steven Jones
Recommendation:	Remove

HSG 264 Material Assessment Scores				Priority Assessment Scores				Risk Priority Rating:
Product:	3	Condition:	2	Occupant Activity:	1	Likelihood of Disturbance:	2	2
Surface Treatment:	3	Asbestos Type:	2	Potential of Human Exposure:	2	Maintenance Activity:	1	
Material Score:	10	Material Category:	A	Priority Score:	6	Total Score (Overall):	16

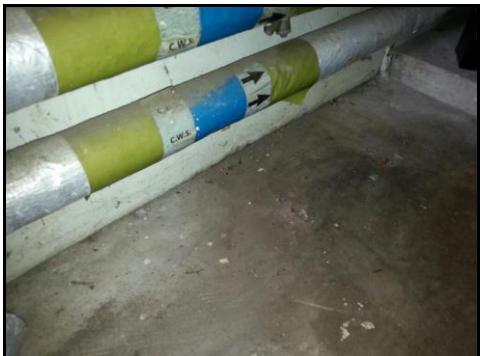
Building ID	Woodfield School
Sample No.	S0022
Floor	Ground Floor
Room No.	001
Room ID	Boiler Room (064)

Item Description	Debris to floor.
Material	Insulation
Asbestos Type	Amosite, Chrysotile
Extent	1m ²
Notes: Timber soffit. Plasterboard walls. Concrete floor. UPVC windows, doors and frame. MMMF insulation to pipework and internal replacement boiler. Limited access around boilers.	
Surveyor:	Steven Jones
Recommendation:	Remove

HSG 264 Material Assessment Scores				Priority Assessment Scores				Risk Priority Rating:
Product:	3	Condition:	3	Occupant Activity:	1	Likelihood of Disturbance:	2	2
Surface Treatment:	3	Asbestos Type:	2	Potential of Human Exposure:	2	Maintenance Activity:	1	
Material Score:	11	Material Category:	A	Priority Score:	6	Total Score (Overall):	17

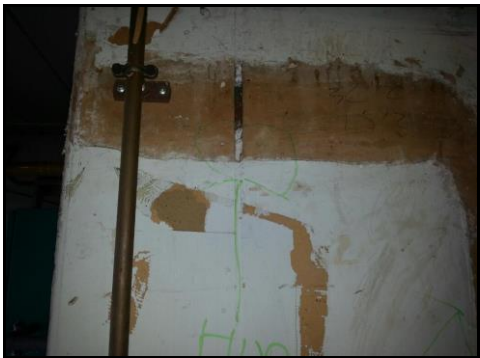
Building ID	Woodfield School		
Sample No.	S0023		
Floor	Ground Floor		
Room No.	001		
Room ID	Boiler Room (064)

Item Description	Thermal residue within wall joint.
		Material	Insulation
		Asbestos Type	Amosite, Chrysotile
		Extent	1m ²
		Notes: Timber soffit. Plasterboard walls. Concrete floor. UPVC windows, doors and frame. MMMF insulation to pipework and internal replacement boiler. Limited access around boilers.	
		Surveyor:	Steven Jones
		Recommendation:	Remove

HSG 264 Material Assessment Scores				Priority Assessment Scores				Risk Priority Rating:
Product:	3	Condition:	2	Occupant Activity:	1	Likelihood of Disturbance:	2	2
Surface Treatment:	3	Asbestos Type:	2	Potential of Human Exposure:	2	Maintenance Activity:	1	
Material Score:	10	Material Category:	A	Priority Score:	6	Total Score (Overall):	16

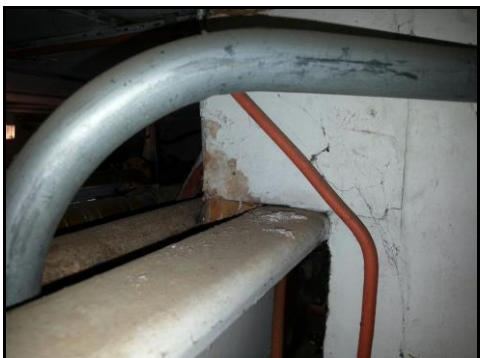
Building ID	Woodfield School		
Sample No.	S0024		
Floor	Ground Floor		
Room No.	001		
Room ID	Boiler room (064)

Item Description	Thermal residue to top of steel beam.
		Material	Insulation
		Asbestos Type	Amosite, Chrysotile
		Extent	1m ²
		Notes: Timber soffit. Plasterboard walls. Concrete floor. UPVC windows, doors and frame. MMMF insulation to pipework and internal replacement boiler. Limited access around boilers.	
		Surveyor:	Steven Jones
		Recommendation:	Remove

HSG 264 Material Assessment Scores				Priority Assessment Scores				Risk Priority Rating:
Product:	3	Condition:	3	Occupant Activity:	1	Likelihood of Disturbance:	2	2
Surface Treatment:	3	Asbestos Type:	2	Potential of Human Exposure:	2	Maintenance Activity:	1	
Material Score:	11	Material Category:	A	Priority Score:	6	Total Score (Overall):	17
