STAGE 1 ROAD SAFETY AUDIT
BINLEY CYCLEWAY – BRINKLOW ROAD TO B4082

2. **ITEMS RESULTING FROM THIS STAGE 1 ROAD SAFETY AUDIT**
BINLEY CYCLEWAY – BRINKLOW ROAD TO B4082

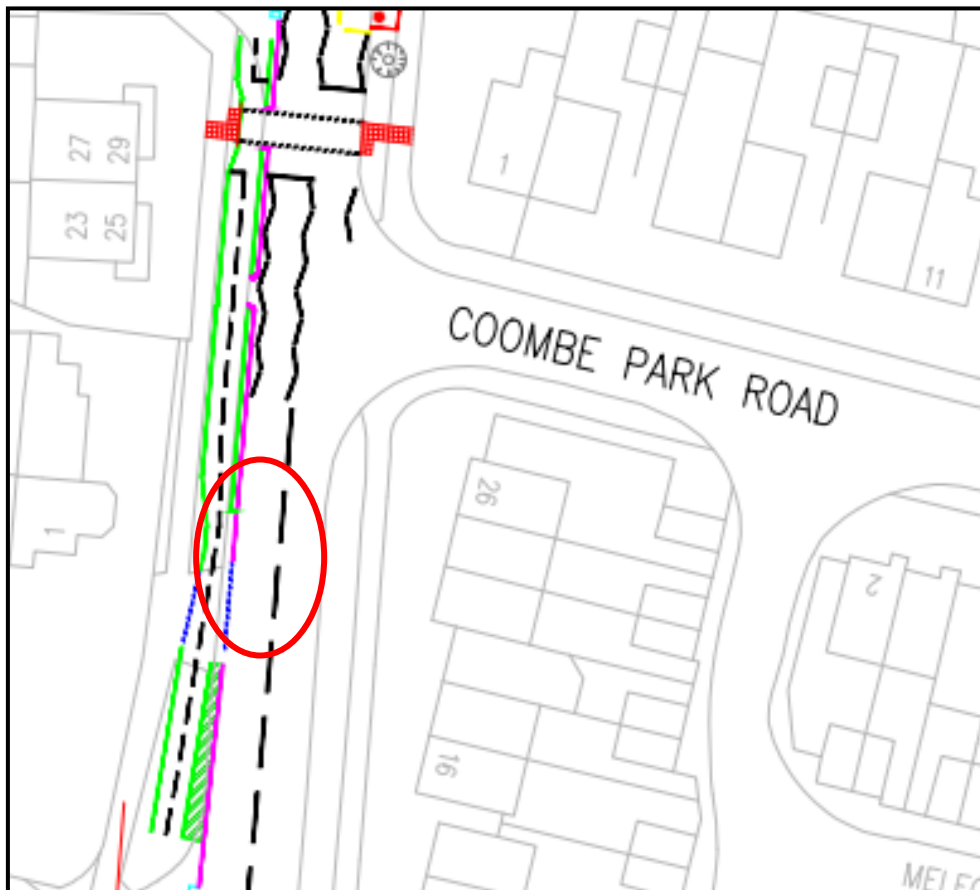
Location – Clifford Bridge Road

2.1 **Problem:** Pinch-point on cycleway

There is a significant narrowing on the cycleway, and this presents a significant road safety hazard. The dynamic kinetic envelope of the cyclist must be included into the design and the design should optimise a cyclist in motion moving laterally to maintain balance. Pinch-points and horizontal alignments on a two-way cycleway may result in cyclist head-on type personal injury collisions. In addition, cyclists may opt to use the footway to traverse this pinch-point and this significantly increases the likelihood of cyclist to pedestrian type personal injury collisions.

Redesign this section of cycleway to remove the pinch-point/ horizontal alignment. This will reduce the likelihood of cyclist head-on and cyclist to pedestrian type personal injury collisions.

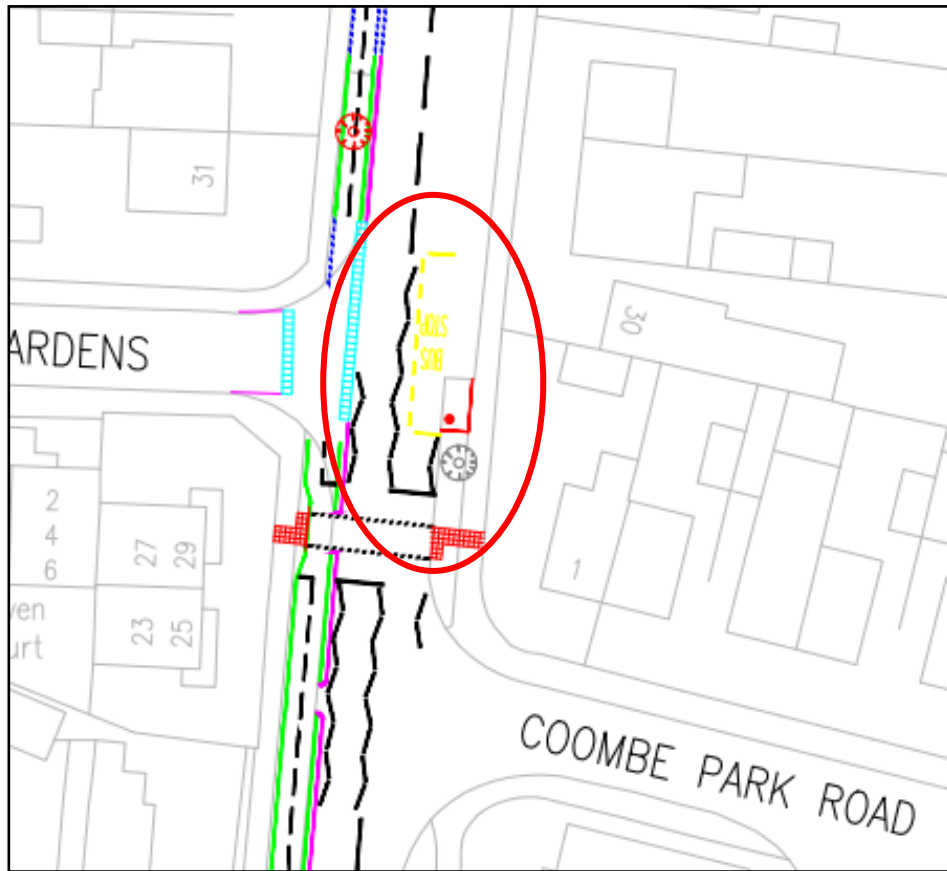
Location - Opposite Numbers 29 & 31 Clifford Bridge Road and junction of Bridgeacre Gardens

2.2 Problem: Bus Stop location on the approach to controlled crossing

The bus stop relocation is on the approach to the proposed formal pedestrian crossing, and in particular the signal heads. Buses waiting within the bus stop will significantly reduce the conspicuity of the signal heads (for vehicles on the approach from north to south) and this significantly increases the risk of vehicle to vehicle and vehicle to pedestrian type personal injury collisions.

Relocate the bus stop away from the formal pedestrian crossing. Relocating the bus stop may significantly reduce the likelihood of vehicle-to-vehicle and vehicle to pedestrian type collisions.

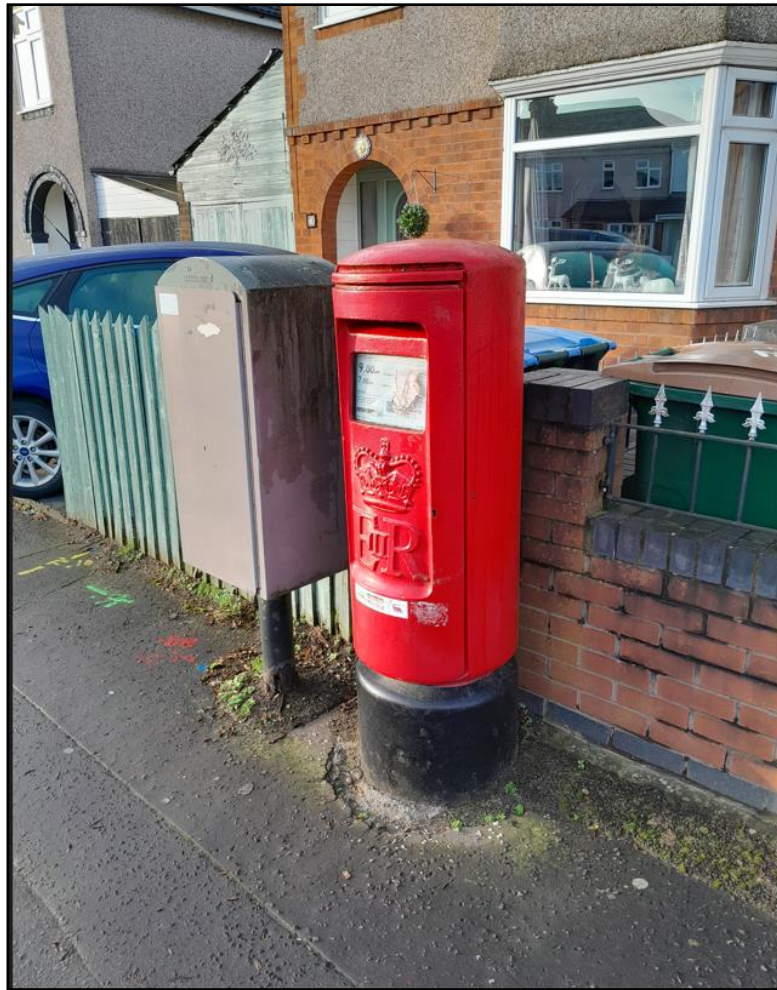
Location – Post-Box in-between Property 71 and 73 Clifford Bridge Road

2.3 Problem: Existing Post-Box on scheme route

There is an existing Post Box that will create a significant narrowing of the footway, and this presents a safety hazard. A pedestrian, particularly if using a mobility scooter, may have to enter the cycleway to traverse this location, which would involve negotiating the 45' kerb and travelling along the cycle track, which is at a lower height. This may result in conflicts with cyclists or a mobility scooter or wheelchair tipping over. This significantly increases the likelihood of cyclist to pedestrian type personal injury collisions.

Redesign this section of the footway and cycleway to either relocate or remove the Post Box thereby removing the obstacle. This will reduce the likelihood of cyclist to pedestrian type personal injury collisions.

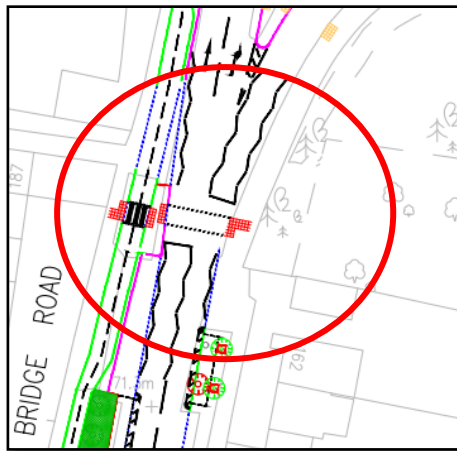
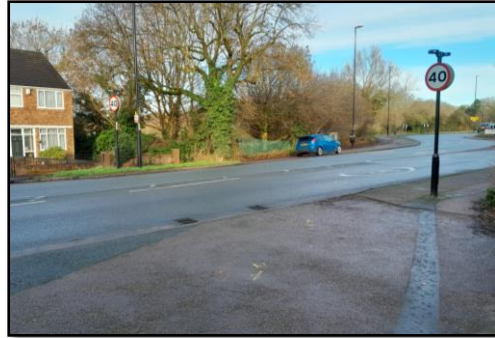
Location – Outside Property 187 Clifford Bridge Road

2.4 Problem: 40mph Speed Limit on Approach to Controlled Pedestrian Crossing

The controlled pedestrian crossing is being proposed in close proximity to the 40mph speed limit. Inappropriate speeds on the approach to a formalised pedestrian crossing significantly increases the likelihood of vehicle to pedestrian type personal injury collisions.

Reduce the speed limit on the approach to the pedestrian crossing facility. In addition, ensure there is high friction surfacing on the approaches to the formal crossing facility. The reduction in the speed limit and the installation of the high friction surfacing will reduce the likelihood of vehicle to pedestrian type personal injury collisions.

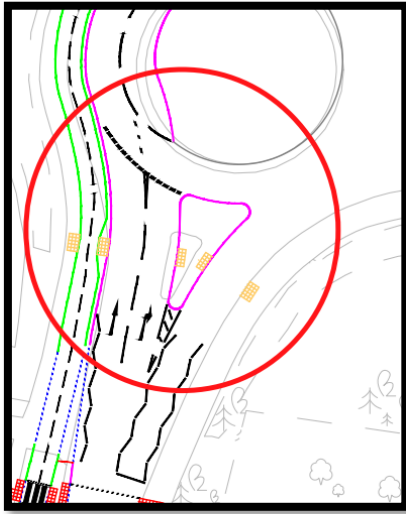
Location – On southern splitter island of northern roundabout

2.5 Problem: Location of Uncontrolled Pedestrian Crossing

An uncontrolled pedestrian crossing is being proposed across the southern splitter island to the roundabout junction. It is in an area of 40mph speed limit where westbound drivers will have recently left a national speed limit carriageway and there is reduced forward visibility of a pedestrian standing on the eastern side of the road. The location of a crossing point at this location significantly increases the likelihood of vehicle to pedestrian type personal injury collisions.

Formalise the existing dropped kerb arrangement on the northern splitter island, as the proposed controlled crossing point on the southern splitter island is only approx. 25m from the controlled crossing location.

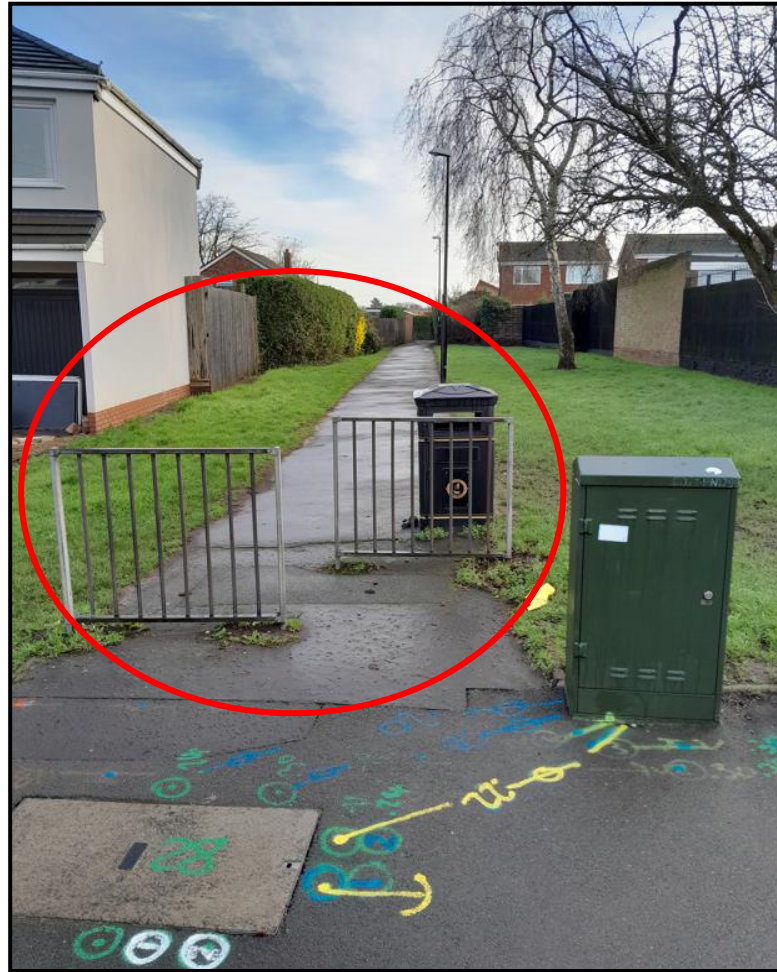
Location – In-between Property Numbers 100 and 98

2.6 Problem: Cycle Prevention Gate

There is an existing cycle prevention gate in between properties 98 and 100 Clifford Bridge Road, the drawing shows a proposed 45' kerb down the middle of this route, it is assumed this becomes a segregated pedestrian and cycle path. The cycle prevention gates are in-line with the proposed cycle track route from Clifford Bridge Road. At the eastern end of the path (between 147 & 149 Coombe Park Road) there appears insufficient width to provide this facility, this significantly increases the likelihood of pedestrian (and other vulnerable footway user) to cyclist personal injury collisions.

Remove the cycleway gate and provide adequate "shared-use" facilities at this location. This will reduce the likelihood of cyclist to vulnerable footway user personal injury.

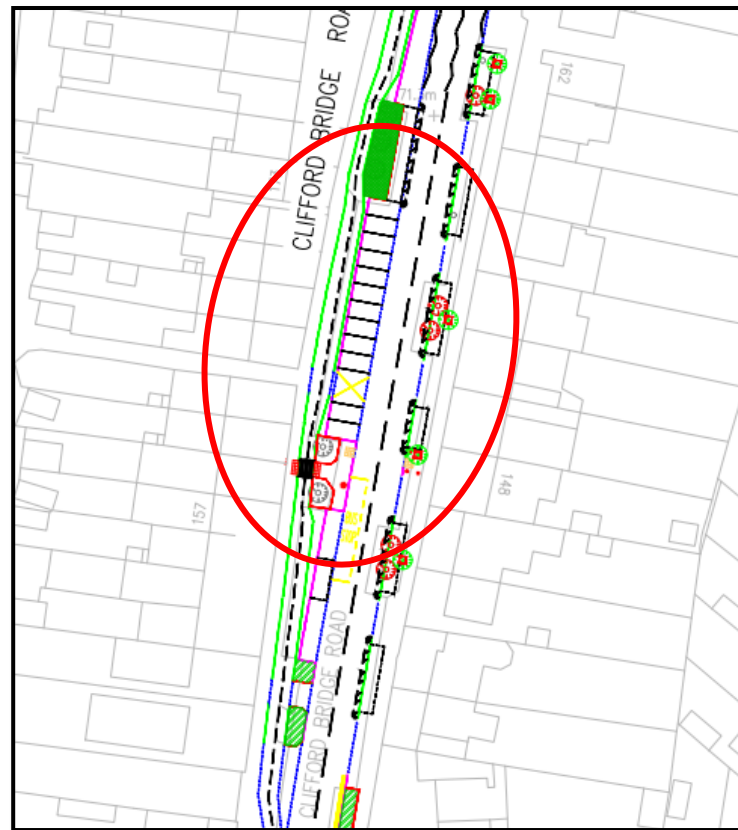
Location – See Plan

2.7 Problem: Perpendicular Parkin

There is existing informal perpendicular parking at the location as indicated by the screenprint above and the problem location plan. This proposal formalises this arrangement. However, this presents a road safety problem as it is in close proximity to the proposed pedestrian crossing facility. Subsequently, drivers using the parking spaces will be required to undertake numerous turning manoeuvres to park and this may distract drivers' attention travelling on Clifford Bridge Road. This significantly increases the likelihood of driver-to-driver personal injury collisions.

Redesign the parking spaces to echelon as this will reduce the need for numerous turning manoeuvres and this will reduce driver distraction on the approach to the formal crossing facility. This will reduce the likelihood vehicle to vehicle type personal injury.
