EARLSDON LIVEABLE NEIGHBOURHOOD SCHEME
STAGE 3 ROAD SAFETY AUDIT

- 1.1** This report describes a Stage 3 Road Safety Audit carried out in Earlsdon, Coventry. The scheme drawings were designed and submitted by Coventry City Council, Transport & Infrastructure Team.

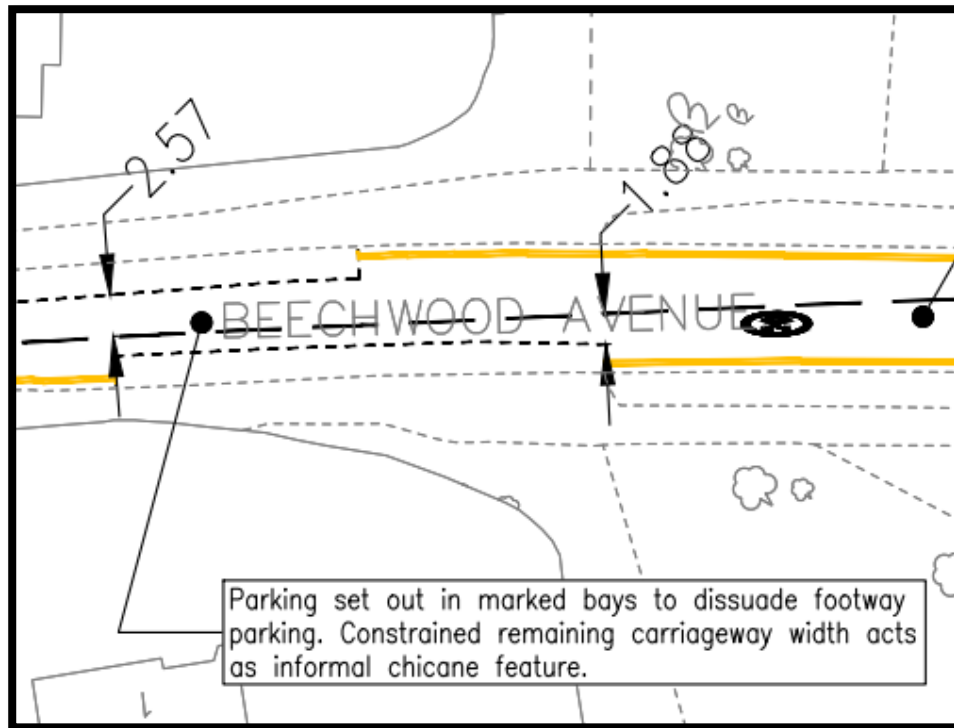
Location: Beechwood Avenue, southeast of Stoneleigh Avenue

2.1 **Problem** – Risk of collisions at pinch point

Parking bays are proposed opposite each other. This reduces the width of the available carriageway when both parking bays are occupied to one car width and increases the risk of conflicts between vehicles, and between vehicles and cyclists.

The Audit Team are not satisfied that this item has been resolved and therefore this road safety problem remains outstanding.

Parking bays should be staggered to facilitate two-way traffic to reduce the potential of personal injury collisions related to the reduced carriageway width.

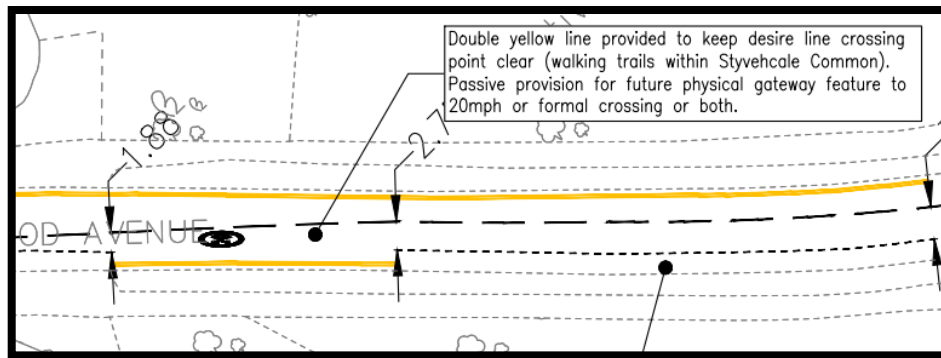
Location: Beechwood Avenue, southeast of Woodlands Avenue

2.2 Problem – Lack of pedestrian crossing point on desire line

No pedestrian and cycle crossing facilities are proposed on the identified desire line between trails within Styvechale Common. This increases the risk of vehicle colliding with vulnerable road users (particularly those with visual and/or mobility impairments, those with pushchairs, and cyclists) as they cross.

The Audit Team are not satisfied that this item has been resolved and therefore this road safety problem remains outstanding.

Pedestrian crossing facilities should be provided on the desire line. This will reduce personal injury collisions related to vulnerable road users crossing at informal crossing points.

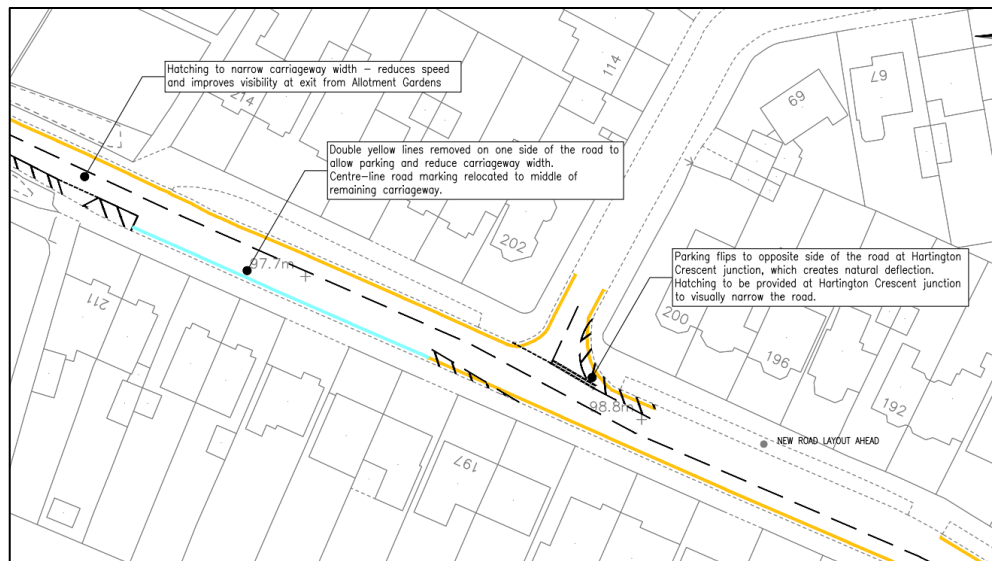
Location: Beechwood Avenue, adjacent to Hartington Crescent

2.3 Problem – Lack of road markings at end of hatching

There are no parking bay or other road markings proposed at the end of the sections of hatching. As a result, drivers are more likely to encroach into the hatching. This increases the risk of vehicles on Beechwood Avenue colliding with vehicles waiting on Hartington Crescent or at the egress from the allotments.

The Audit Team are not satisfied that this item has been resolved and therefore this road safety problem remains outstanding.

Road markings should be provided at the end of the sections of hatching.

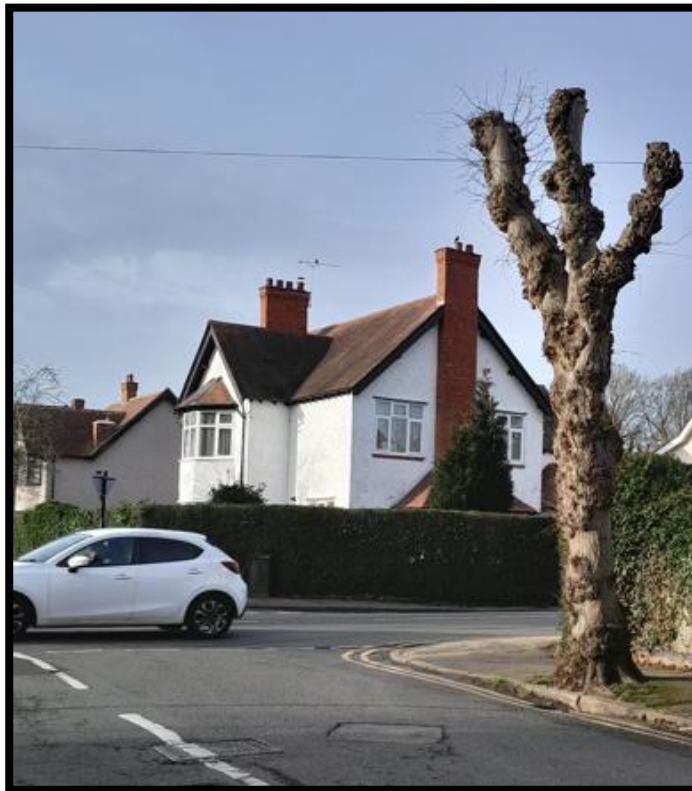
Warwick Avenue, junction with Beechwood Avenue

2.4 Problem – Lack of pedestrian crossing points at junctions

The submitted drawings for the above junctions do not show pedestrian crossing points and tactile paving. A lack of designated pedestrian crossing points may result in visually-impaired pedestrians crossing at an unsafe location. This increases the risk of vehicle to pedestrian type collisions.

Designated pedestrian crossing points with tactile paving should be provided at all junctions. The crossing points should be in locations that maximise inter-visibility between pedestrians and drivers and take into account the presence of trees in the footway (see example below).

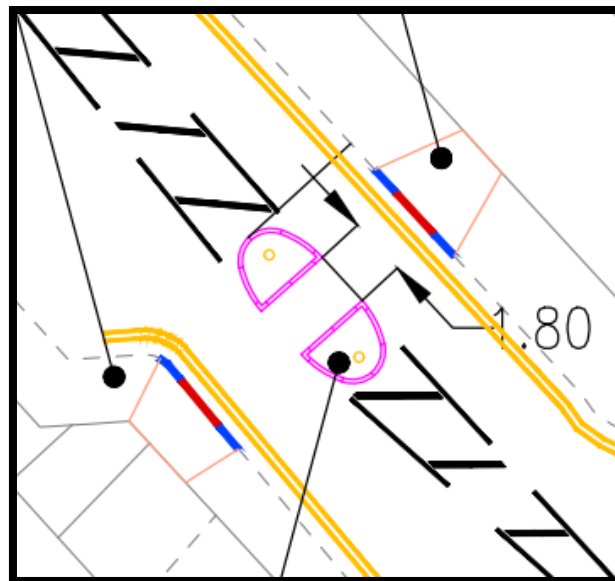
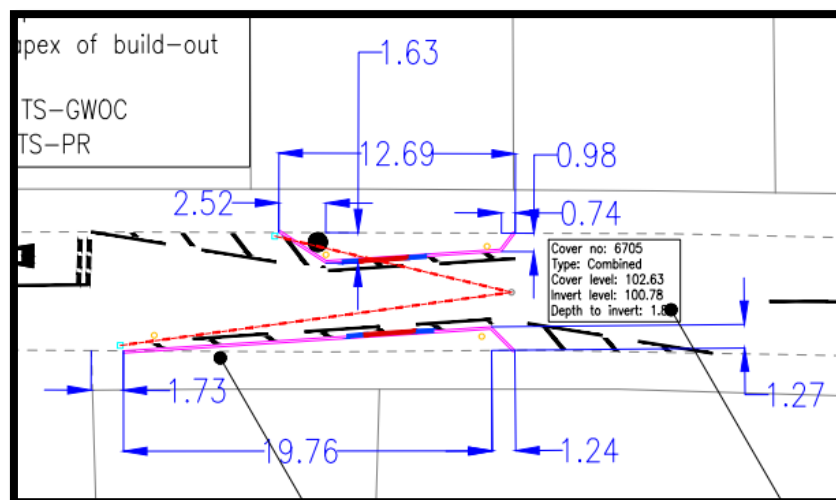
Location: Beechwood Avenue, north of Styvechale Avenue

2.6 Problem – Width of carriageway at pedestrian refuge and priority chicane

The submitted plans do not specify the width of the carriageway at the proposed pedestrian refuge and priority chicane. Carriageway widths of between 3.1m and 3.9m at pinch points can result in close overtaking of cyclists by drivers. This increases the risk of vehicle to cyclist type collisions.

The Audit Team are not satisfied that this item has been resolved and therefore this road safety problem remains outstanding.

The carriageway width either side of the refuge and at the chicane should be a minimum of 3.9m, or cycle bypasses should be provided.

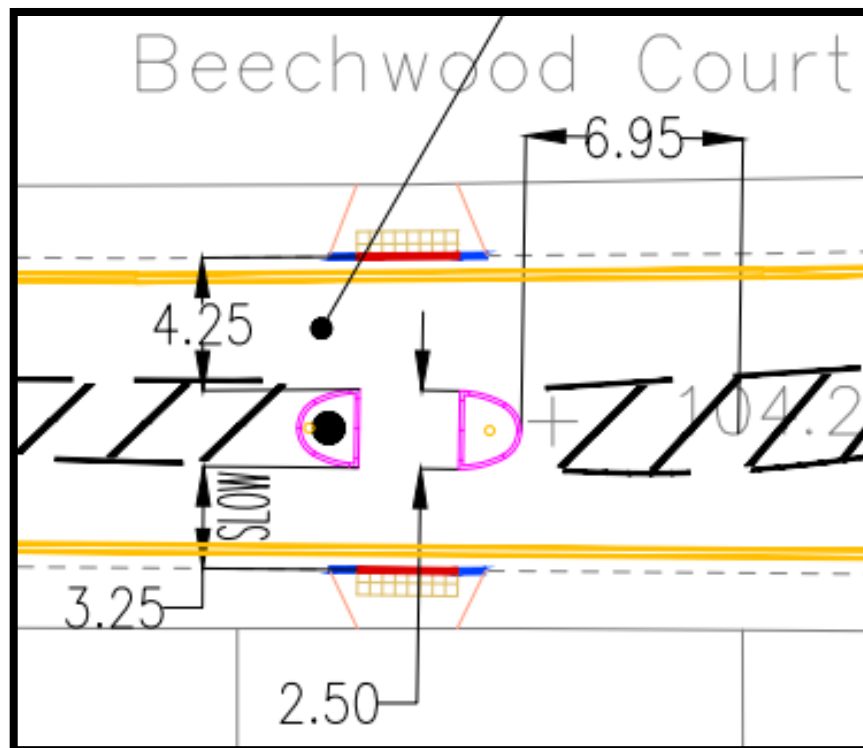
Location: Beechwood Avenue, south of Rochester Road

2.8 Problem – Width of carriageway at pedestrian refuge

The proposed width of the westbound traffic lane at the proposed pedestrian refuge is 3.25m. Carriageway widths of between 3.1m and 3.9m at pinch points can result in close overtaking of cyclists by drivers. This increases the risk of vehicle to cyclist type collisions.

The Audit Team are not satisfied that this item has been resolved and therefore this road safety problem remains outstanding.

The carriageway width either side of the refuge should be a minimum of 3.9m.

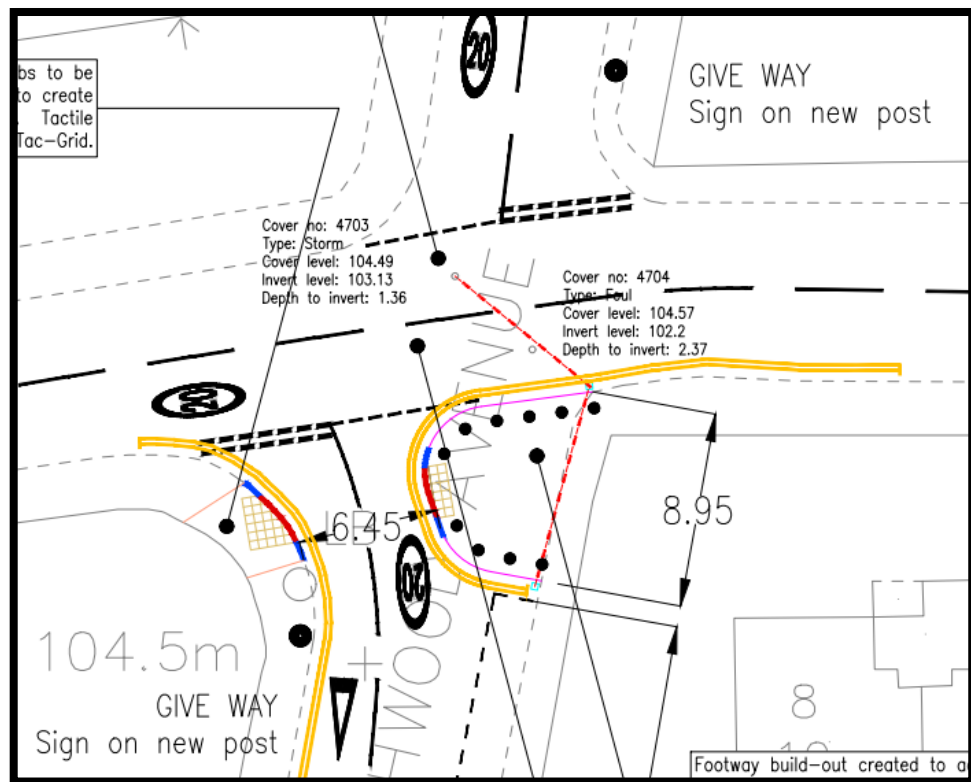
Location: Beechwood Avenue, junction with Rochester Road

2.9? Problem – Junction geometry

The submitted plans do not include vehicle tracking to demonstrate that large vehicles can undertake all movements at the junction safely. Large vehicles may have to enter the path of oncoming traffic or overhang the footway in order to manoeuvre through the junction. This increases the risk of vehicle to vehicle and vehicle to pedestrian type collisions.

The Audit Team are not satisfied that this item has been resolved and therefore this road safety problem remains outstanding?

An assessment of vehicle swept paths should be undertaken and any necessary changes made to the proposed highway layout to ensure that large vehicles can undertake all movements at the junction safely.

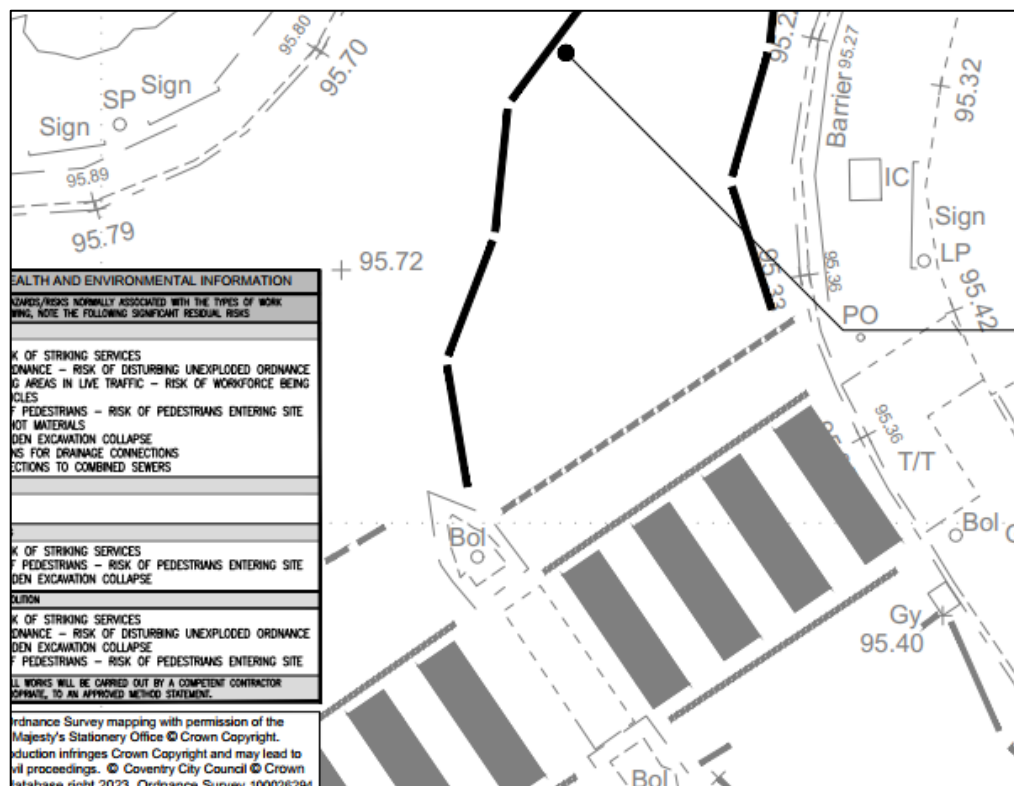
Location: Earlsdon Avenue South

2.10 Problem – Proximity of zebra crossing to roundabout

The zebra crossing is located immediately adjacent to the roundabout. This increases the risk that drivers concentrating on negotiating the roundabout not seeing a pedestrian crossing. Furthermore, vehicles exiting the roundabout have to wait in the circulatory area to allow pedestrians to cross and a vehicle waiting at the give way line of the roundabout obstructs the zebra crossing. These issues increase the risk of rear shunts and vehicle to pedestrian type collisions.

The Audit Team are not satisfied that this item has been resolved and therefore this road safety problem remains outstanding.

The zebra crossing should be relocated away from the roundabout to enable vehicles to wait without obstructing the circulatory area or the zebra crossing.

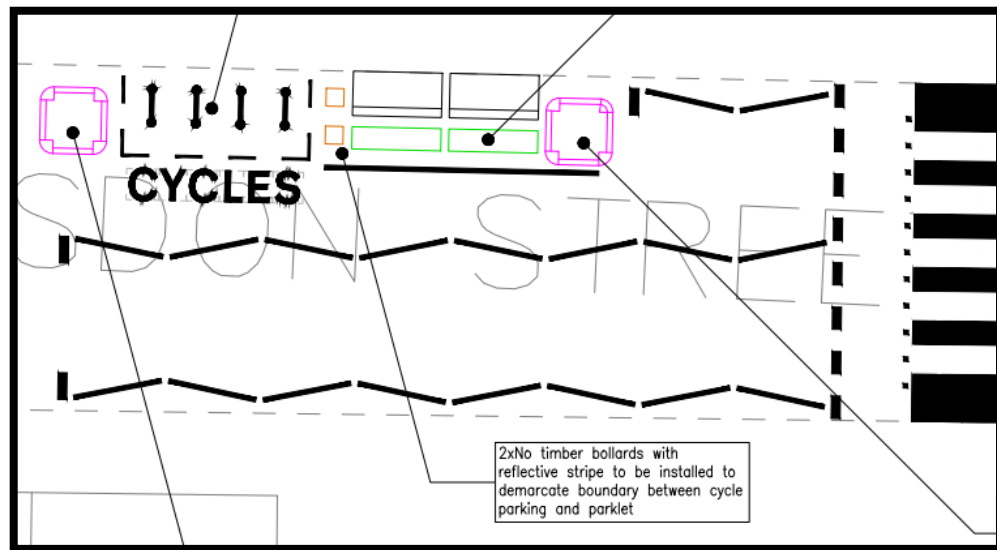
Location: Earlsdon Street, on approach to zebra crossing

2.13 Problem – Street furniture in visibility splay

Street furniture including cycle parking and seating is proposed in the pedestrian visibility splay and current controlled area of the zebra crossing. This may obstruct drivers' visibility of pedestrians waiting at the crossing and reduces the width of the north eastbound traffic lane to less than the minimum width required. This increases the risk of vehicle to vehicle and vehicle to pedestrian type collisions.

The Audit Team are not satisfied that this item has been resolved and therefore this road safety problem remains outstanding.

The proposed street furniture should be relocated outside the extents of the current controlled area.

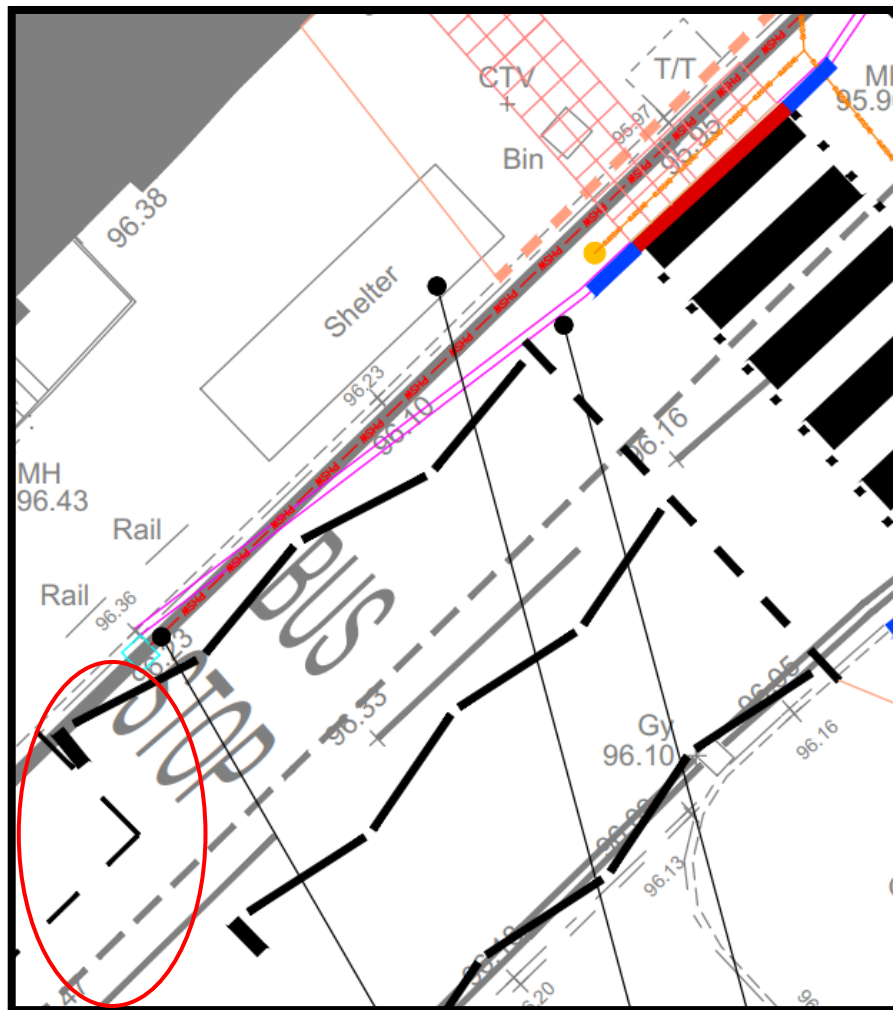
Location: Earlsdon Street

2.14 Problem – Parking bay on approach to proposed zebra crossing

A parking bay is proposed on the approach to the zebra crossing. Vehicles parked in the bay may reduce the intervisibility between drivers and pedestrians. This increases the risk of vehicle to pedestrian type collisions.

The Audit Team are not satisfied that this item has been resolved and therefore this road safety problem remains outstanding.

The controlled area of the zebra crossing should be extended.

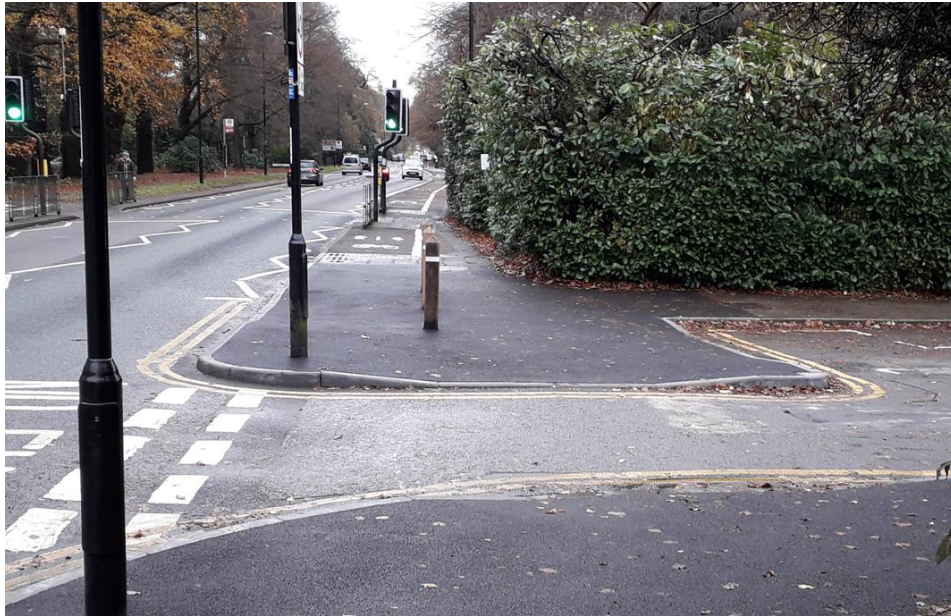
Location: Kenilworth Road / Stoneleigh Avenue

4.1 Problem – Lack of tactile paving

The junction has been changed; however, it does not have any tactile paving. Subsequently, visually impaired pedestrians will be unable to traverse this section of road safely. This significantly increases the likelihood of vehicle to pedestrian type personal injury collisions.

Install tactile paving at this location. This will significantly reduce the likelihood of vehicle to pedestrian type personal injury collisions.

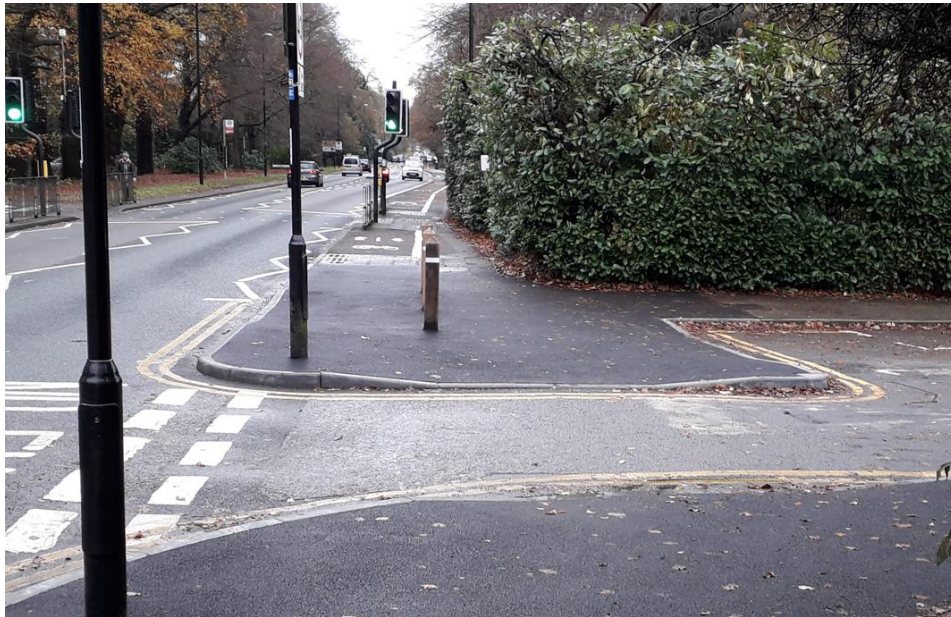
Location: Kenilworth Road / Stoneleigh Avenue

4.2 Problem – Lack of shared-use signage

There is a lack of signage indicating to pedestrians and cyclists that they are entering a section of shared-use footway / cycleway. This increases the likelihood of cyclist to pedestrian type personal injury collisions.

Install shared-use signage at this location. This will reduce the likelihood of cyclist to pedestrian type personal injury collisions.

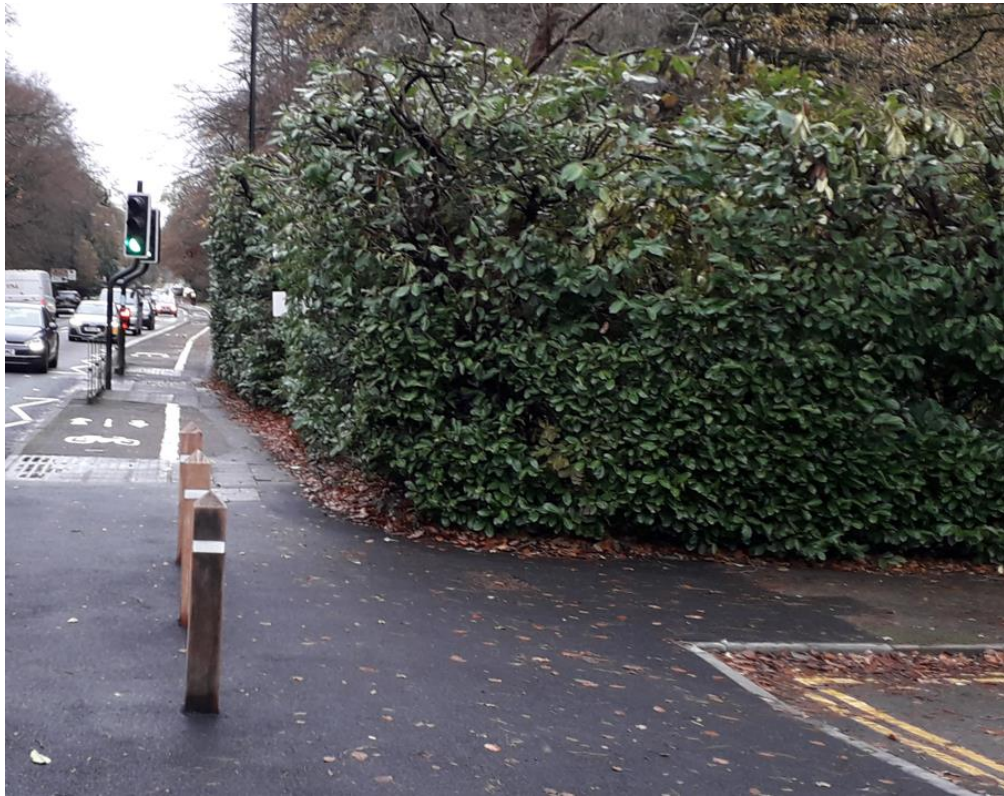
Location: Kenilworth Road / Stoneleigh Avenue

4.3 Problem – Vegetation obstructing footway

Vegetation is obstructing the footway. As a result, pedestrians may enter the cycle track. This increases the likelihood of cyclist to pedestrian type personal injury collisions.

Clear the vegetation from the footway and ensure that the vegetation is regularly maintained. This will reduce the likelihood of cyclist to pedestrian type personal injury collisions.

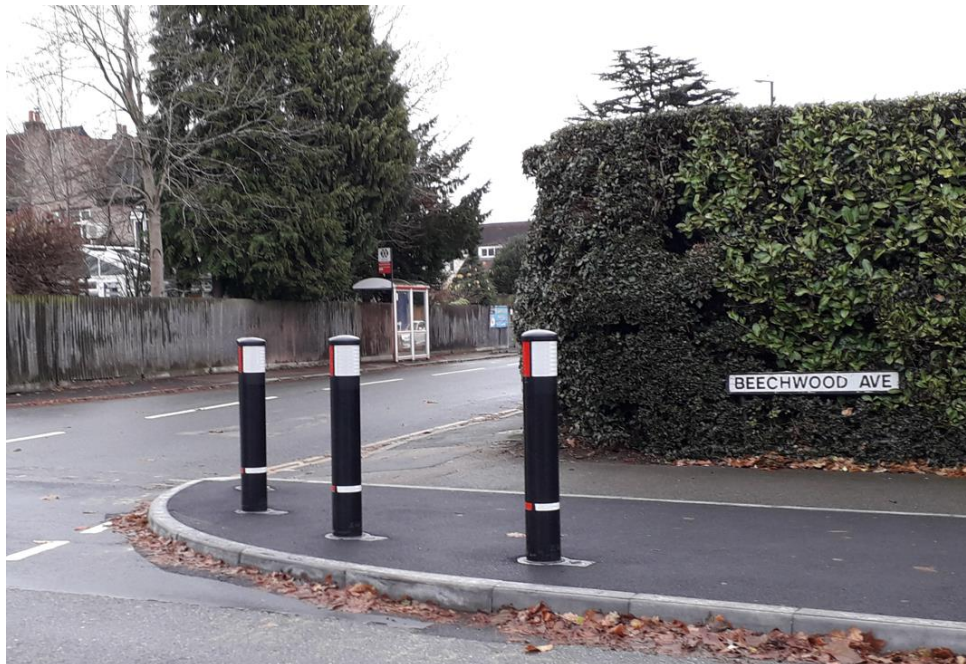
Location: Beechwood Avenue/ Rochester Road

4.4 Problem – Sideway Visibility

The priority of the junction has been changed, however, as highlighted in the photograph above, “Y” visibility has significantly reduced. Subsequently, drivers will have to drive into Rochester Road. This increases the likelihood of vehicle to vehicle type personal injury collisions.

Re-design the junction to ensure safe “Y” visibility is achieved on both approaches on Beechwood Avenue.

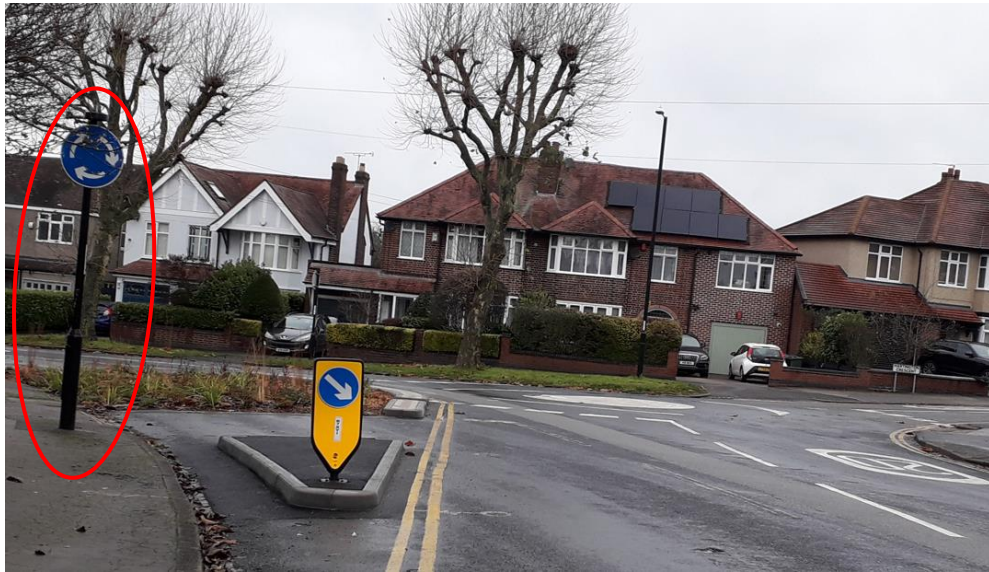
Location: Beechwood Avenue

4.5 Problem – Conspicuity of the Roundabout Sign

The conspicuity of the roundabout sign is significantly reduced. This may reduce drivers' awareness of the roundabout and this significantly increases the likelihood of vehicle to vehicle type personal injury collisions.

Relocate the sign to maximise drivers' awareness of the roundabout junction.

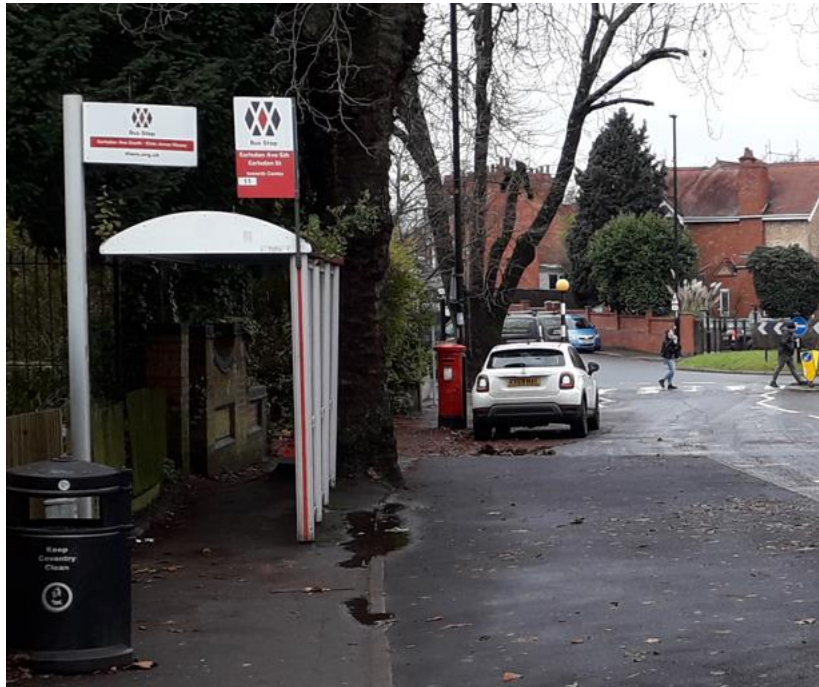
Location: Earlsdon Avenue South

4.6 Problem – Drainage

The crossfall of the build-out has been constructed with a gradient that flows water towards the bus stop. This is resulting in significant water pooling. In adverse weather, this may result in water freezing and this increases the likelihood of pedestrian trip/slip type personal injury collisions.

Reconstruct the footway buildout or install additional drainage facilities to prevent ponding. This will significantly reduce the likelihood of slip/trip type personal injury collisions.
