# London Road/Abbey Road Improvements – RSA Stage 1 Designer Responses

For Coventry City Council

Nov 2022

LAR-JUN-HWY-RSA1-DOC-SM-0001-Rev-01

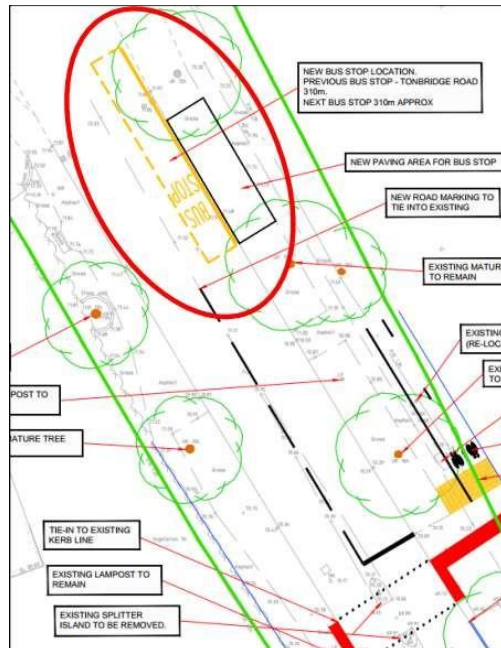
Proposed bus stop location – London Road

The bus stop relocation is on the approach to the proposed signalised junction, and in particular the signal heads. Buses waiting within the bus stop will significantly reduce the conspicuity of the signal heads (for vehicles on the approach from north-west to south-east) and this significantly increases the risk of vehicle to vehicle and vehicle to pedestrian type personal injury collisions.

Relocate the bus stop to a safer position. This will significantly reduce the likelihood of vehicle-to-vehicle and vehicle to pedestrian type collisions.

The proposed position was discussed on site between Scott Mills and Martin Wilkinson. It was felt that the location indicated provided better visibility of the bus as vehicles approached the junction. London Road is relatively straight as the screen shot below indicates. Alternative locations are possible and were discussed. If the location was moved another 30m north (towards Pinley roundabout, ASDA) then this would clash with the northbound bus stop. This would create an un-desired pinch point for vehicular traffic between the buses. Moving the bus stop much further northbound would make the travel between bus stops greater than the recommended 400m. The distance is currently approx. 330m, so moving further north would increase this to 400m.

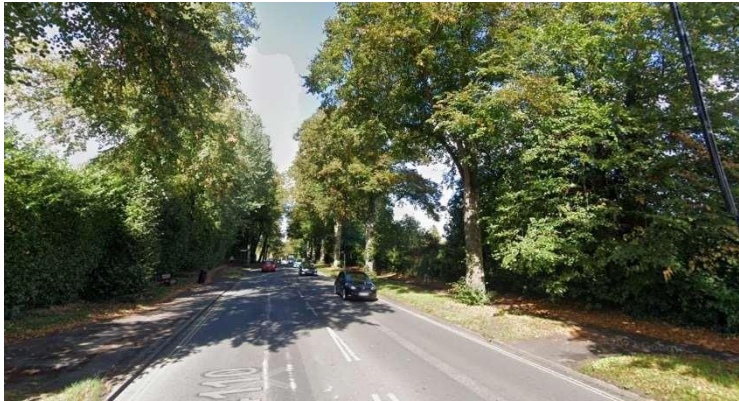
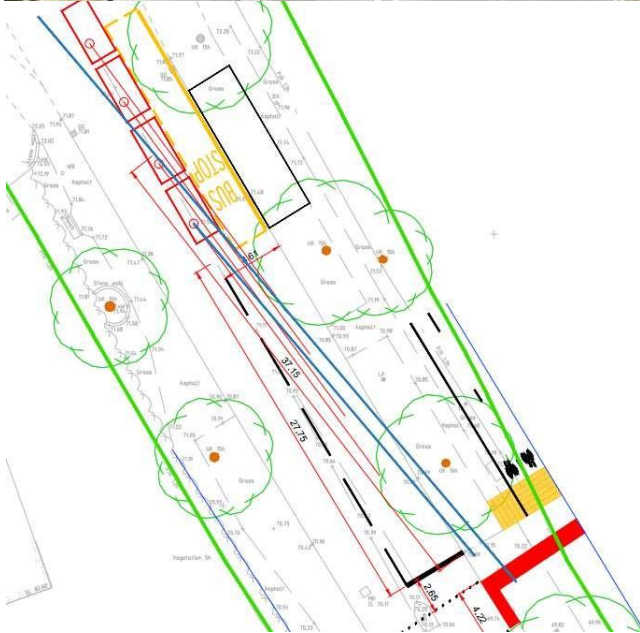
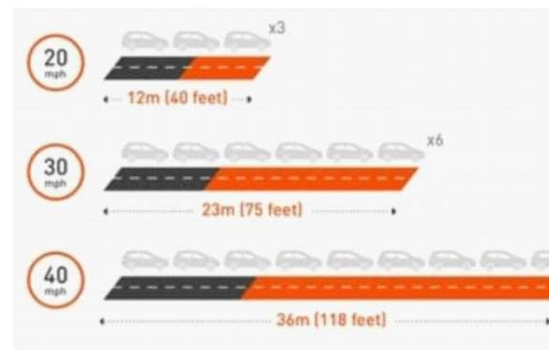
It is also noted that the bus stop is located 27.75m from the proposed STOP LINE. At 30mph the braking distance is 23m. It has been tracked back to anticipate a vehicle overtaking the bus and it appears feasible that the signal head could be seen from 37m, as shown below.

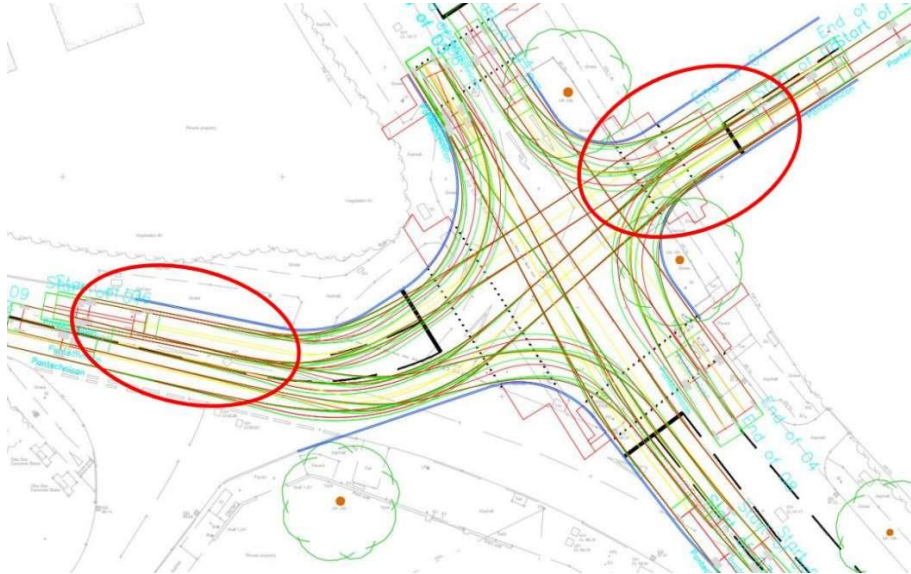
Swept path analysis – issues with overlapping of kerbs and encroachment into adjacent lanes. Abbey Road junction and new access.

The submitted swept path drawing clearly demonstrates road safety problems related to vehicles turning from London Road into Abbey Road and the new proposed access road. As highlighted in the screen-print below, larger vehicles making the left turn manoeuvre from London Road traverse the central carriageway markings and this significantly increases the likelihood of vehicle to vehicle type personal injury collisions.

Make changes to the design so that larger vehicles can make the left-turn manoeuvre from London Road into Abbey Road and the new access road without traversing the central carriageway markings. This will significantly reduce the likelihood of vehicle to vehicle collisions

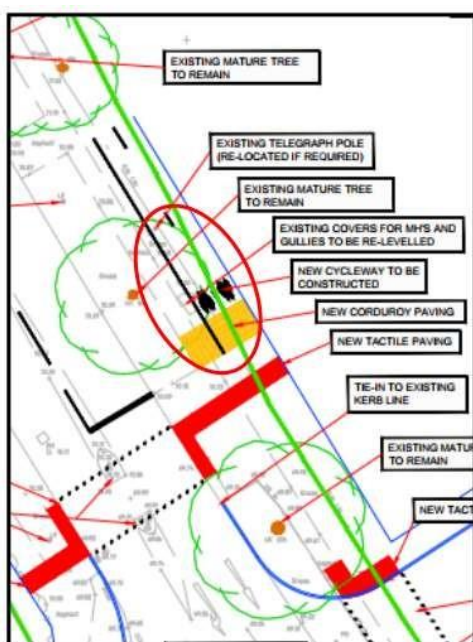
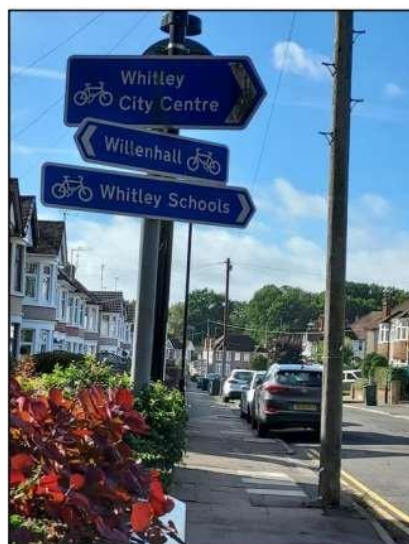
Various cycleway facilities – through scheme

The proposed cycleway on the north-eastern side of London Road is unorthodox as the cyclists will be situated on the inside and pedestrians in the middle adjacent to the road. Cycleways are normally installed adjacent to the highway as they travel faster than pedestrians, and its good practice to keep pedestrians away from higher modes of transport. In addition, cyclists adjacent to the highway are not close to the verge/ trees or street furniture. Installing a cycleway at the back of the footway and pedestrians in the middle of the footway significantly increases the likelihood of cycle to pedestrian type personal injury collisions. The relocation of the footway adjacent to the carriageway also results in pinch points for wheelchair and mobility scooter users due to existing trees, which may result in them having to use the cycle track, which will increase the likelihood of cycle to pedestrian type personal injury collisions.

1. Re-examine the cycleway design on the north-eastern side of the scheme
2. Ensure the proposed cycleway infrastructure is connected to the existing

This comment is being addressed as part of the continuing design. The north-eastern cycleway will be switched with the footway so it is closer to the main highway.

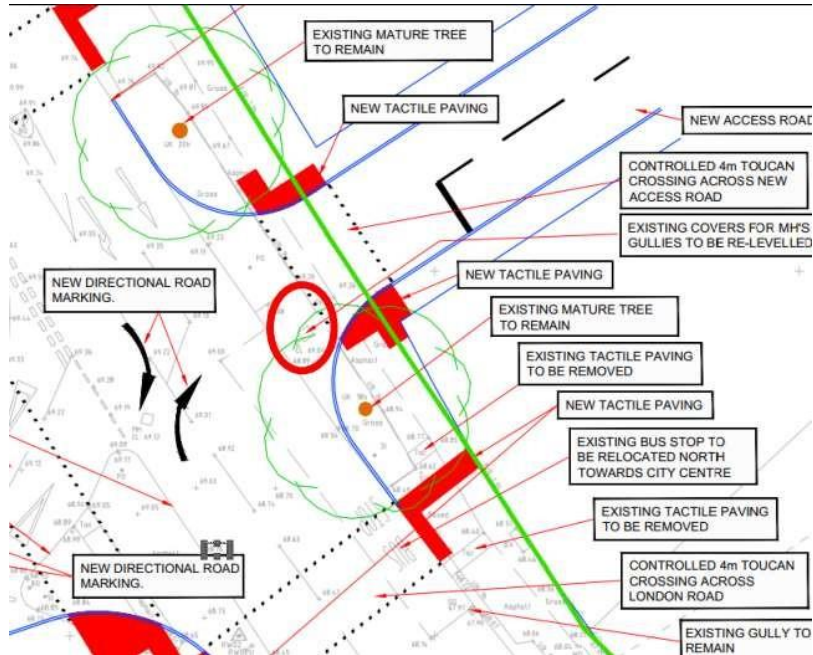
Service covers on London Road

The existing covers are to be re-levelled but will remain in situ. This location is where a high proportion of vehicles will be turning out of the new access into London Road. Having service covers at on a corner increases the risk of vehicles skidding and also increases the likelihood of the service cover failing and becoming a maintenance issue. This increases the likelihood of vehicle to vehicle type personal injury collisions

Relocate the service covers so that it does not cause any road safety hazards.

The designer will co-ordinate with the design and the statutory undertakers to determine the extent of works.

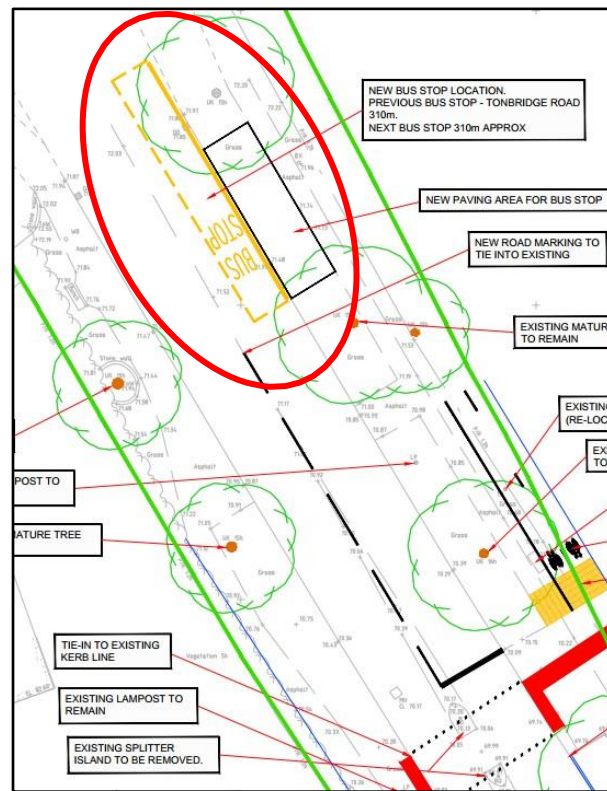
**Location:** London Road - see screen-print

*The bus stop relocation is on the approach to the proposed signalised junction, and in particular the signal heads. Buses waiting within the bus stop will significantly reduce the conspicuity of the signal heads (for vehicles on the approach from north-west to south-east) and this significantly increases the risk of vehicle to vehicle and vehicle to pedestrian type personal injury collisions.*

*Relocate the bus stop to a safer position. This will significantly reduce the likelihood of vehicle-to-vehicle and vehicle to pedestrian type collisions.*

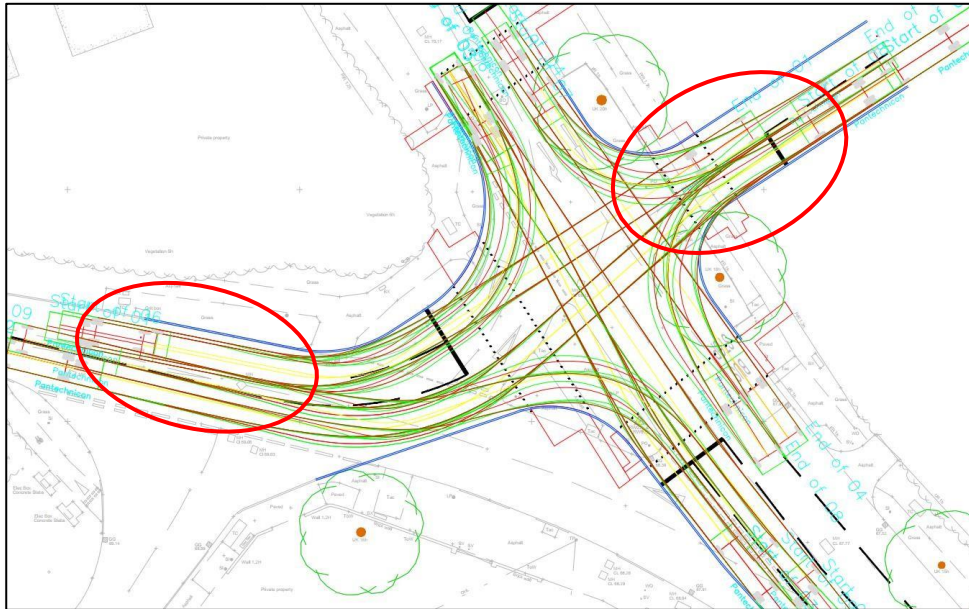
**Location** – Abbey Road and new access

*The submitted swept path drawing clearly demonstrates road safety problems related to vehicles turning from London Road into Abbey Road and the new proposed access road. As highlighted in the screen-print above, larger vehicles making the left turn manoeuvre from London Road traverse the central carriageway markings and this significantly increases the likelihood of vehicle to vehicle personal injury collisions.*

*Make changes to the design so that larger vehicles can make the left-turn manoeuvre from London Road into Abbey Road and the new access road without traversing the central carriageway markings. This will significantly reduce the likelihood of vehicle to vehicle collisions.*

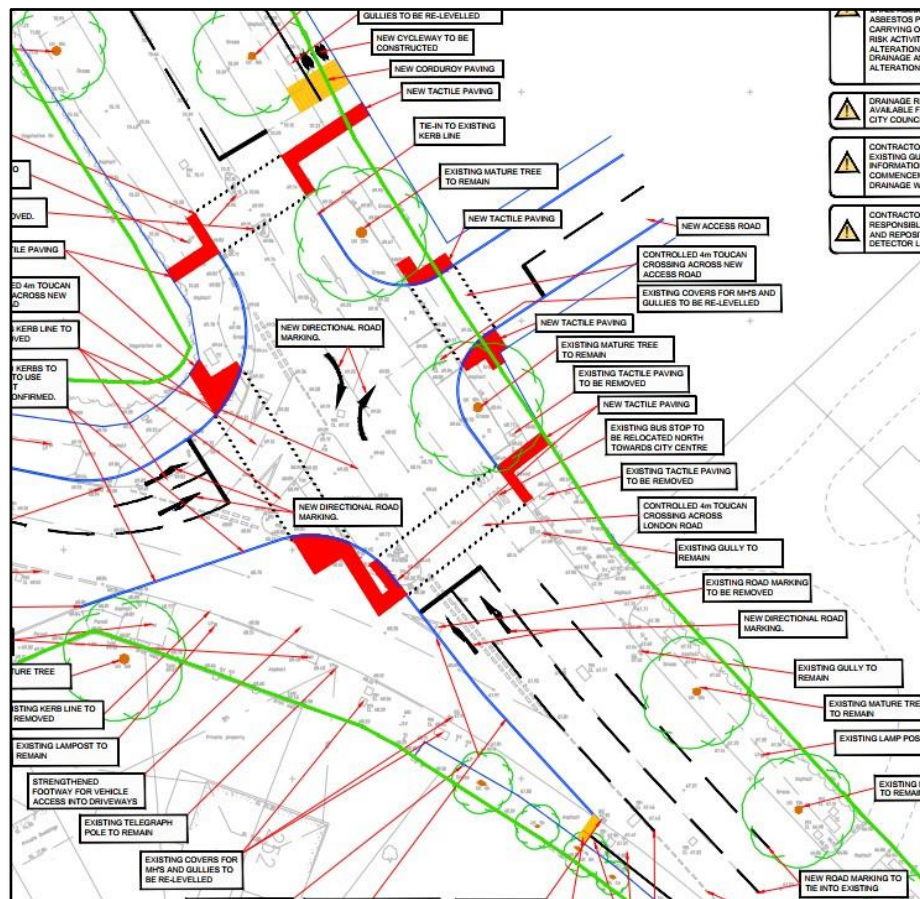
**Location** – London Road - throughout scheme

*The proposed highway lining and signage is inadequate and this compromises safety throughout the scheme. The drawing highlights incorrect carriageway markings such as diag 1004 whereby they should be to diag 1005; this may result in driver confusion. In addition, there are no proposed advanced direction arrows on any of the approaches, and subsequently this may result in late driver decision making and this may result in personal injury collisions related to side-swipes.*

*The approach to Abbey Road (drivers travelling from south-east to north-west) is confusing for drivers as there is no guidance. The lack of lining, such as bifurcation markings, significantly increases the likelihood of vehicle-to-vehicle personal injury collisions.*

1. Evaluate the proposed lining and signing to ensure it is adequate and satisfies the requirements set out in TSRGD.
2. Install "wicket" signs to compliment the carriageway markings

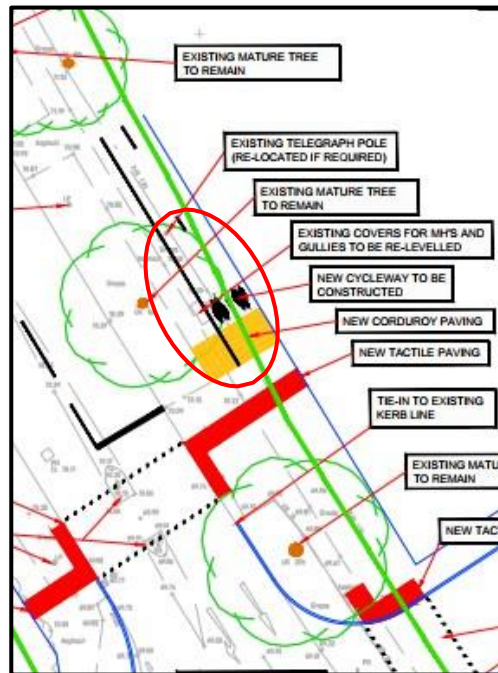
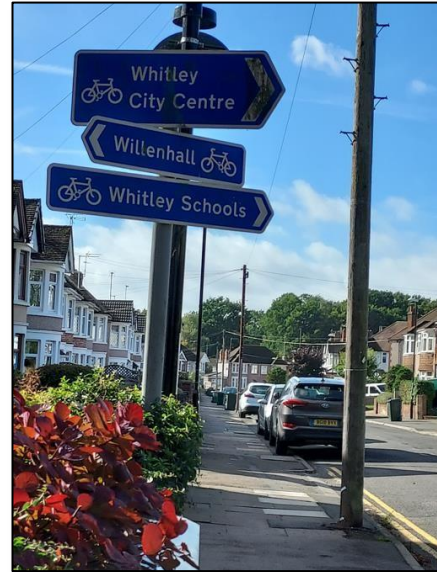
Location – throughout

*The proposed cycleway on the north-eastern side of London Road is unorthodox as the cyclists will be situated on the inside and pedestrians in the middle adjacent to the road. Cycleways are normally installed adjacent to the highway as they travel faster than pedestrians, and its good practice to keep pedestrians away from higher modes of transport. In addition, cyclists adjacent to the highway are not close to the verge/ trees or street furniture. Installing a cycleway at the back of the footway and pedestrians in the middle of the footway significantly increases the likelihood of cycle to pedestrian type personal injury collisions. The relocation of the footway adjacent to the carriageway also results in pinch points for wheelchair and mobility scooter users due to existing trees, which may result in them having to use the cycle track, which will increase the likelihood of cycle to pedestrian type personal injury collisions*

1. *Re-examine the cycleway design on the north-eastern side of the scheme*
2. *Ensure the proposed cycleway infrastructure is connected to the existing*

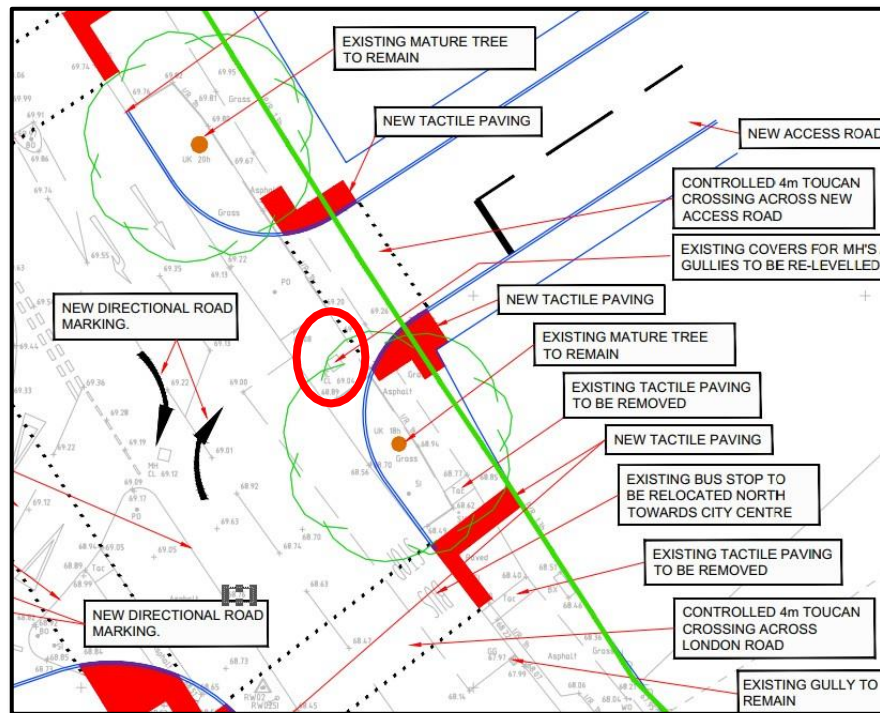
**Location** – London Road junction with new access

*The existing covers are to be re-levelled but will remain in situ. This location is where a high proportion of vehicles will be turning out of the new access into London Road. Having service covers at on a corner increases the risk of vehicles skidding and also increases the likelihood of the service cover failing and becoming a maintenance issue. This increases the likelihood of vehicle to vehicle type personal injury collisions.*

*Relocate the service covers so that it does not cause any road safety hazards.*
