Abbey Road Improvements – RSA Stage 3 Designer Responses

For Coventry City Council

ABR-HWY-RSA3-DOC-SM-0001-Rev-01

STAGE 3 ROAD SAFETY AUDIT
LONDON ROAD / ABBEY ROAD SIGNALISED JUNCTION

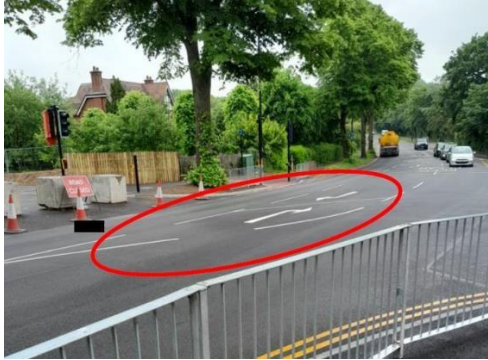
3.1 Problem Dedicated right turn lane.	
Summary The dedicated right-turn lane (from London Road into Abbey Road) layout is not sufficient as it is not long or wide enough to accommodate an average sized car. Subsequently, vehicles will have to wait half on/half off. Vehicles will over hang the inside running lane and this significantly increases the likelihood of vehicle to vehicle swipe type injury collisions.	
Plan

Recommendation Reconfigure the lining so that the dedicated right-turn lane is sufficient to accommodate right-turners. This will reduce the likelihood of side swipe personal injury collisions.	Recommendation Accepted Y/N
	Y
Designer Response The lining has been increased as much as the site constraints allow. See the attached plan within Appendix A.

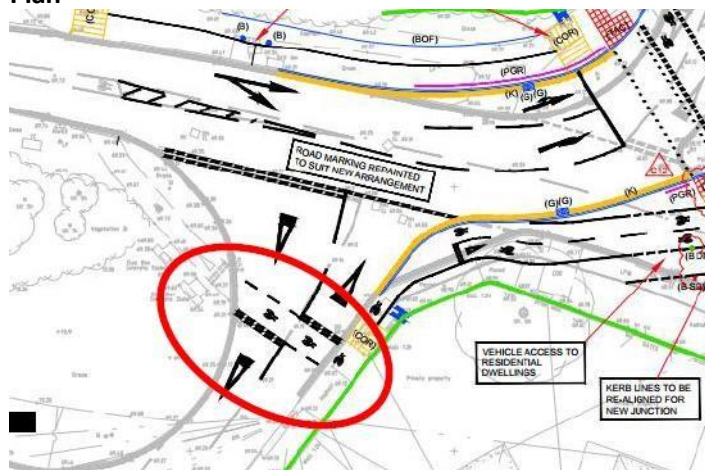
The conspicuity of the cycleway crossing is significantly reduced as this section of highway has a minor sunken trench and this reduces drivers forward visibility on the approach to the cycleway give way. Subsequently, drivers on the approach may not be aware of the give way configuration and this significantly increases the likelihood of vehicle to cycle personal injury collisions.

Reconfigure the cycleway crossing so that drivers are aware that they are required to give way to cyclists. This will reduce the likelihood of vehicle to cyclist personal injury collisions.

A site visit has been undertaken and the white linings are visible on the approach to the crossing. See photo below. Visibility to the approach is very good and pedestrians/cyclists waiting at the edges of the crossing can be seen. There are also advance triangle warning lines to warn in advance. The design was based upon the figure below, taken from LTN 1/20.

It is proposed that this junction is monitored and if required then additional measures such as signing can be explored.

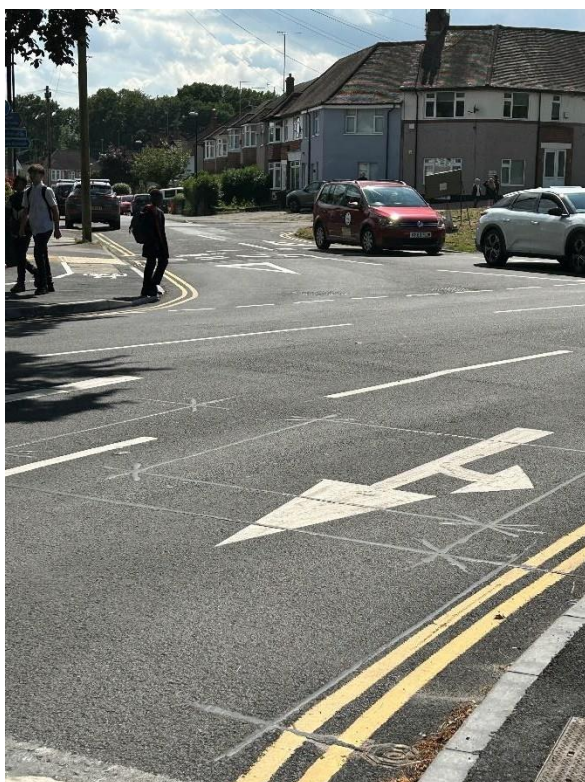
As noted in 3.3 pedestrians do utilise this crossing as well, but this is a dedicated cycleway and there is no proposal to adjust to shared surface.

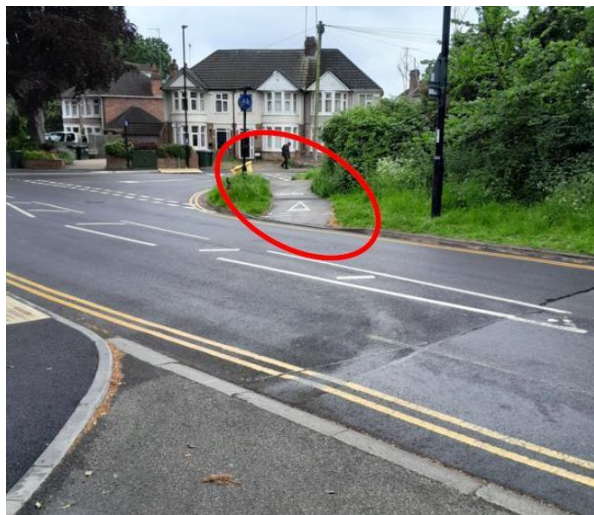
There is a lack of pedestrian facilities on the western corner of the junction of Ashington Grove and Abbey Road. Subsequently, pedestrians are using the cycleway to manoeuvre through this location, and this significantly increases the likelihood of cyclist to pedestrian type personal injury collisions.

Review pedestrian facilities in the area and install additional facilities to accommodate all vulnerable road users. This will significantly reduce the likelihood of pedestrian and cyclist personal injury collisions.

The scope of the design was limited to the improvement of Abbey Road/London Road junction and provide signalisation of it. Road markings were provided as noted in 3.2. The review of pedestrian facilities in the area does fall outside the scope of this scheme.

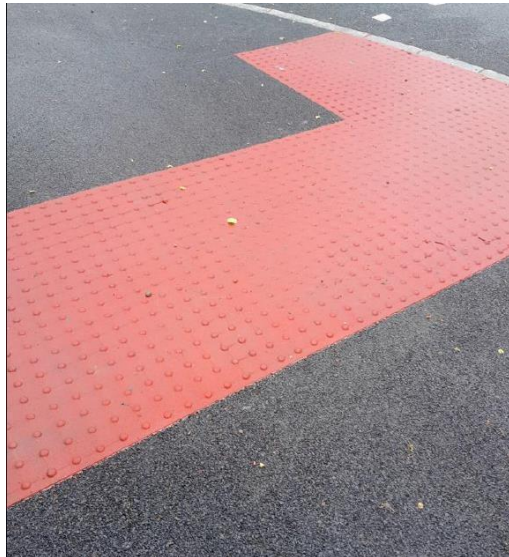
The tactile paving (tac-grid) was slippery during the road safety audit visit. This significantly increases the likelihood of pedestrians slip/trip type personal injury collisions.

Review the tactile paving and re-install

The comment has been passed to Tac-Grid for review. It will be replaced if it is found to be defective.

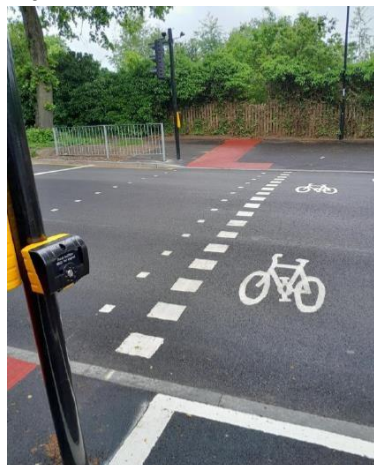
Separate cycle crossing facilities have been provided across Abbey Road and London Road (northern arm). However, signals are only provided on the adjacent pedestrian crossings and these are either not visible or not in the direct line of sight of cyclists waiting at the stop lines. Therefore, cyclists using these facilities are unable to see/observe instructions on whether it is safe to cross or not. This significantly increases the likelihood of vehicle to cyclist type personal injury collisions.

Separate cycle signals should be provided on both cycle crossing facilities to ensure that cyclists can see/observe whether it is safe to cross or not. This will significantly reduce the likelihood of vehicle to cyclist type personal injury collisions.

This has been passed to Yunex (signal designers) for review and rectifications.

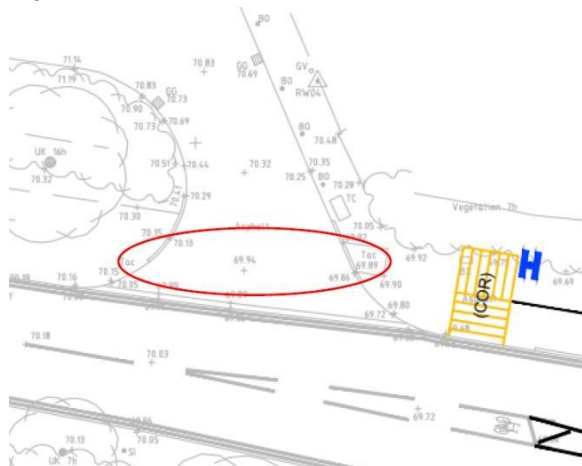
The footway on the eastern side of Abbey Road/Abbey Court junction has been reconstructed. However, no tactile paving has been provided at the pedestrian dropped kerb. As a result, visually impaired pedestrians may not detect the crossing point and/or may cross at an unsafe location. This increases the likelihood of vehicle to visually impaired pedestrian type personal injury collisions.

Tactile paving should be provided at the eastern side of the junction

The contractor should install the appropriate tactile/tac-grid that was previously provided and not re-installed at the time of the reconstruction.

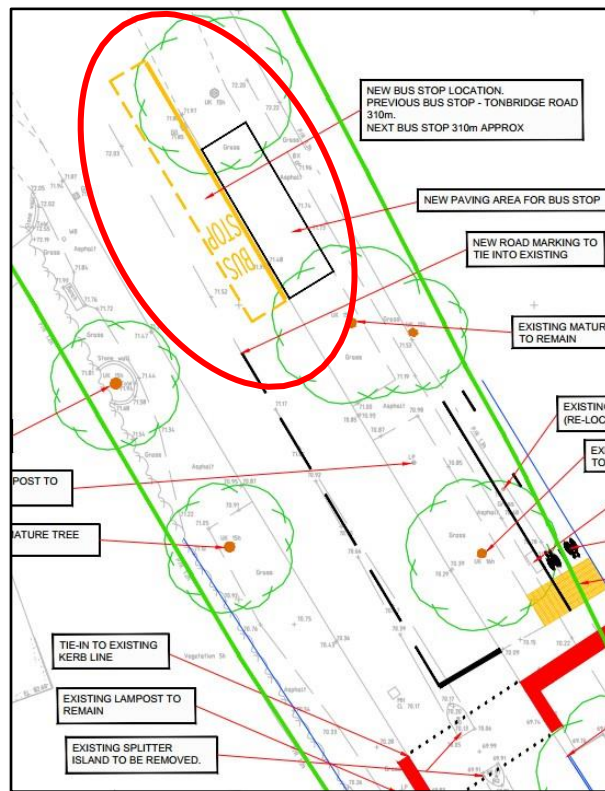
Location: London Road - see screen-print

The bus stop relocation is on the approach to the proposed signalised junction, and in particular the signal heads. Buses waiting within the bus stop will significantly reduce the conspicuity of the signal heads (for vehicles on the approach from north to south)-west to south-east) and this significantly increases the risk of vehicle to vehicle and vehicle to pedestrian type personal injury collisions.

The designer's response in regards to stopping distances is noted, however, the audit team still regard the location of the bus stop may result in conspicuity problems. Relocating the bus stop may significantly reduce the likelihood of vehicle-to-vehicle and vehicle to pedestrian type collisions.

The Audit Team are satisfied that this item has been resolved.

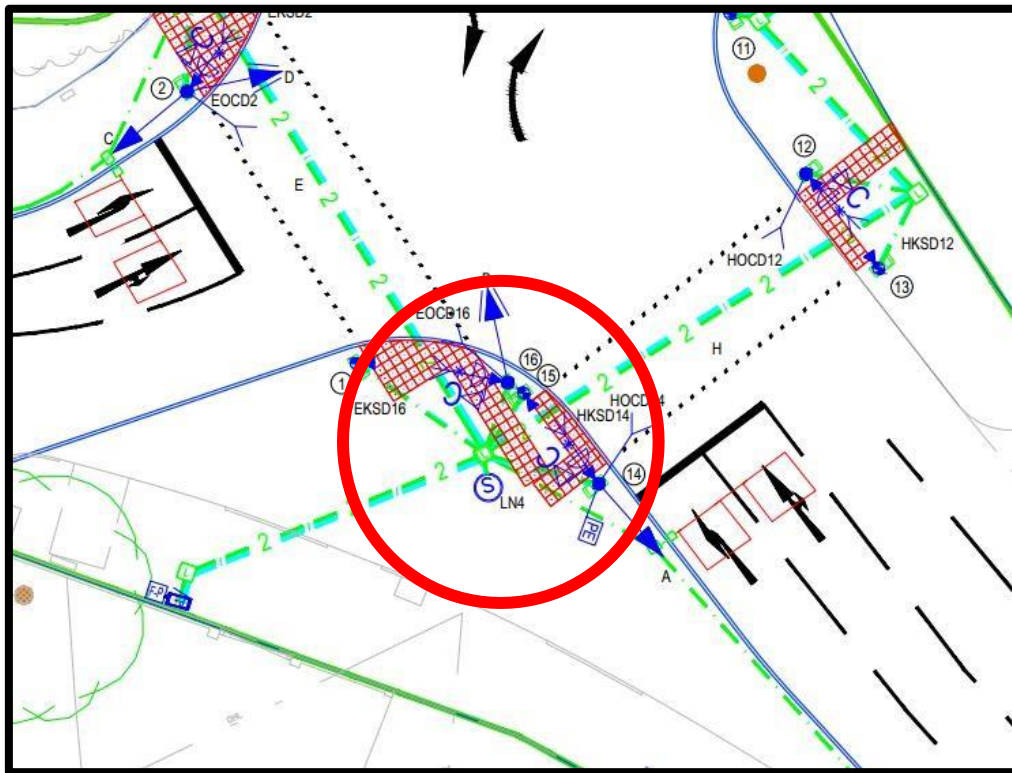
Location – See screen-print below

The submitted drawings are confusing as different drawings highlight different tactile paving layouts for the same locations. As highlighted in the above drawing abstract, the tactile paving has been designed immediately adjacent to tactile paving that is advising pedestrians to travel in different directions. This may result in visually impaired pedestrians becoming confused and entering the highway at the wrong location; and this may result in pedestrian to vehicle type personal injury collisions.

If the above extract shows the proposed tactile layout, redesign the tactile paving so that the tactile paving is separated. This will significantly reduce pedestrian confusion and this will significantly reduce the likelihood of vehicle to pedestrian type personal injury collisions.

The Audit Team are satisfied that this item has been resolved.

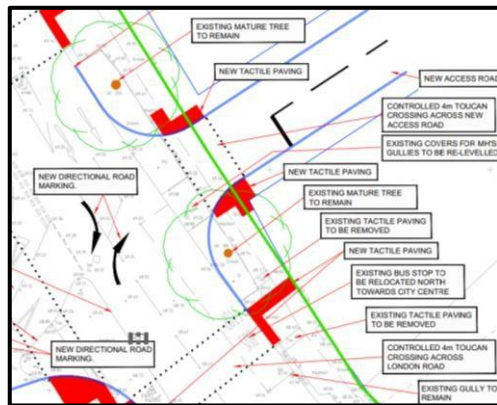
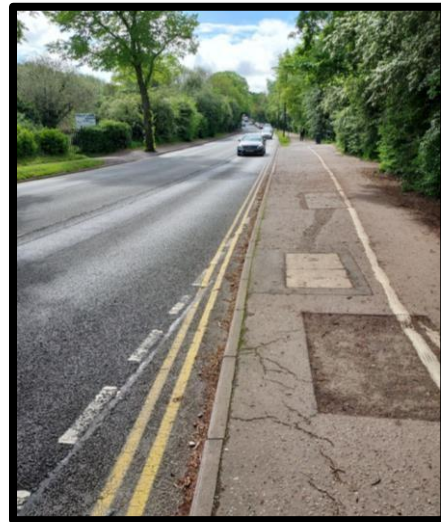
Location – London Road junction with new access

The existing covers are to be re-levelled but will remain in situ. This location is where a high proportion of vehicles will be turning out of the new access into London Road. Having service covers at/on a corner increases the risk of vehicles skidding and also increases the likelihood of the service cover failing and becoming a maintenance issue. This increases the likelihood of vehicle to vehicle type personal injury collisions.

There are service covers on the proposed cycleway and the designs do not indicate that they will be made cycle friendly. Service covers can make cycling unsafe, particularly in adverse weather conditions; and significantly increases the likelihood of cyclist personal injury.

Examine existing service covers and make the service covers cycle friendly so they do not cause any road safety hazards.

The Audit Team are satisfied that this item has been resolved.

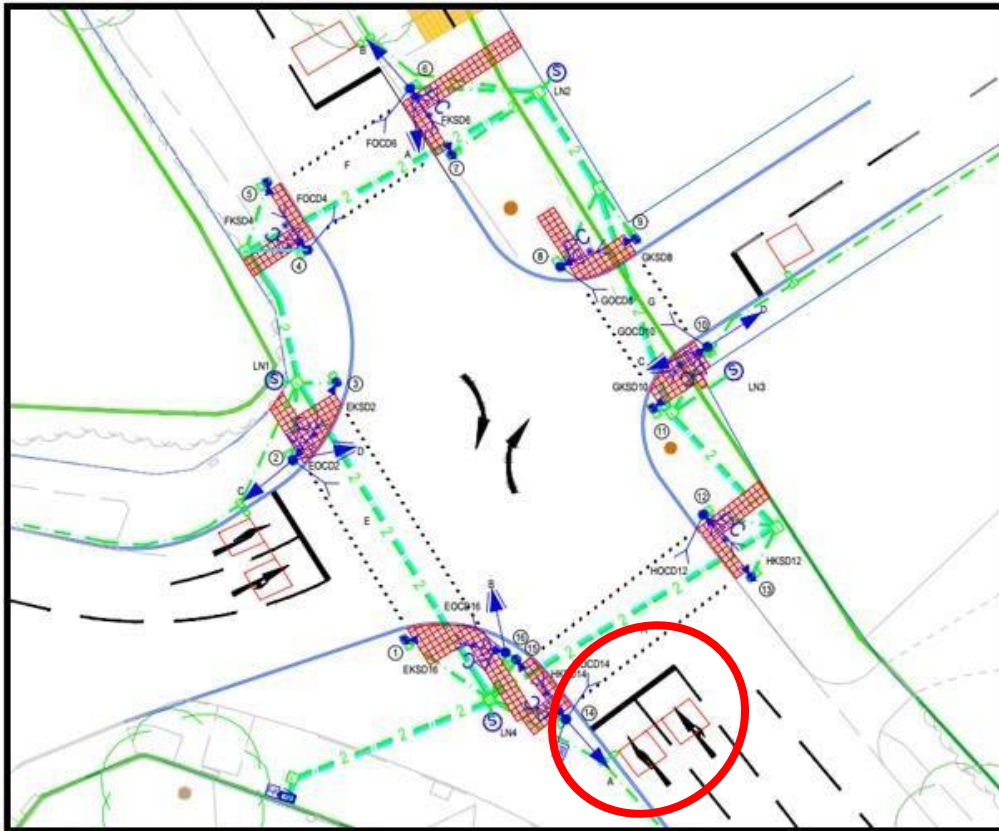
Location – London Road inbound approach to new junction

The proposed layout comprises a dedicated left-turn and straight on/ right turn configuration on the London Road inbound approach to the new junction. London Road is a high traffic volume route into the city centre, and the proposed lane configuration can result in driver frustration due to traffic queueing behind right turners into the new access. This may result in drivers using the dedicated left-turn lane to manoeuvre through the junction, or try to bypass waiting right turn traffic and this may result in drivers colliding with left-turners and the footway on the north-western side of the junction. This significantly increases the likelihood of personal injury collisions related to side-swipe collisions and vehicle to pedestrian type collisions.

Redesign the junction layout to consider the impact of driver frustration related to the lane layout and signal phasing. This will significantly reduce the likelihood of personal injury collisions related to the junction layout.

The Audit Team are satisfied that this item has been resolved.

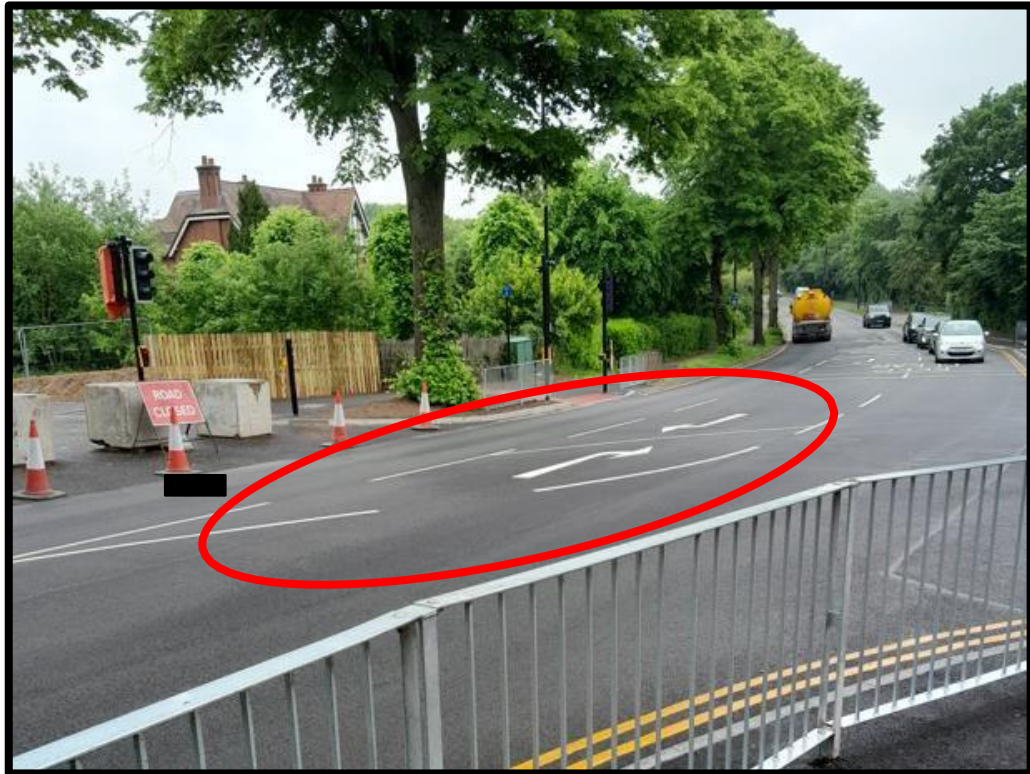
Location – London Road/ Abbey Road Junction

*The dedicated right-turn lane *from London Road into Abbey Road) layout is not sufficient as it is not long or wide enough to accommodate an average sized car. Subsequently, vehicles will have to wait half on / half off. Vehicles will overhang the inside running lane and this significantly increases the likelihood of vehicle-to-vehicle side swipe type personal injury collisions.*

Reconfigure the lining so that the dedicated right-turn lane is sufficient to accommodate right-turners. This will reduce the likelihood of side swipe personal injury collisions.

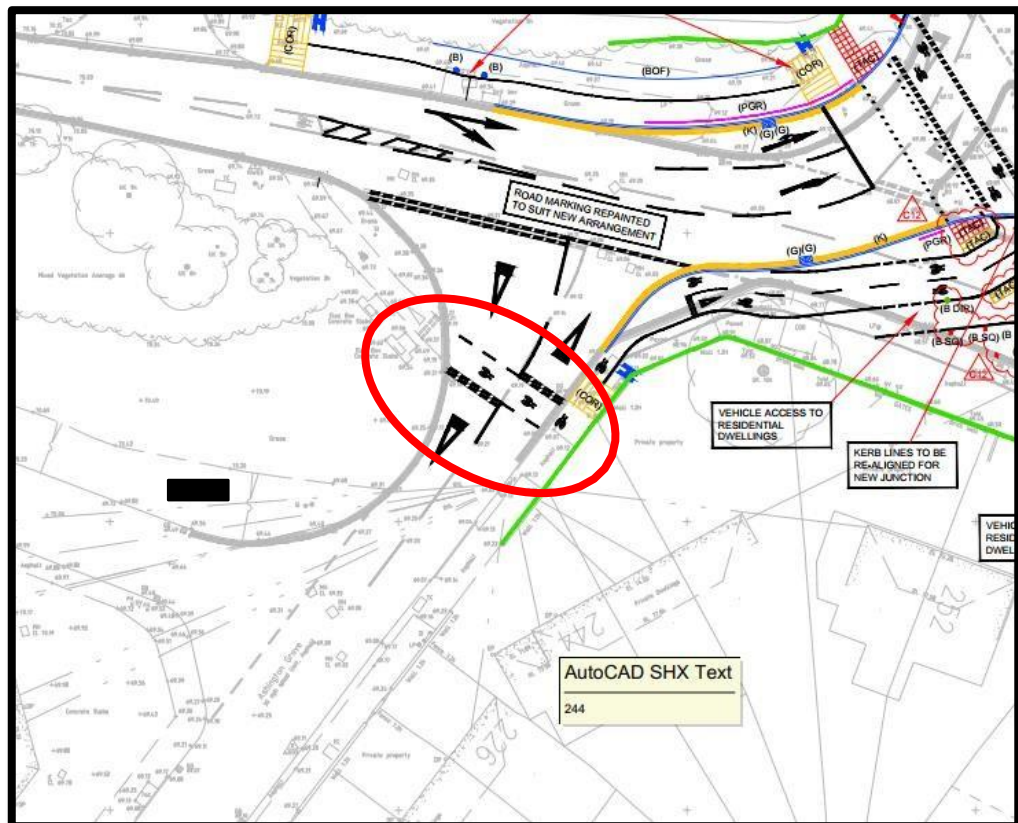
Location – Ashington Grove/ Abbey Road Junction

The conspicuity of the cycleway crossing is significantly reduced as this section of highway has a minor sunken trench and this reduces drivers forward visibility on the approach to the cycleway give way. Subsequently, drivers on the approach may not be aware of the give way configuration and this significantly increases the likelihood of vehicle to cycle personal injury collisions.

Reconfigure the cycleway crossing so that drivers are aware that they are required to give way to cyclists. This will reduce the likelihood of vehicle to cyclist personal injury collisions.

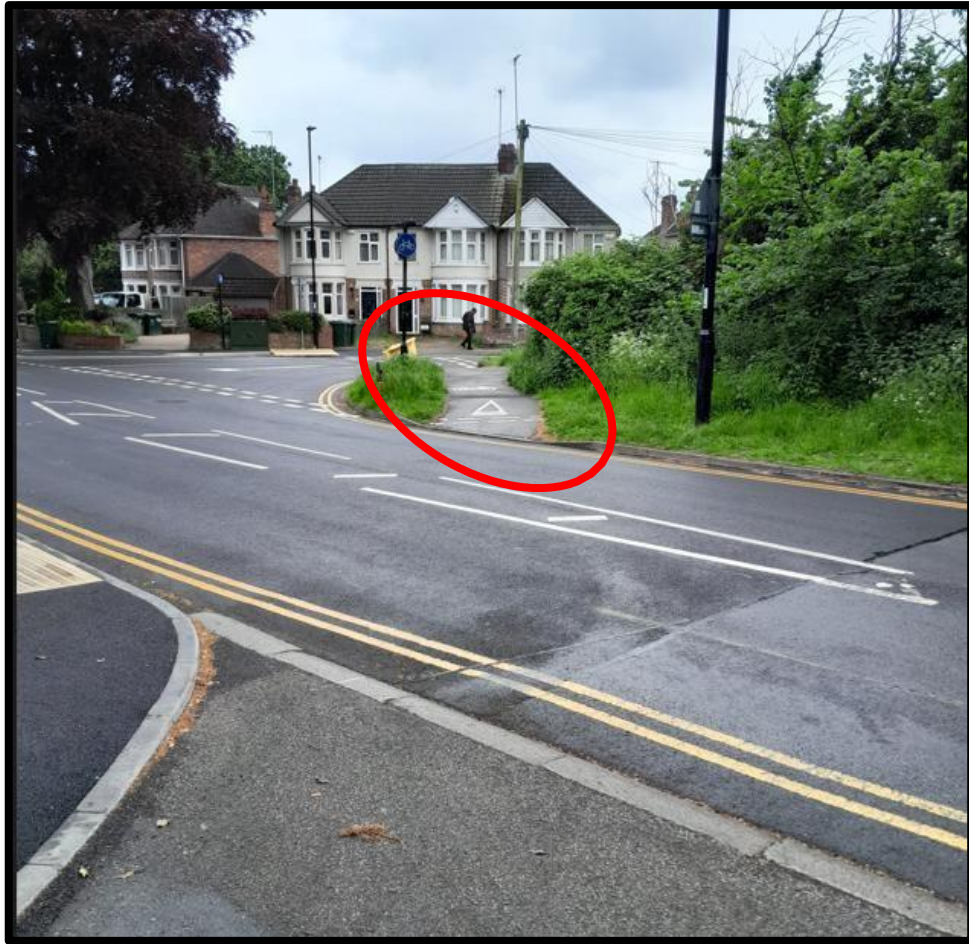
Location – Ashington Grove/ Abbey Road Junction

There is a lack of pedestrian facilities on the western corner of the junction of Ashington Grove and Abbey Road. Subsequently, pedestrians are using the cycleway to manoeuvre through this location, and this significantly increases the likelihood of cyclist to pedestrian type personal injury collisions.

Review pedestrian facilities in the area and install additional facilities to accommodate all vulnerable road users. This will significantly reduce the likelihood of pedestrian and cyclist type personal injury collisions.

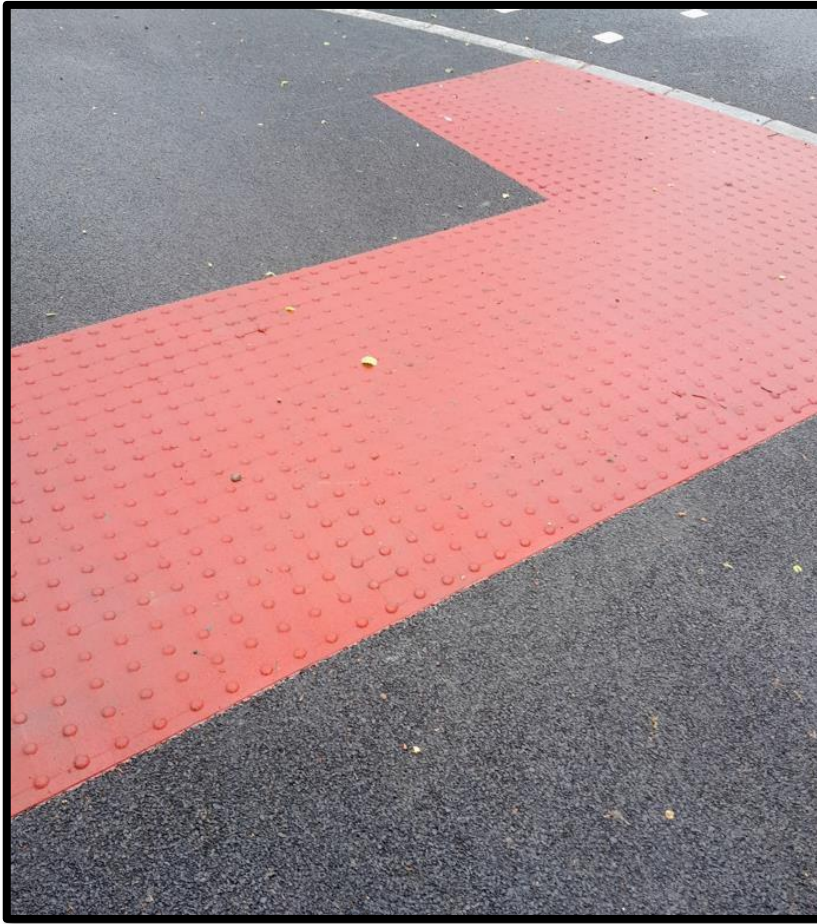
Location – Throughout

The tactile paving (tac-grid) was slippery during the road safety audit site visit. This significantly increases the likelihood of pedestrians slip/trip type personal injury collisions.

Review the tactile paving and reinstall. This will significantly reduce the likelihood of pedestrian trip/fall type personal injury collisions.

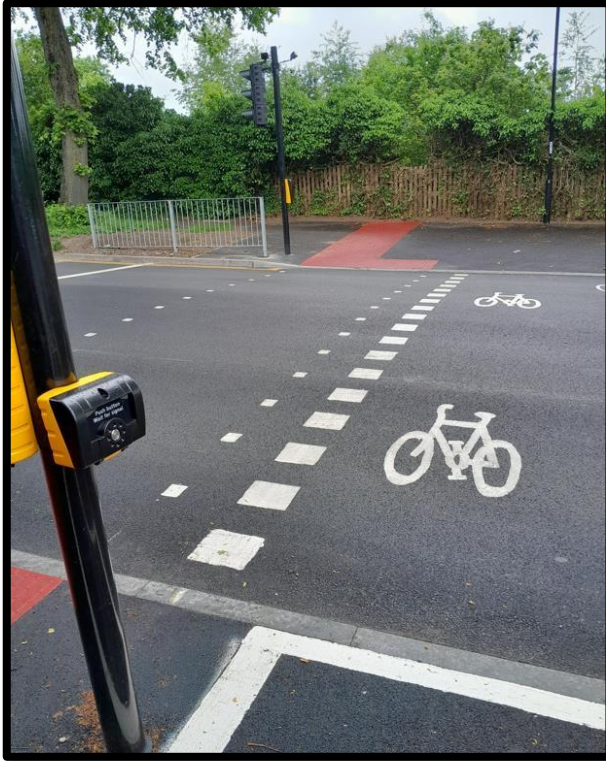
Location – London Road (northern arm) and Abbey Road

Separate cycle crossing facilities have been provided across Abbey Road and London Road (northern arm). However, signals are only provided on the adjacent pedestrian crossings and these are either not visible or not in the direct line of sight of cyclists waiting at the stop lines. Therefore, cyclists using these facilities are unable to see/observe instructions on whether it is safe to cross or not. This significantly increases the likelihood of vehicle to cyclist type personal injury collisions.

Separate cycle signals should be provided on both cycle crossing facilities to ensure that cyclists can see / observe whether it is safe to cross or not. This will significantly reduce the likelihood of cyclist to vehicle type personal injury collisions. The signals on the pedestrian crossings across Abbey Road and London Road (northern arm) should show pedestrians only.

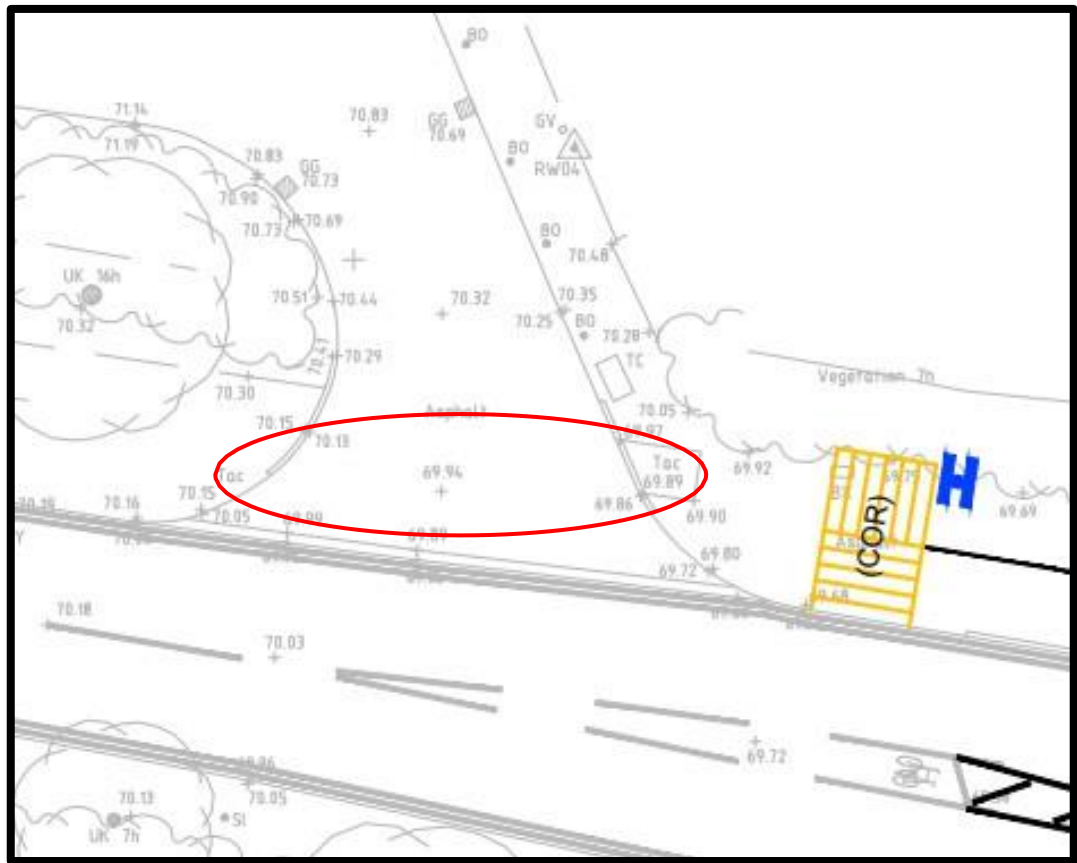
Location – Abbey Road, junction with Abbey Court

The footway on the eastern side of the Abbey Road / Abbey Court junction has been reconstructed. However, no tactile paving has been provided at the pedestrian dropped kerb. As a result, visually impaired pedestrians may not detect the crossing point and / or may cross at an unsafe location. This increases the likelihood of vehicle to visually impaired pedestrian type personal injury collisions.

Tactile paving should be provided on the eastern side of the junction.
