Far Gosford Street Conservation Area Brief History & Character Statement

Problems faced by historic buildings in the area and the reasons for them

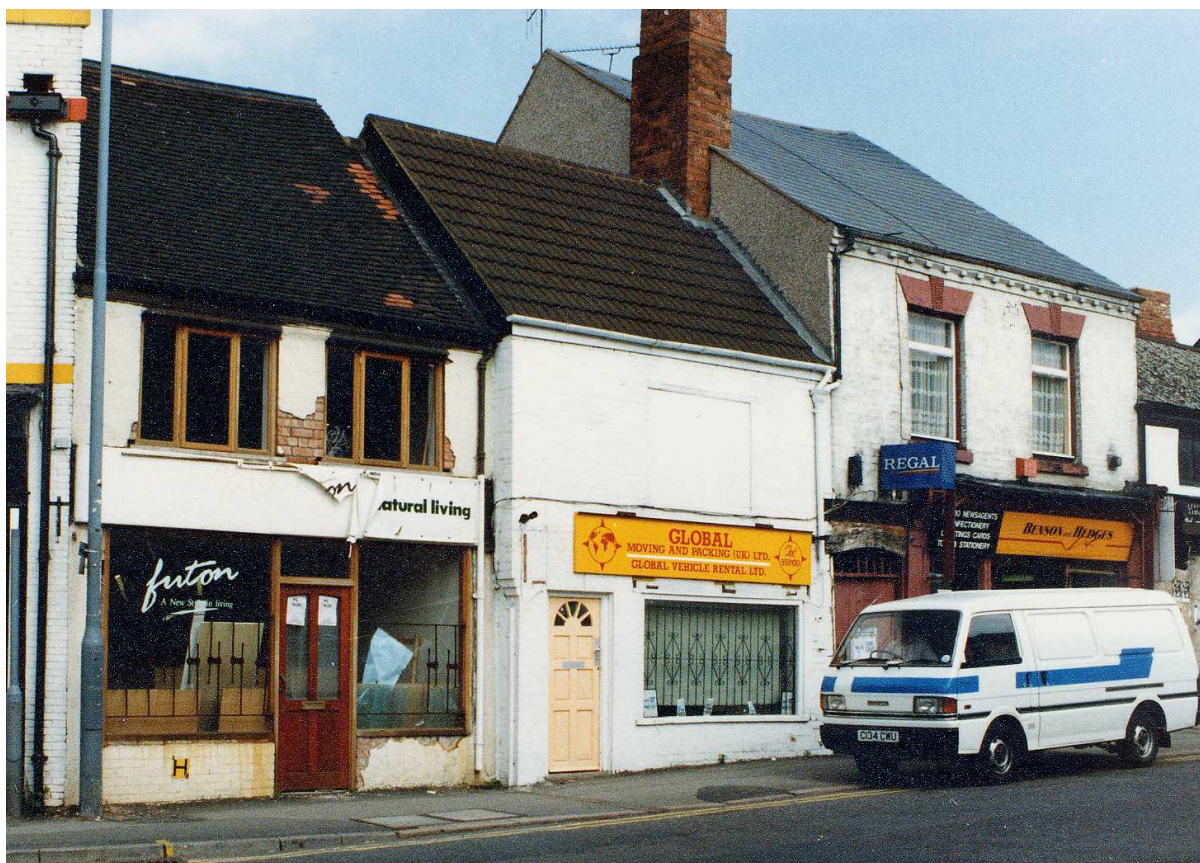
ABOVE: Nos 28 & 29 in 1991. There is nothing to betray their timber-framed origins on the street frontage...

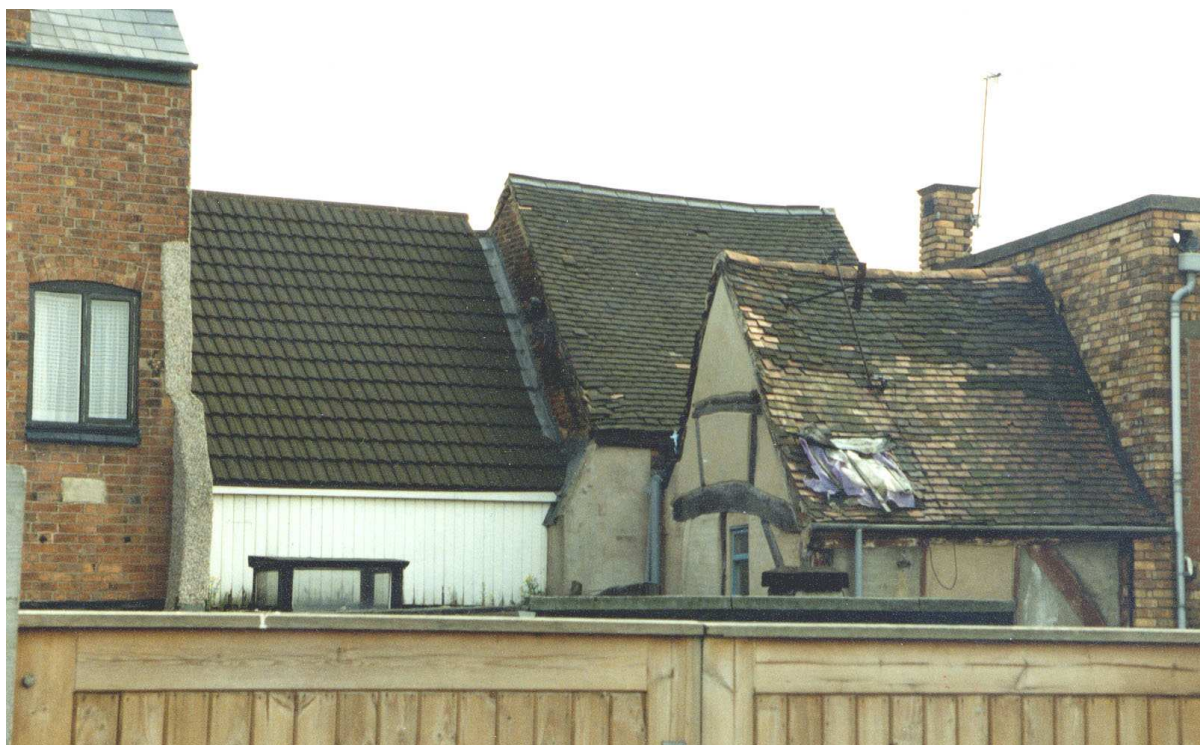
...but from the rear, as seen from Sky Blue Way, N° 28's rear wing still has the frame exposed to view. It is not currently known how much (if any) timber-framing evidence survives inside N° 29.

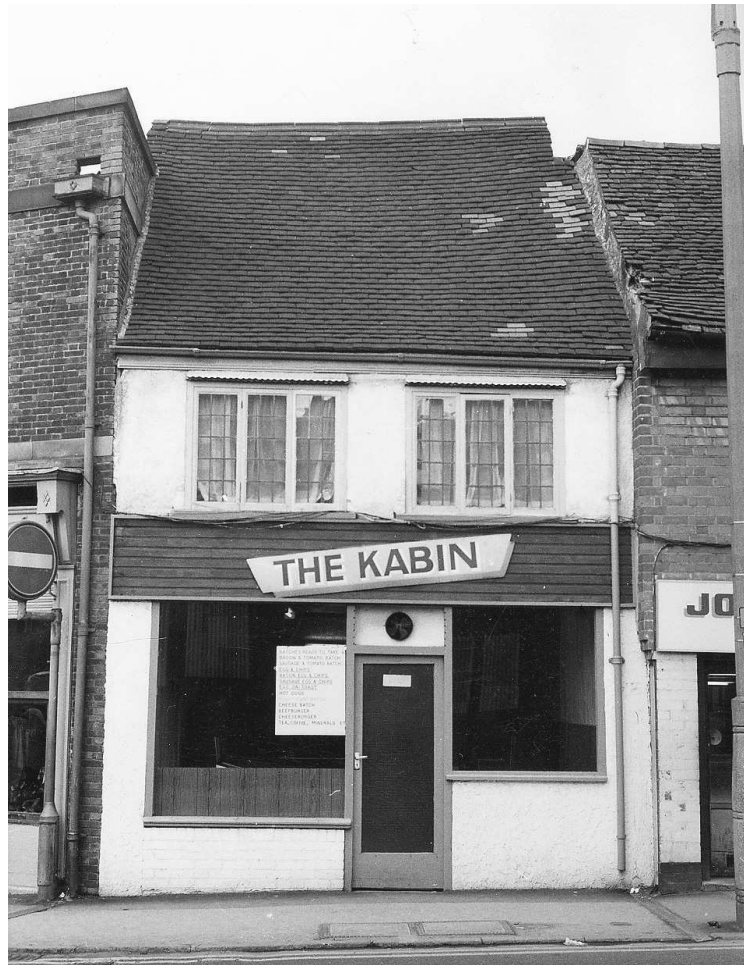
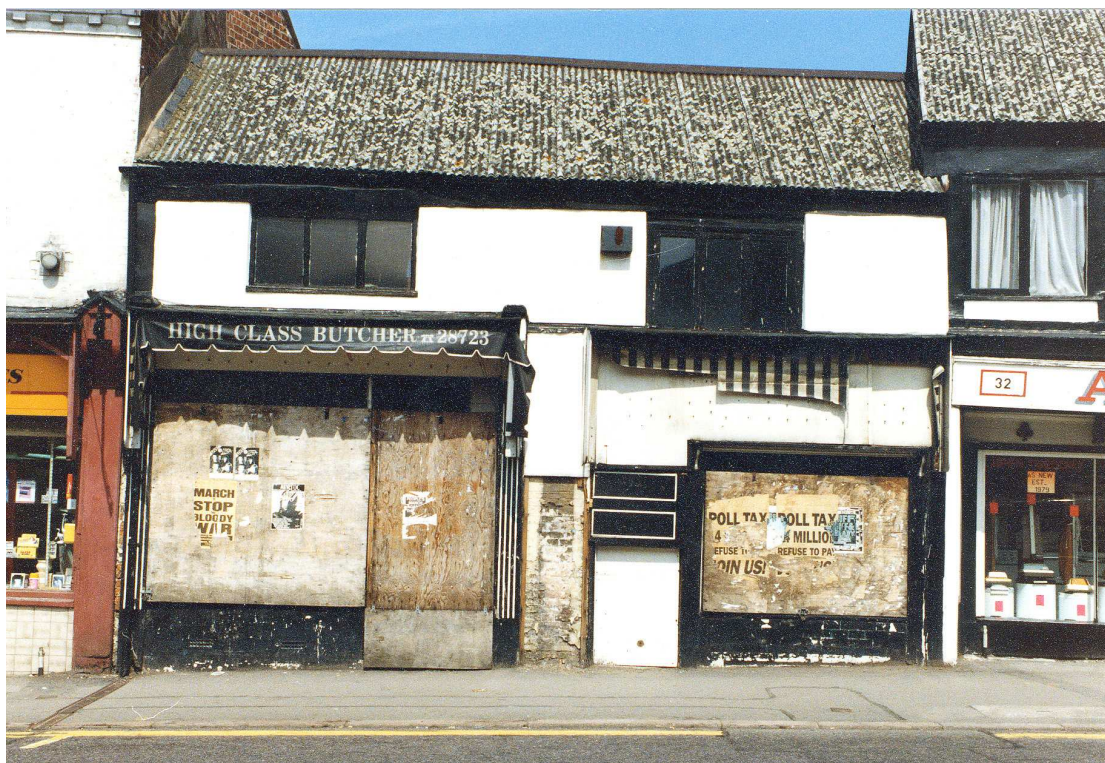
*ABOVE: A mid-1970s view of N° 28, showing the older timber casement windows with leaded lights.
BELOW: N° 31 as it appeared in 1991. This is another building with likely timber-framed origins*

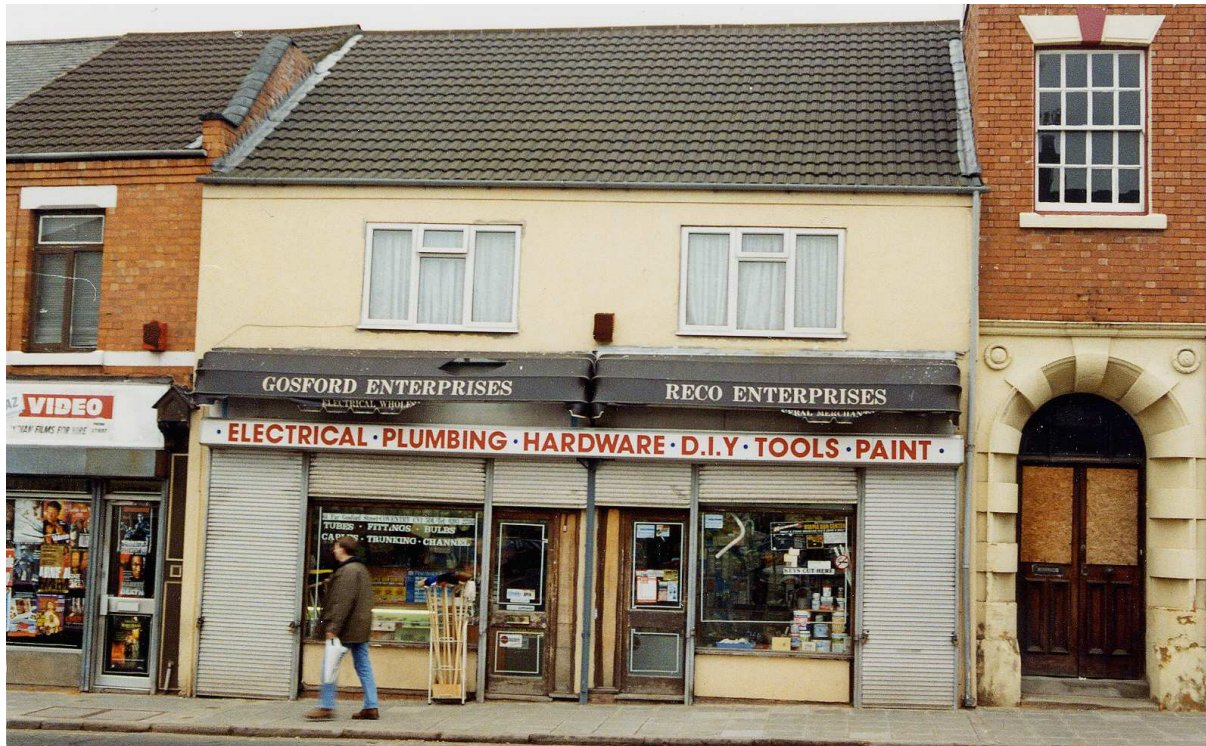
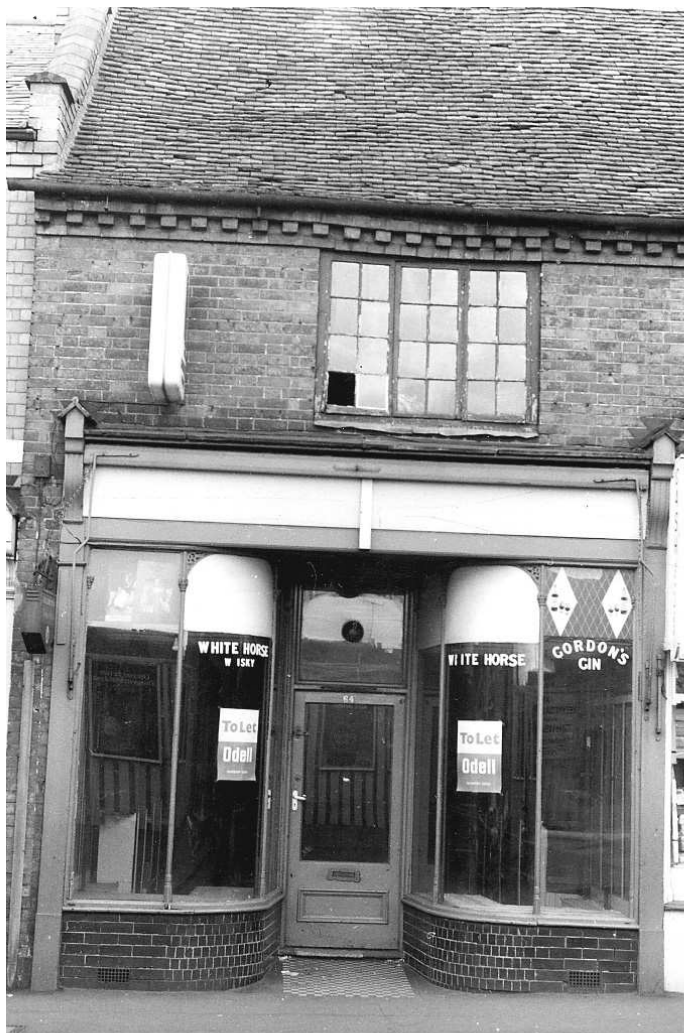
ABOVE: Nos 64 & 64A as they appeared in 1991. The various later modernizations to the frontage have hidden all vestiges of the building's 16th century, timber-framed origins.

LEFT: In the mid-1970s the building had already long had a brick refronting, but at that date it still presented a 19th-century upper storey and an early 20th century shop front.

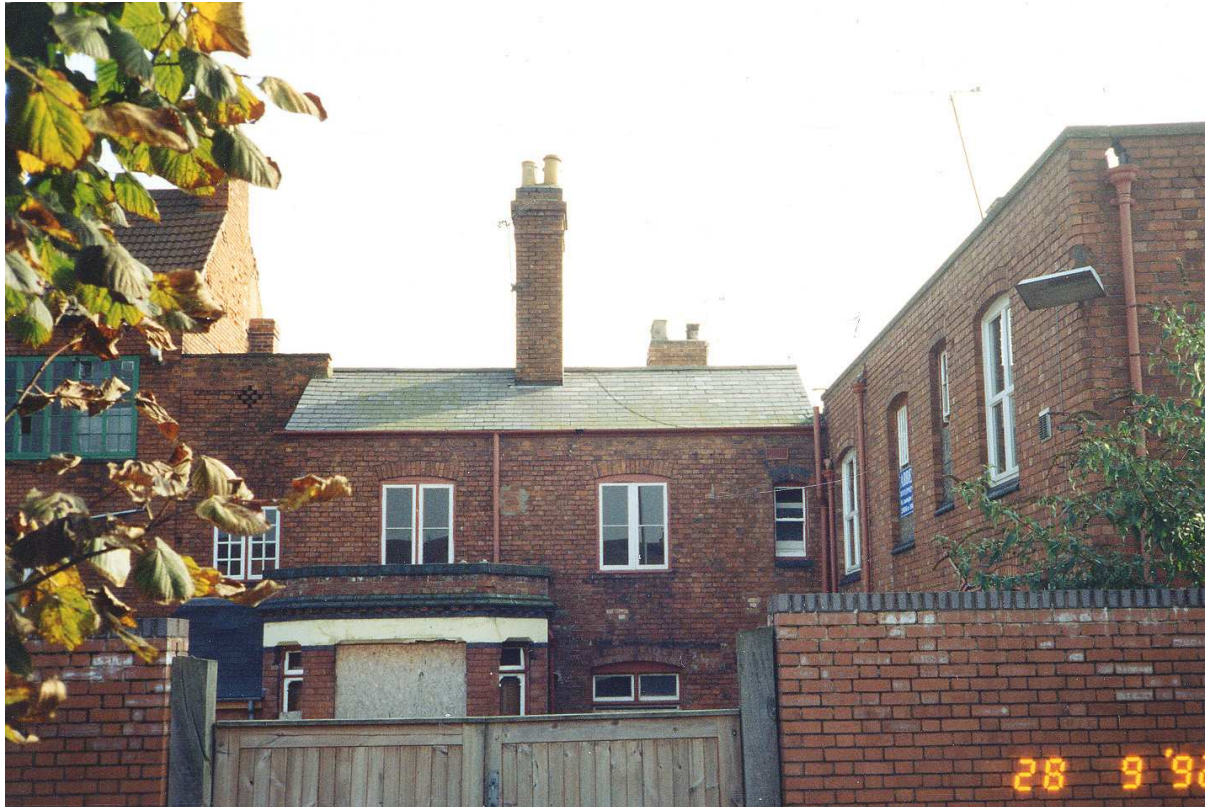
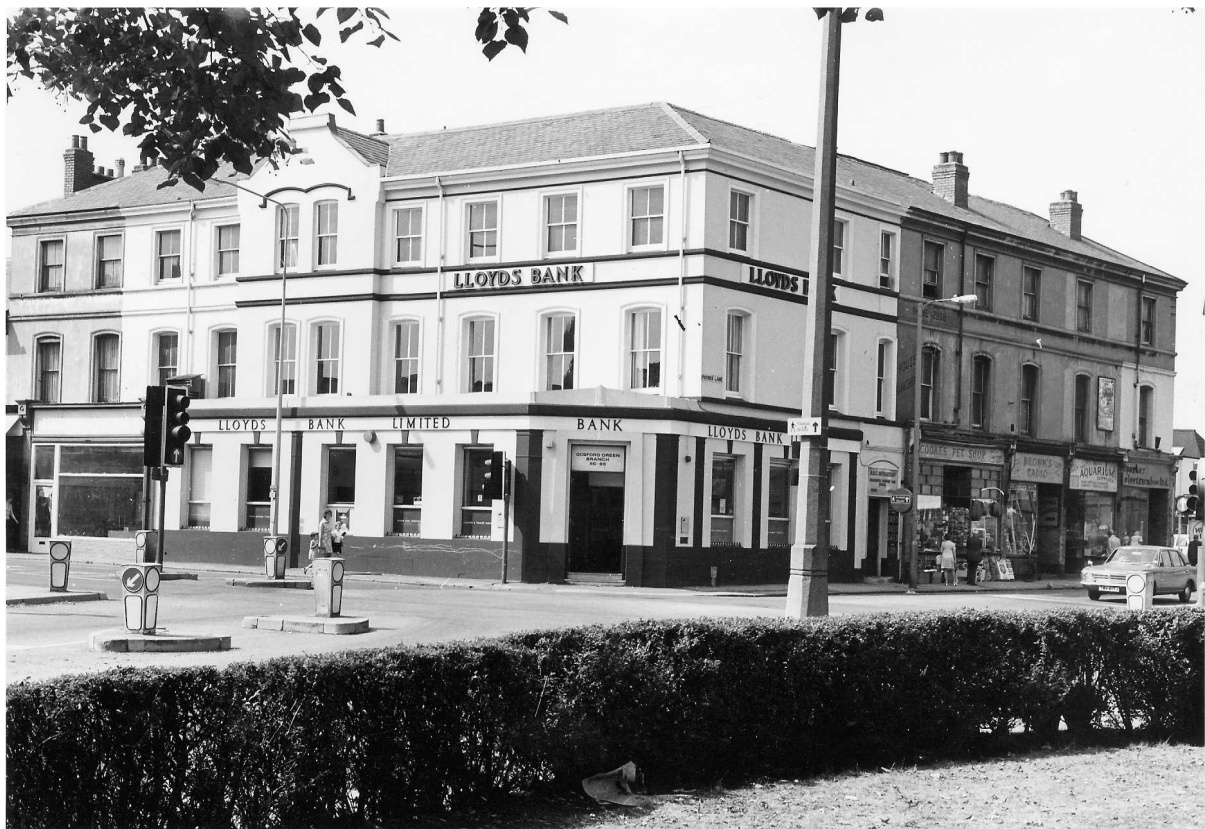
ABOVE: The rear elevation of Nos 65-66 (ex-Pitt's Head PH) in 1992. Note the added bay window.
 BELOW: Nos 84-88 (ex-Coronet/Humber cycle works) in the 1970s, before the rear section was removed.

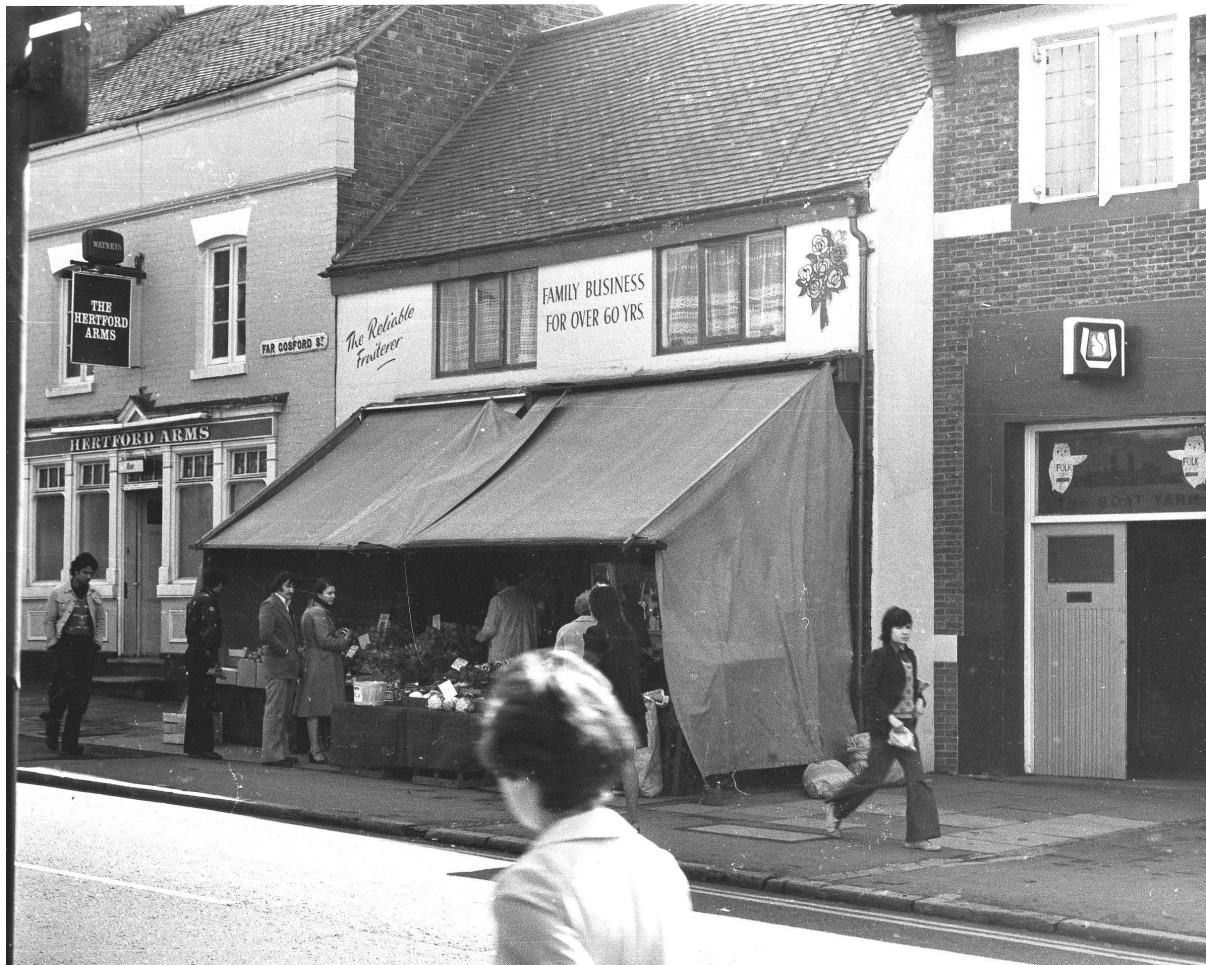
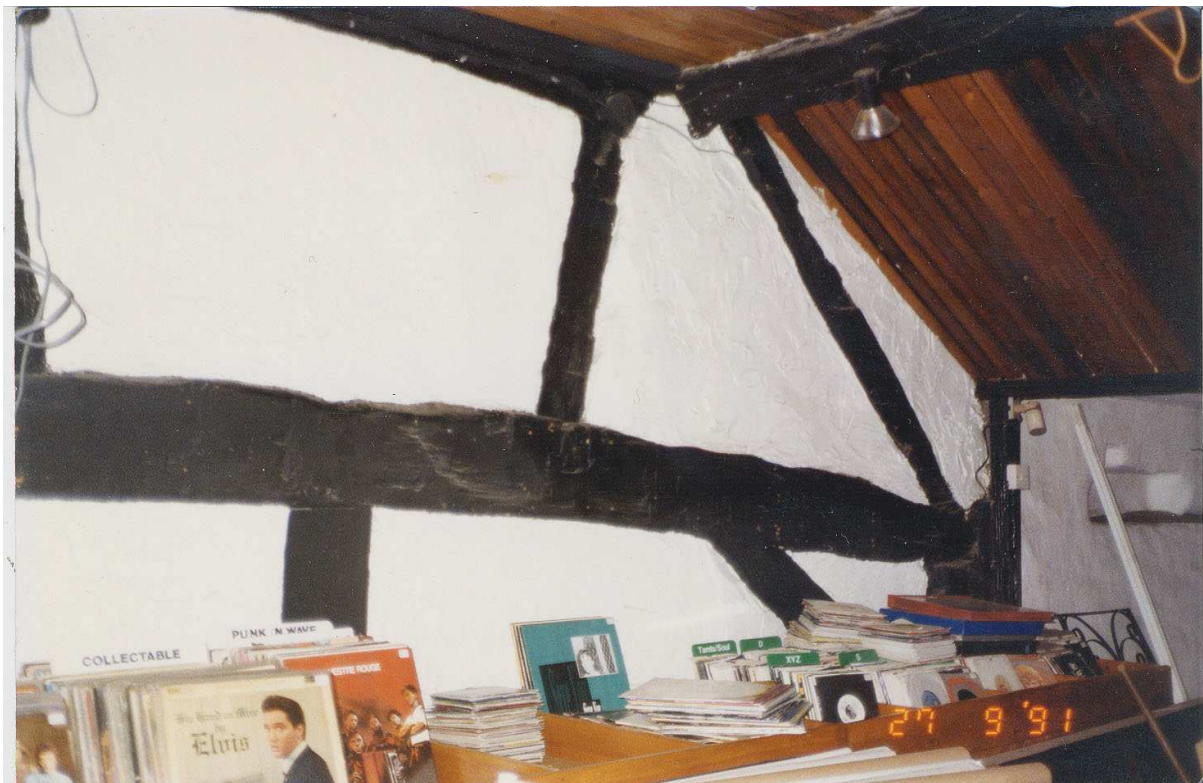
ABOVE: Another 16th century timber-framed building, N^o 117 (1970s); BELOW: Timber-framing inside N^o 142

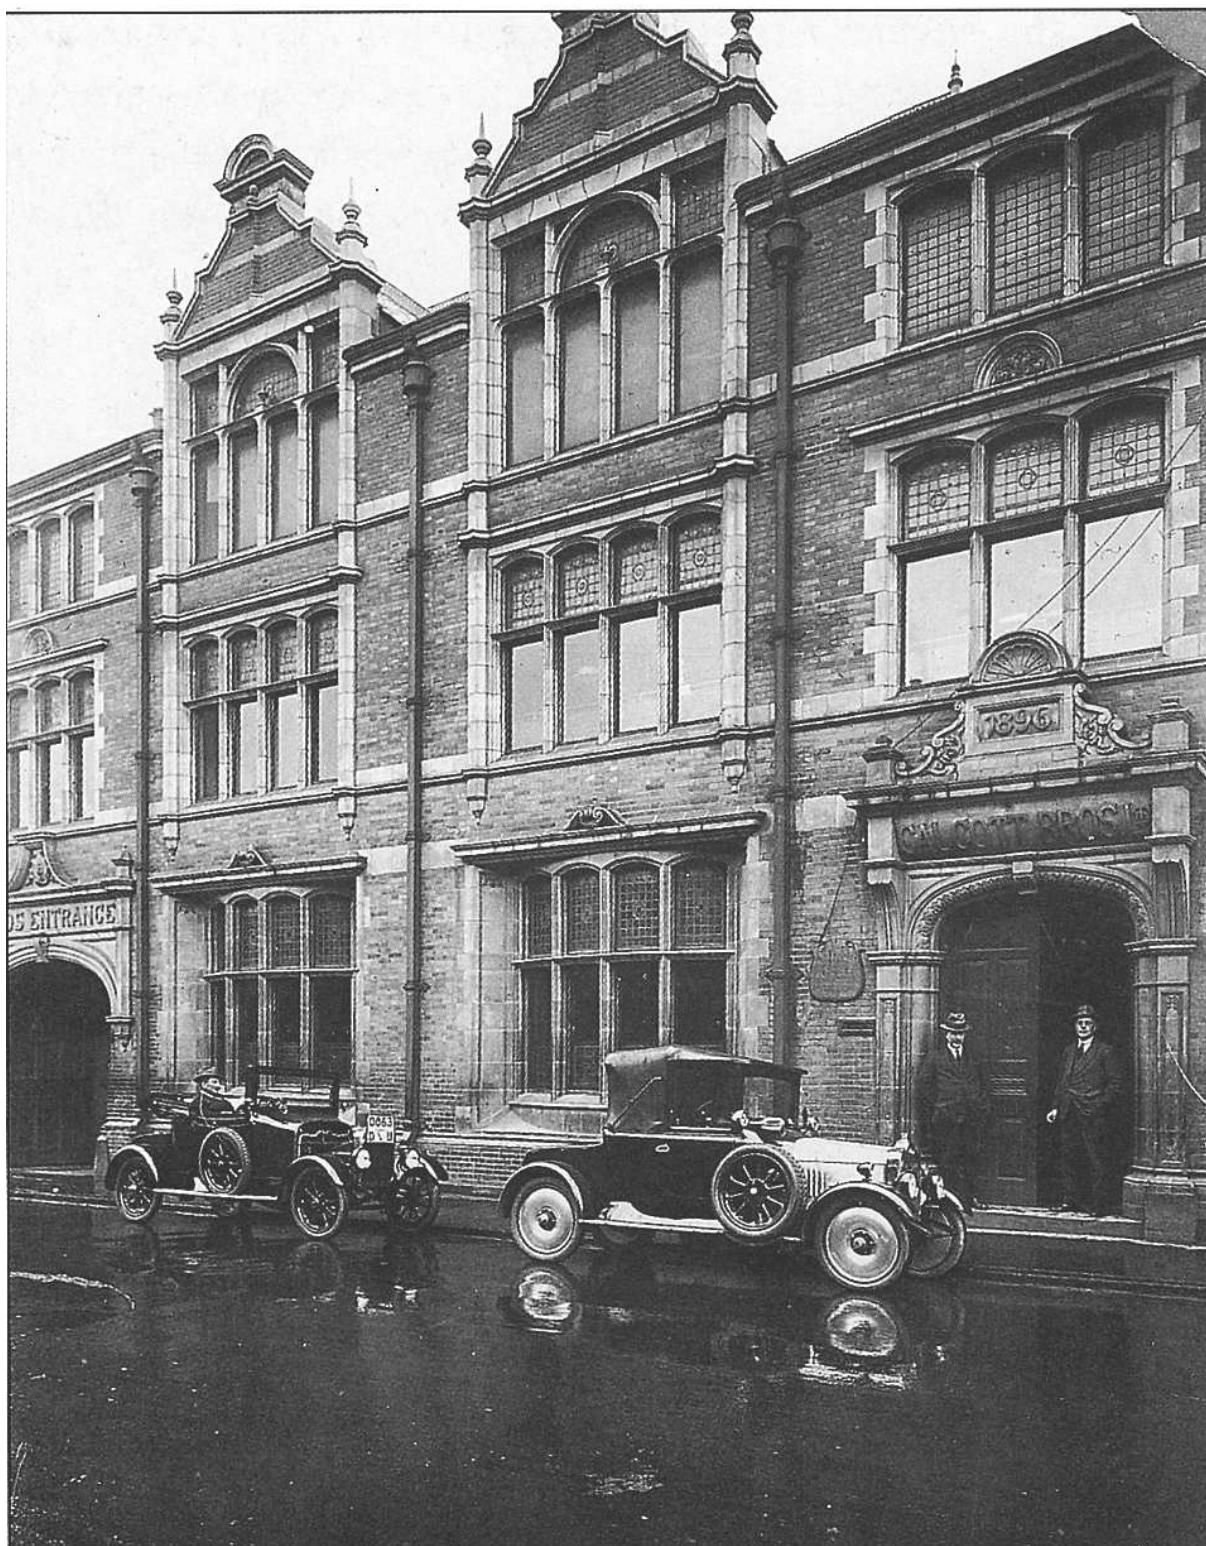
A fine photograph of the Calcott Brothers' car factory, taken in April 1921, showing two examples of Calcott cars outside. (For an attempted recreation of this scene in 1995, see page 92!) Although the building as it stands today still largely resembles this scene, a number of changes are apparent when this photograph is compared with the one on page 28, viz.: the first ground floor bay window on the left has been removed to create a new carriageway entrance to the rear yard; the double doors on the right have been removed and the opening has been infilled with a modern window and brickwork below. The 'Goods Entrance' sign (far left) has been covered over and the 'Calcott Bros. Ltd.' Carved over the main entrance has sadly been defaced by an attempt to cut away the letters, but they are still legible. Leaded glass in the toplights of the windows has also disappeared (except on the second floor windows).

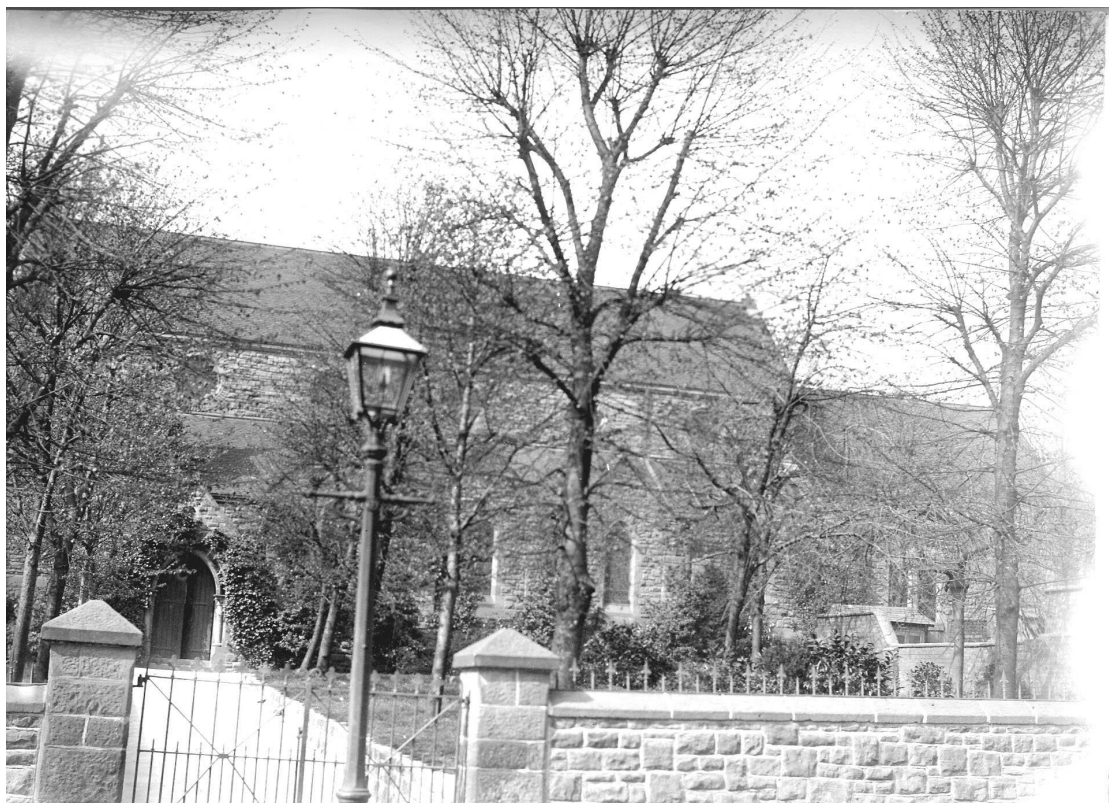
An early view of the church (c. 1889) from Lowe's volume of newscuttings on Churches. The original gates and iron spikes topping the wall can be seen, along with the young trees bordering the church path. Note also the low Windsor-style lamppost in the foreground!

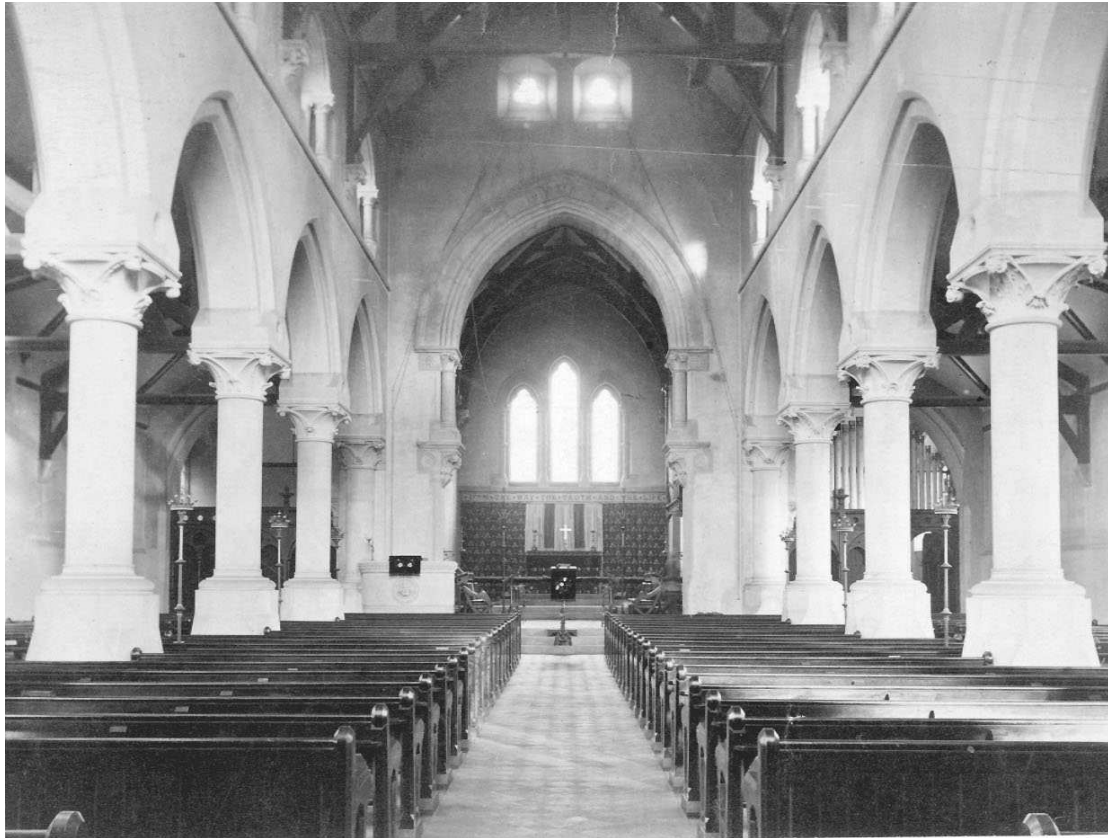
The church interior, also from Lowe's volume of newscuttings on Coventry churches, c. 1889. Note the elaborate roof construction and the decoration to the capitals of the arcade piers.

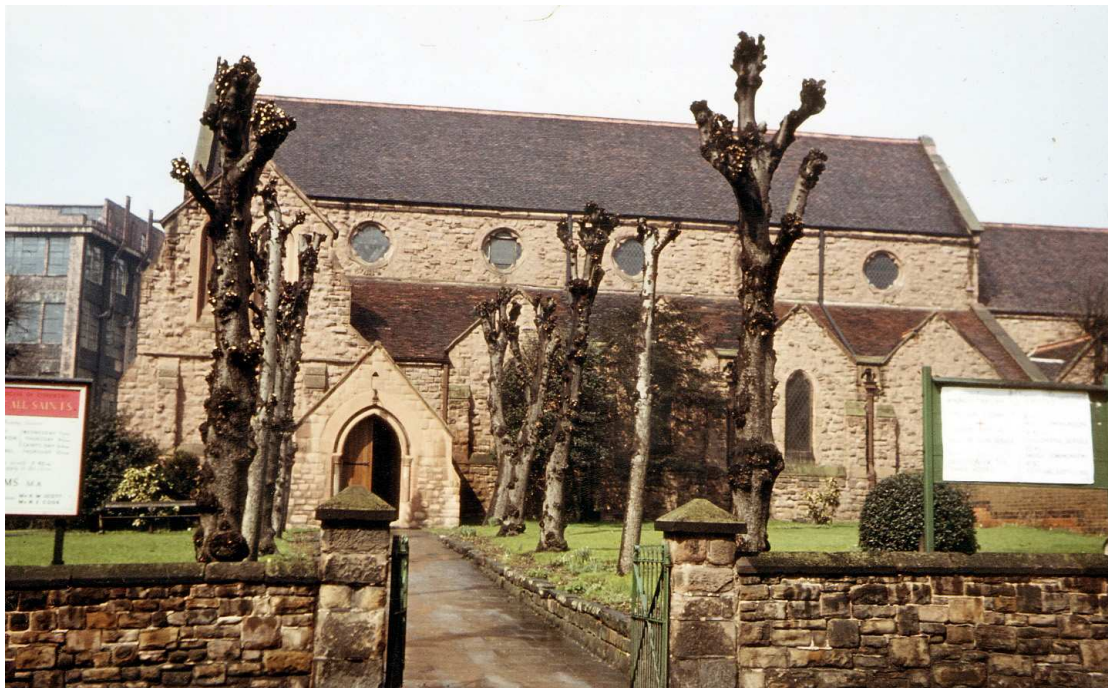
A view of the church as it appeared from the south, c. 1970, shortly before its closure. The trees have been severely pollarded; otherwise, the churchyard looks much as it does today. Note the distinctive round windows lighting the clerestory level of the nave and the gabled south aisle. The old British Thomson-Houston / Lucas Aerospace factory can be seen on the far left.

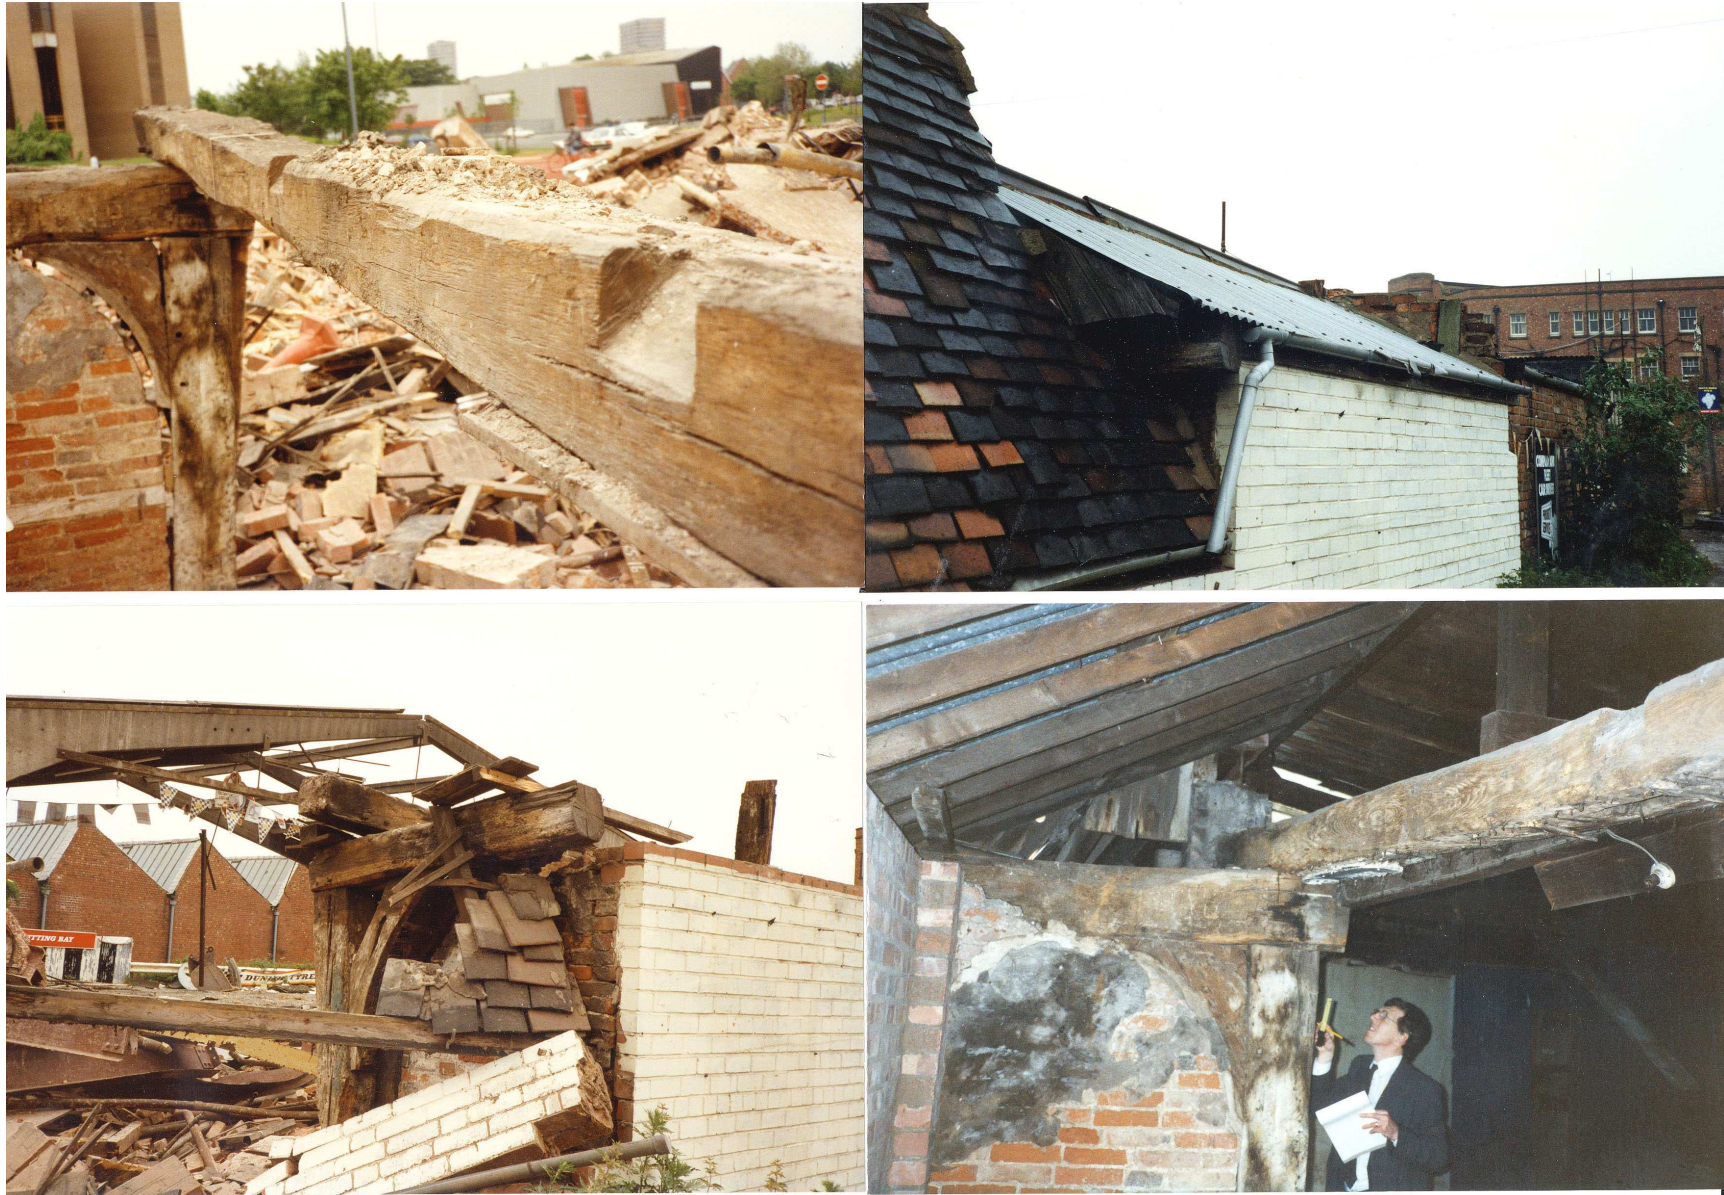
Views of the Anchorsmith Tavern timbers during removal (left) and while still in situ in the lean-to structure at the side of Bridge Buildings (right) (1991)

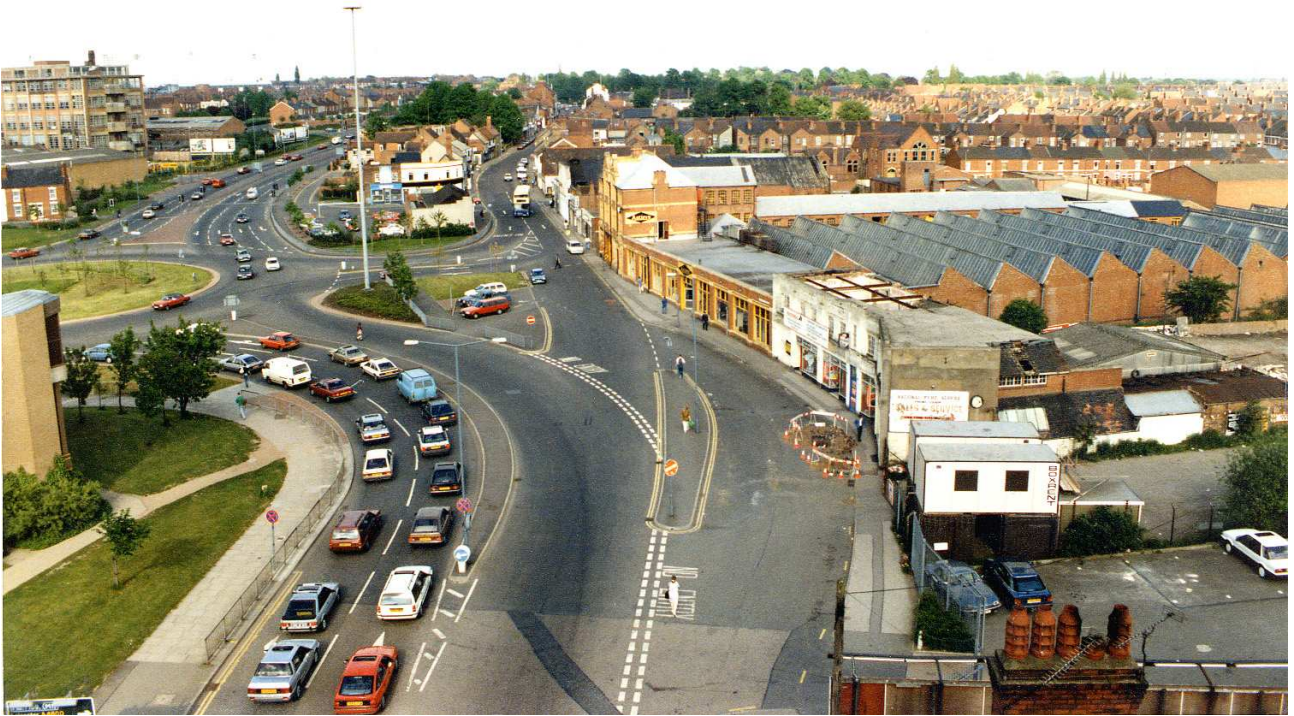
A general view of the entrance to the Conservation Area at the western (city centre) end in 1991. Bridge Buildings (next to Astley's) was under demolition at the time. This photograph gives a good idea of how the Sky Blue Way relief road has affected Far Gosford Street.

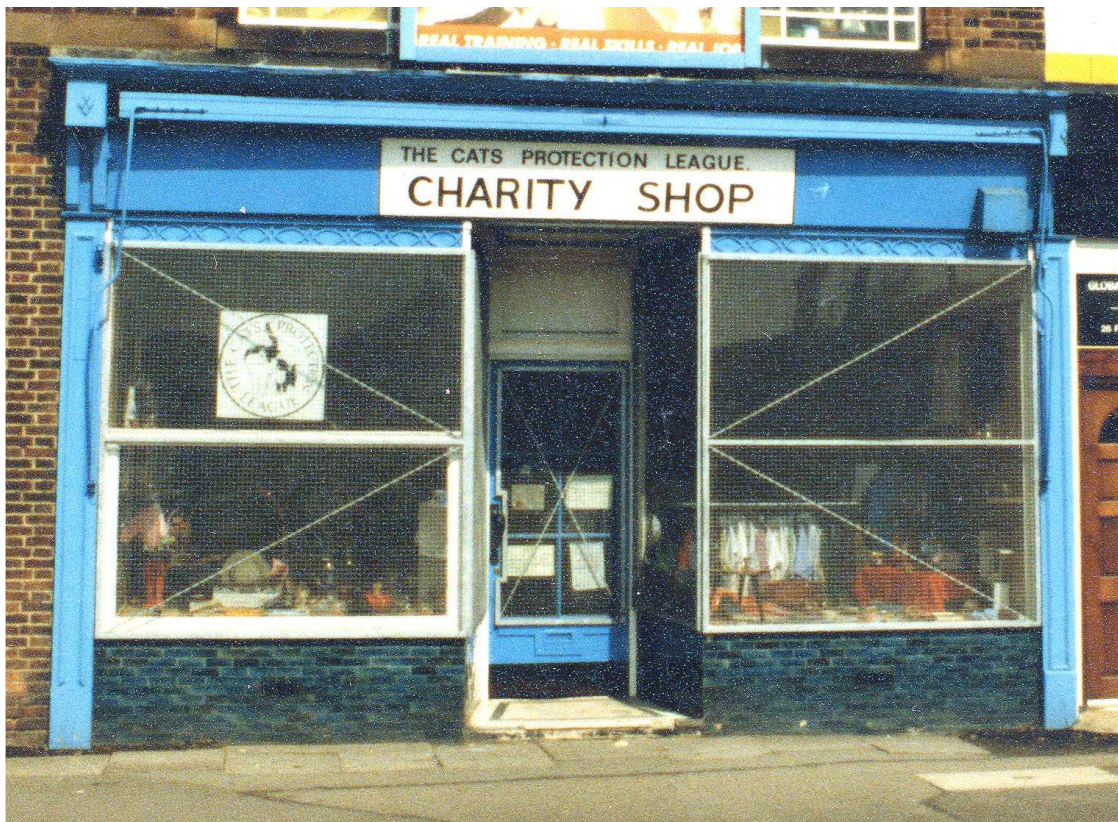
A traditional shopfront surviving at N° 142 Lower Ford Street. Note the deeply recessed central door, the glazed tiles on the stallrisers and the decorative motifs below the fascia (instead of transom lights) and on the consoles (see diagrams on page 46 for explanation of technical terms).

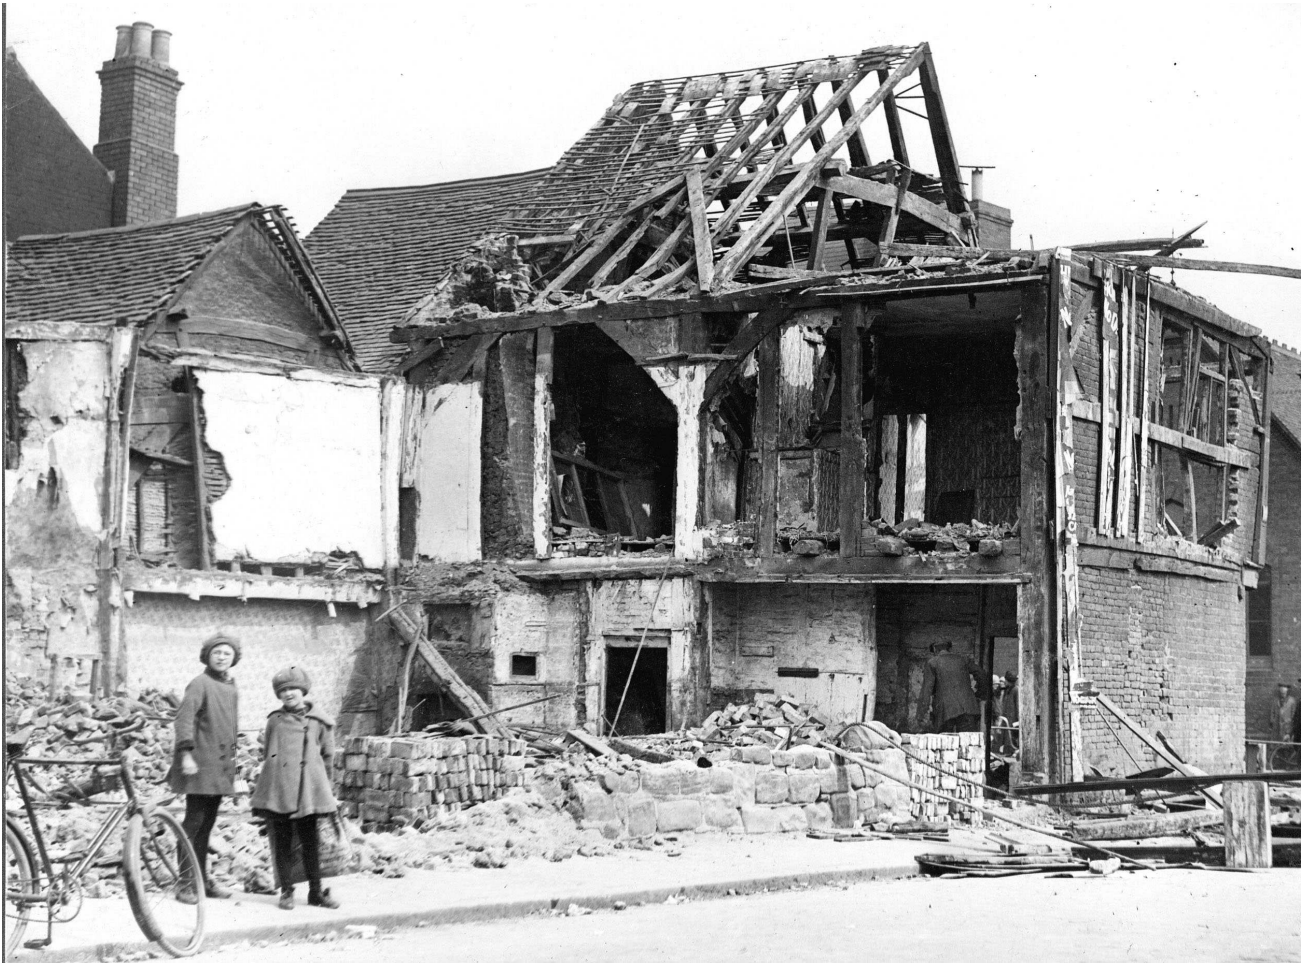
Another view of timber-framed buildings on the site of 26-27 Far Gosford Street under demolition in 1927 (compare similar picture on page 14). Note the presence of sandstone blocks adjacent to the pavement and the distinctive coats and hats worn by the children.

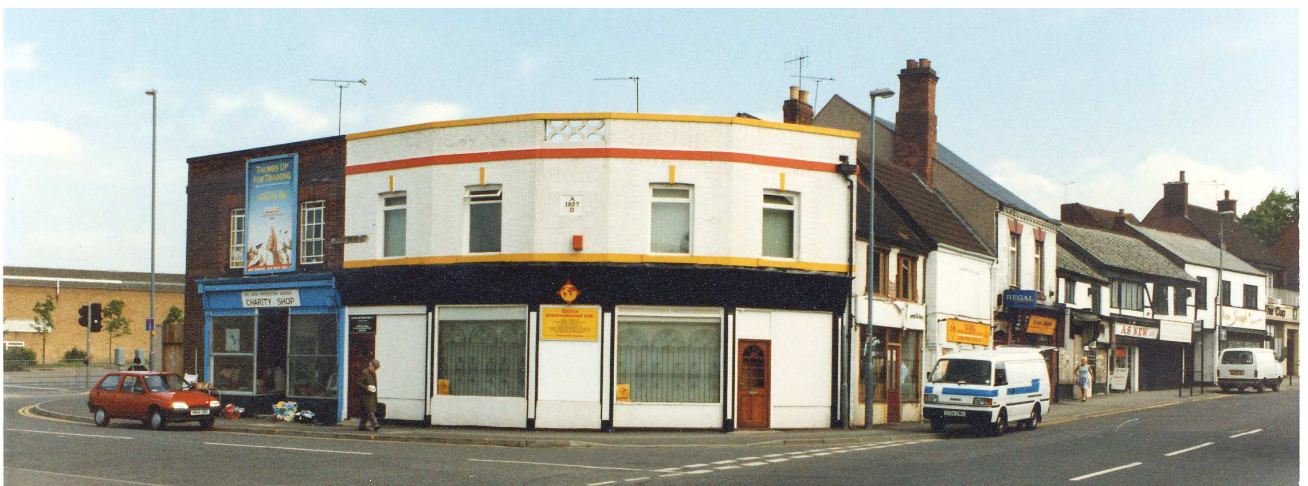
These are the buildings that replaced those shown above in 1927 – N^o 142 Lower Ford Street, on the left, is the only one retaining its original design, albeit marred by the billboard at first floor level. The irregular jumble of mainly mediæval buildings begins immediately to the right – one of the features that gives Far Gosford Street its distinctive character.

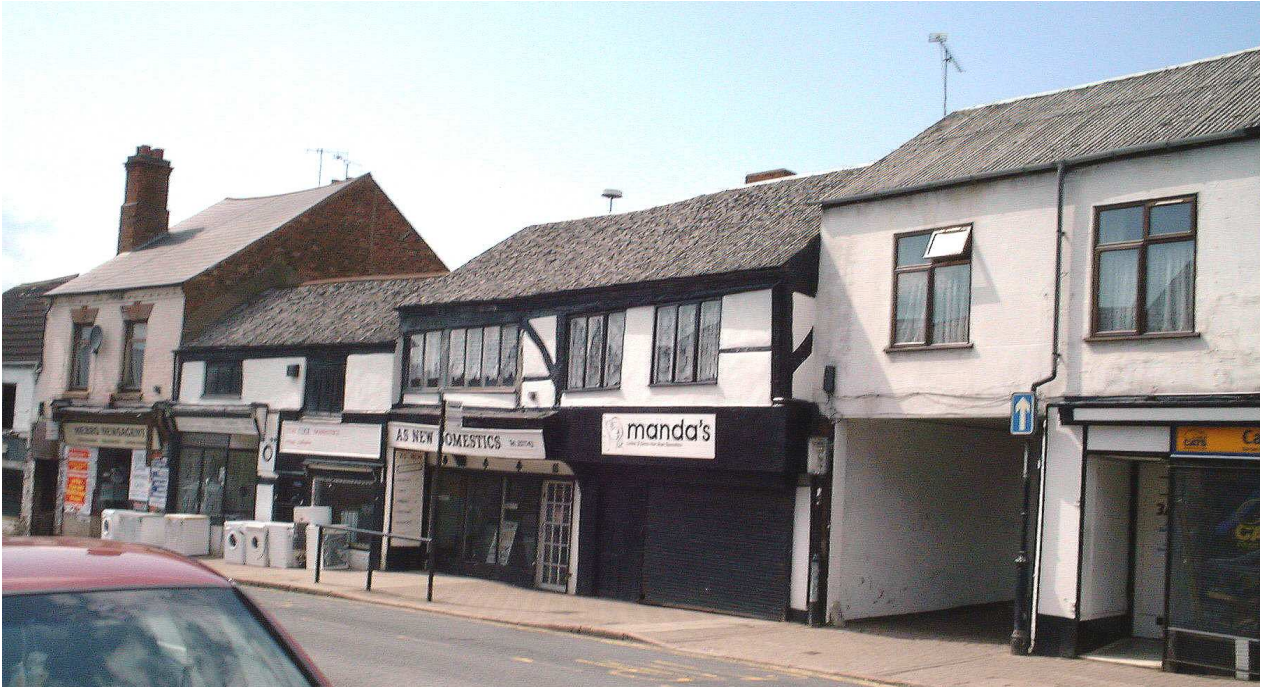
N^{os} 30 to 34 are seen here; N^{os} 32 & 33 are grade II statutory listed buildings, betraying elements of their timber framing; N^{os} 31 & 34 may have had similar origins, but have undergone much alteration. The carriageway at N^o 34 formerly led into Harnall Row, now mostly obliterated by Sky Blue Way.

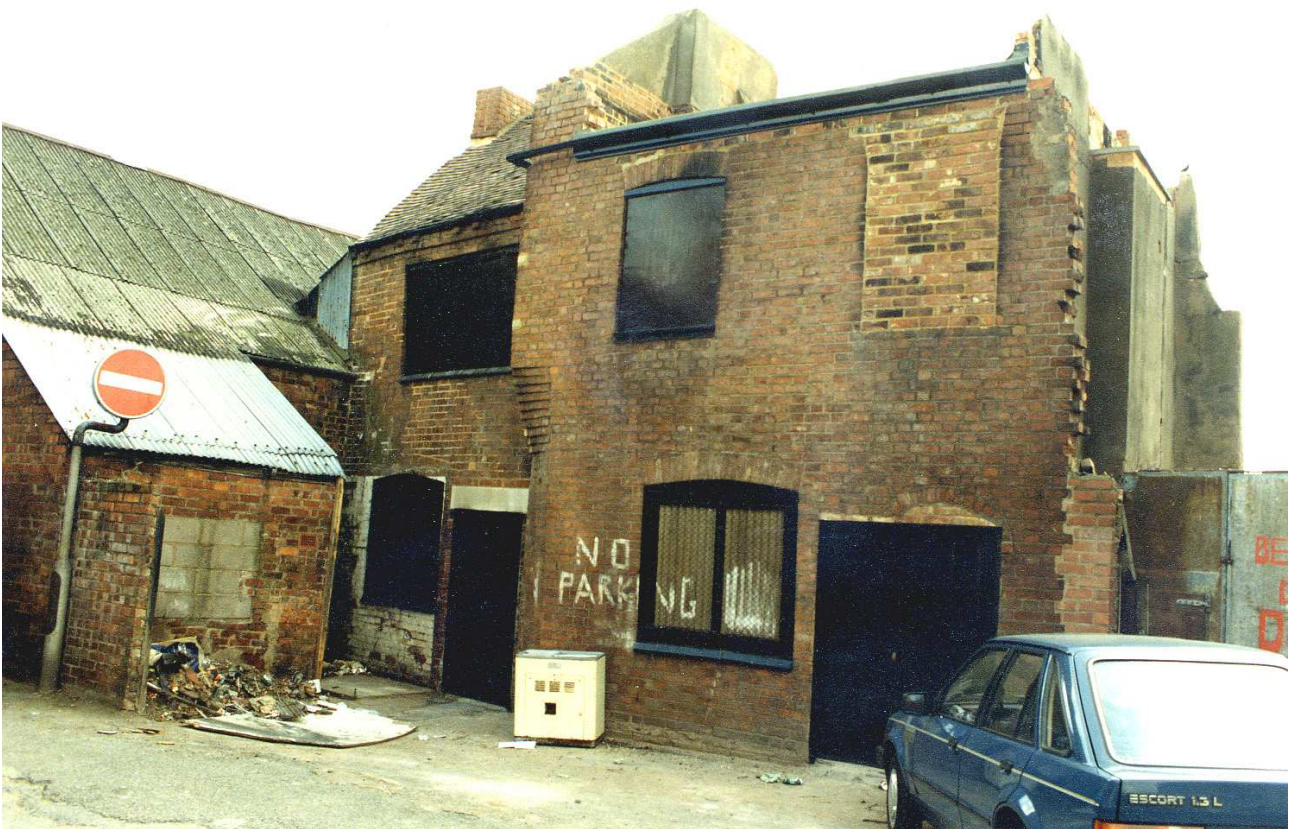
This building at the back of N^o 33 Far Gosford Street is the sole survivor of the tenements that once lined Harnall Row, typical of the many 'court' dwellings that sprang up in the former rear gardens of properties fronting Far Gosford Street during the industrial 'boom' period of the first half of the nineteenth century.
