Far Gosford Street Conservation Area Brief History & Character Statement

Problems faced by historic buildings in the area and the reasons for them

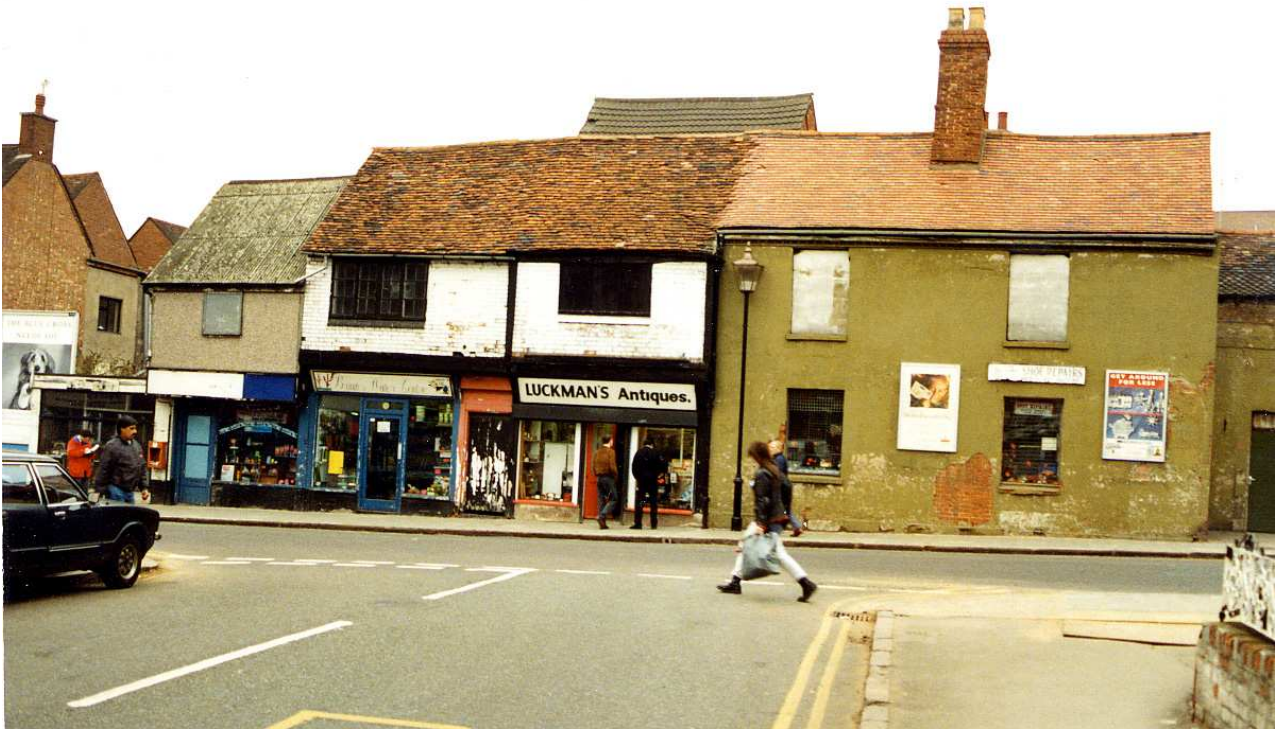
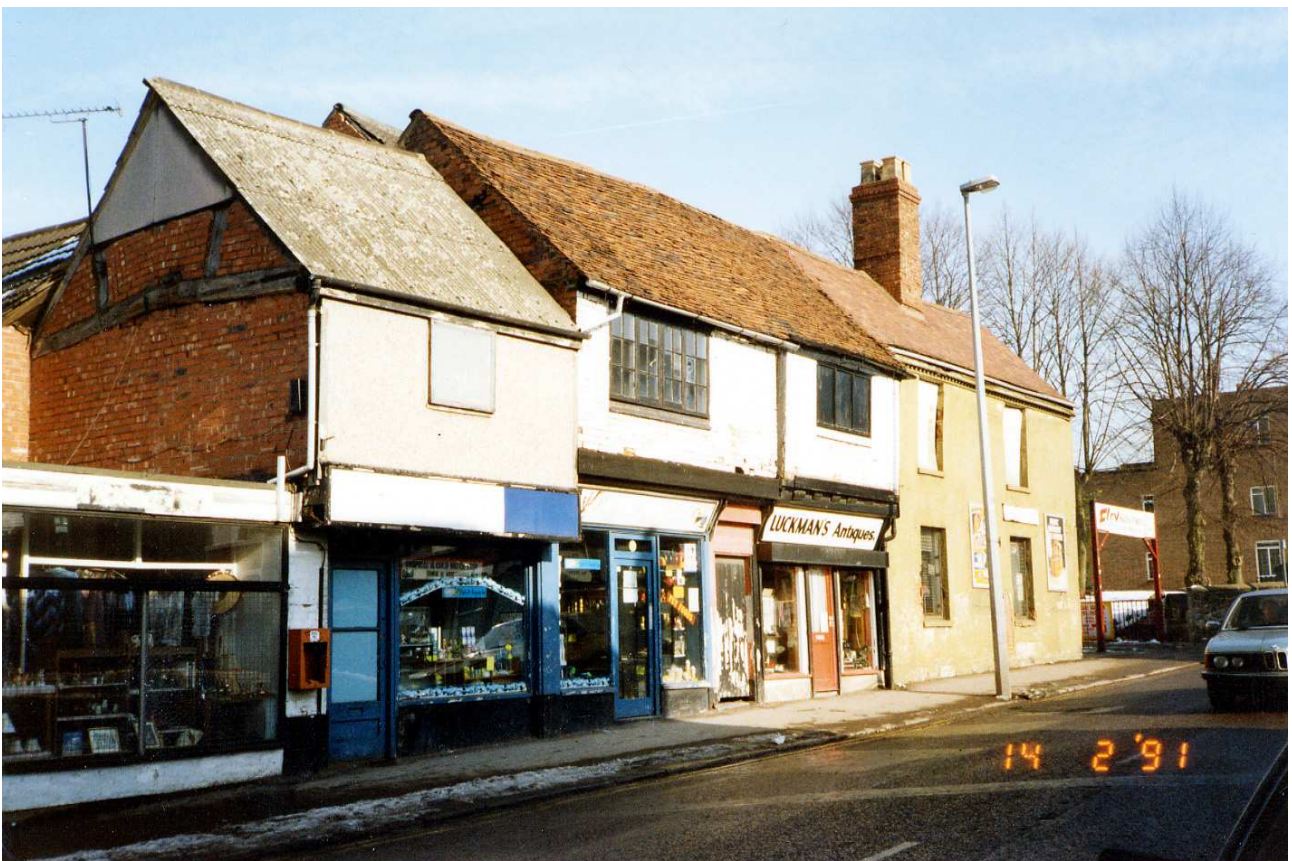
ABOVE and BELOW: Two perspectives on the mediæval group of timber-framed buildings at 38-41 Far Gosford Street, as they appeared in the early 1990s, before advancing dereliction at N^o 41 forced partial demolition for safety reasons. N^{os} 38-40 are statutory listed buildings, grade II; N^o 41 is unlisted, yet is contemporary with N^o 40 and still contains much timber framing, which is visible internally. It is hoped that this building can be rescued and restored as part of the proposed Townscape Heritage Initiative scheme. N^o 37 was also originally part of this grouping, but disappeared as a result of wartime bomb damage.

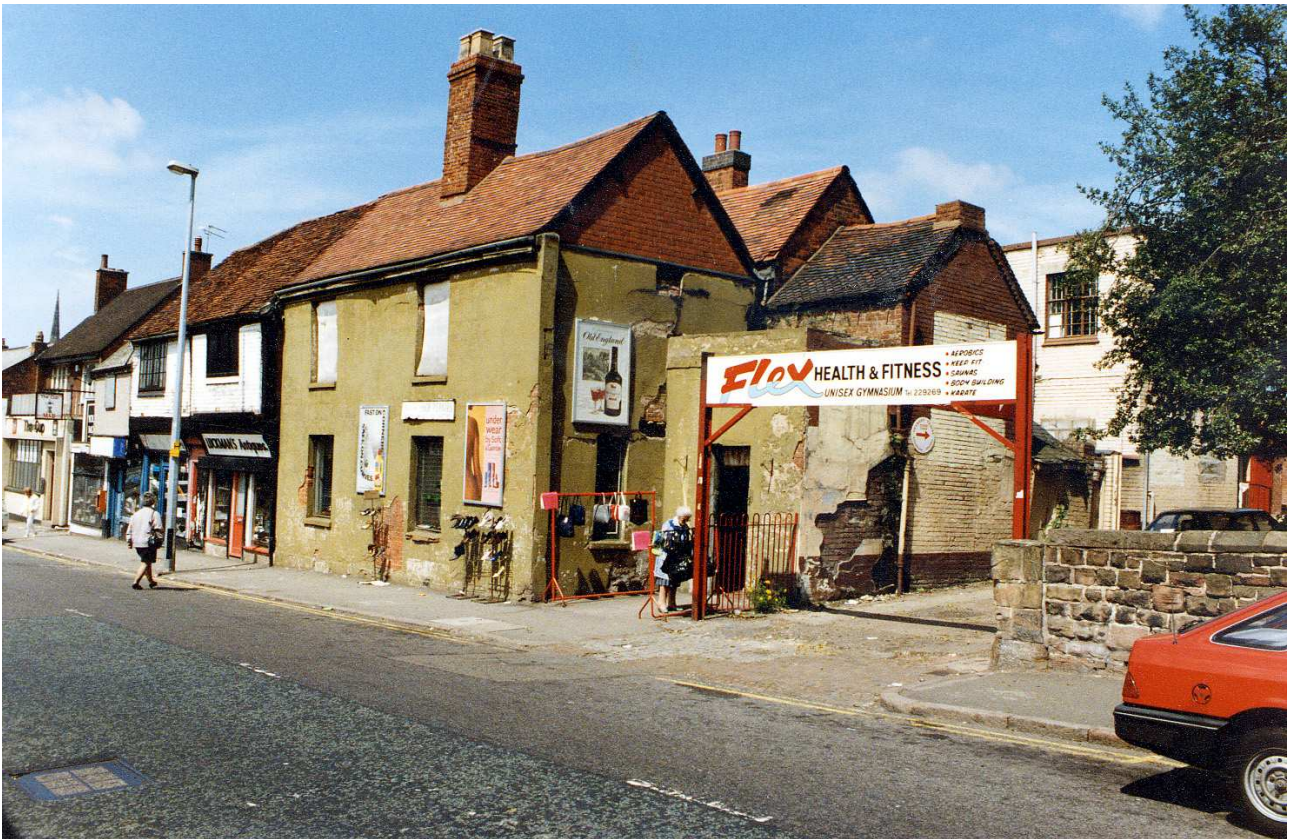
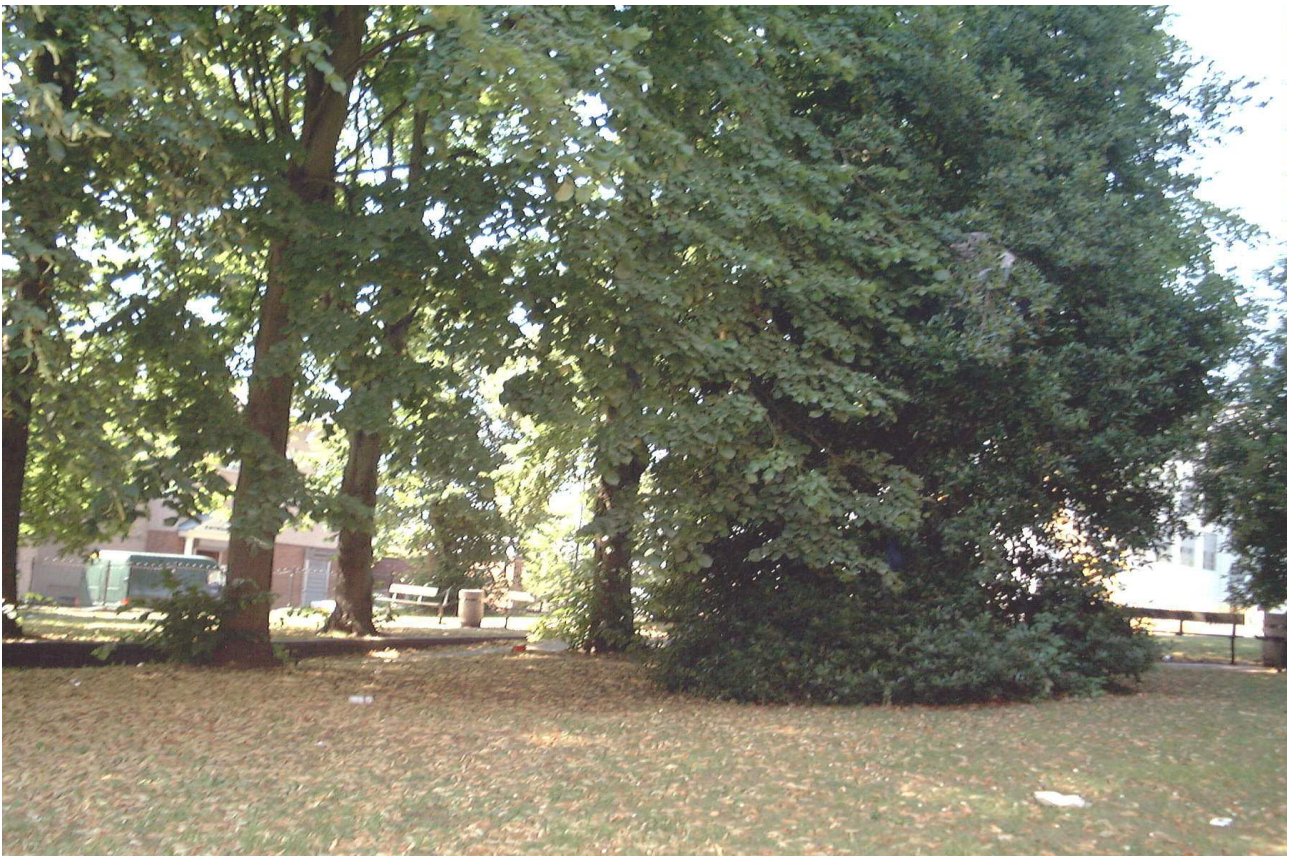
ABOVE: Another view of Nos 37-41, showing the rear wing and other later additions to No 41, which have subsequently had to be demolished. Note the tall central chimneystack on the front block. The rendered wall hides a brick refronting, probably of 18th or 18th century date, to the original timber-framed structure. BELOW: All Saints' Churchyard as it appears today, seen from the Sky Blue Way side. The trees need pruning!

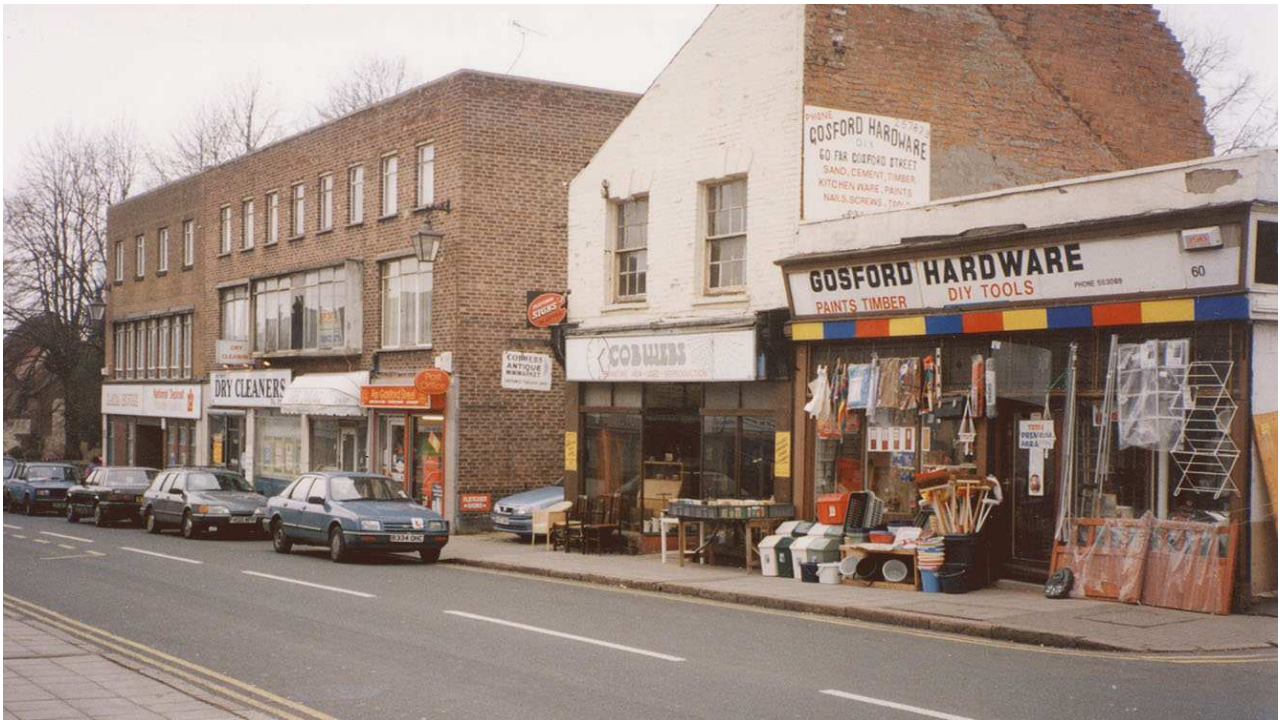
ABOVE: Nos 52-60 comprise a modern block of shops, with flats over, the older No 58 (see below) and all that remains of Nos 59-60, which once had an upper floor. These premises are now derelict, but an attractive traditionally styled shopfront, with stained glass in the transom lights, is hidden behind the external display clutter in this 1991 photograph.

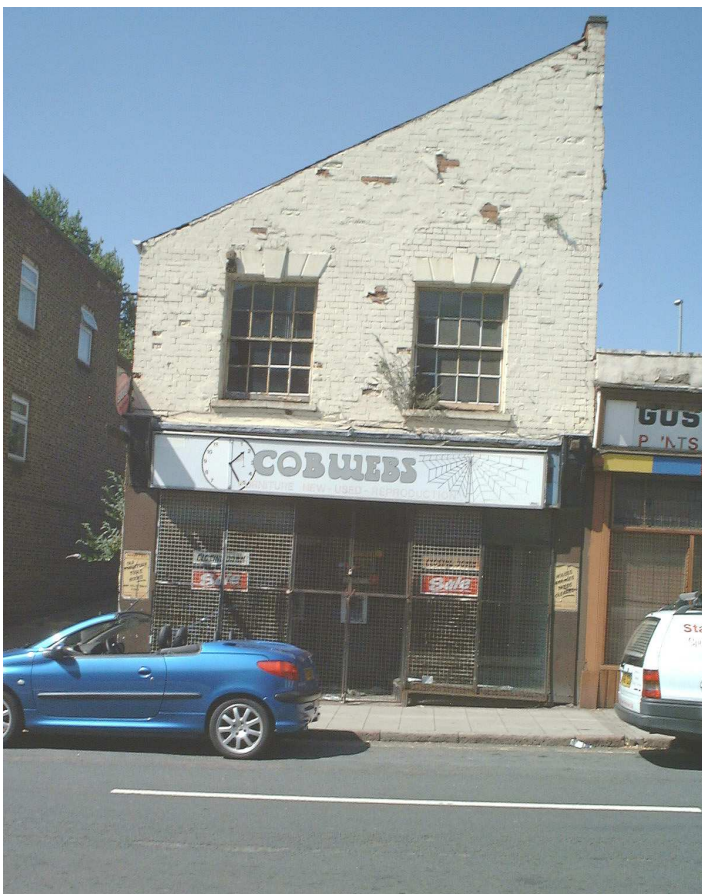
This recent picture shows that No 58 is now empty and semi-derelict. Whilst not an exceptional building, it retains its original, small-paned sash windows on the first floor and, unusually for this street, presents a gable end to the street frontage, which gives it a certain quirky interest. It also retains the skeleton of a traditional shopfront. Refurbishment should be considered as an alternative to redeveloping this property along with the derelict Nos. 59-60 and the gap site at the former Nos 61-62.

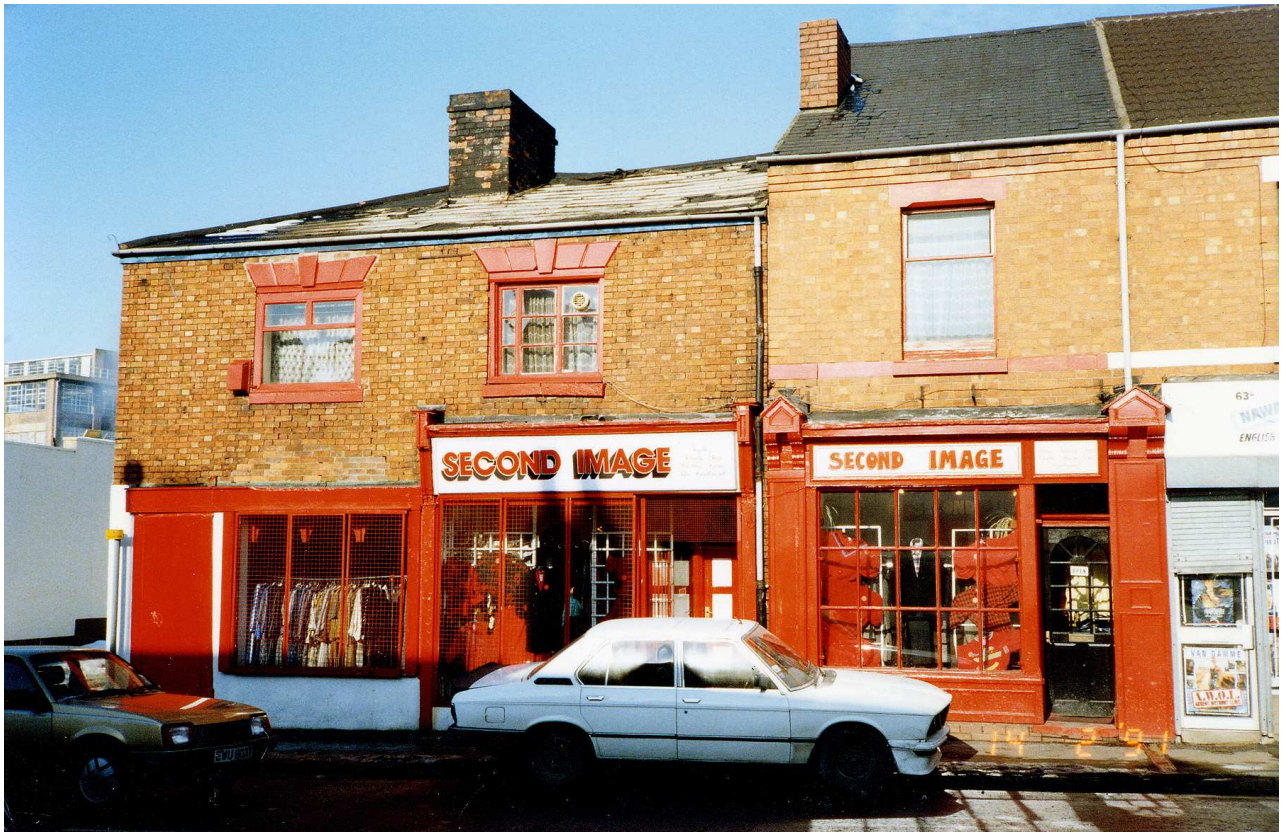
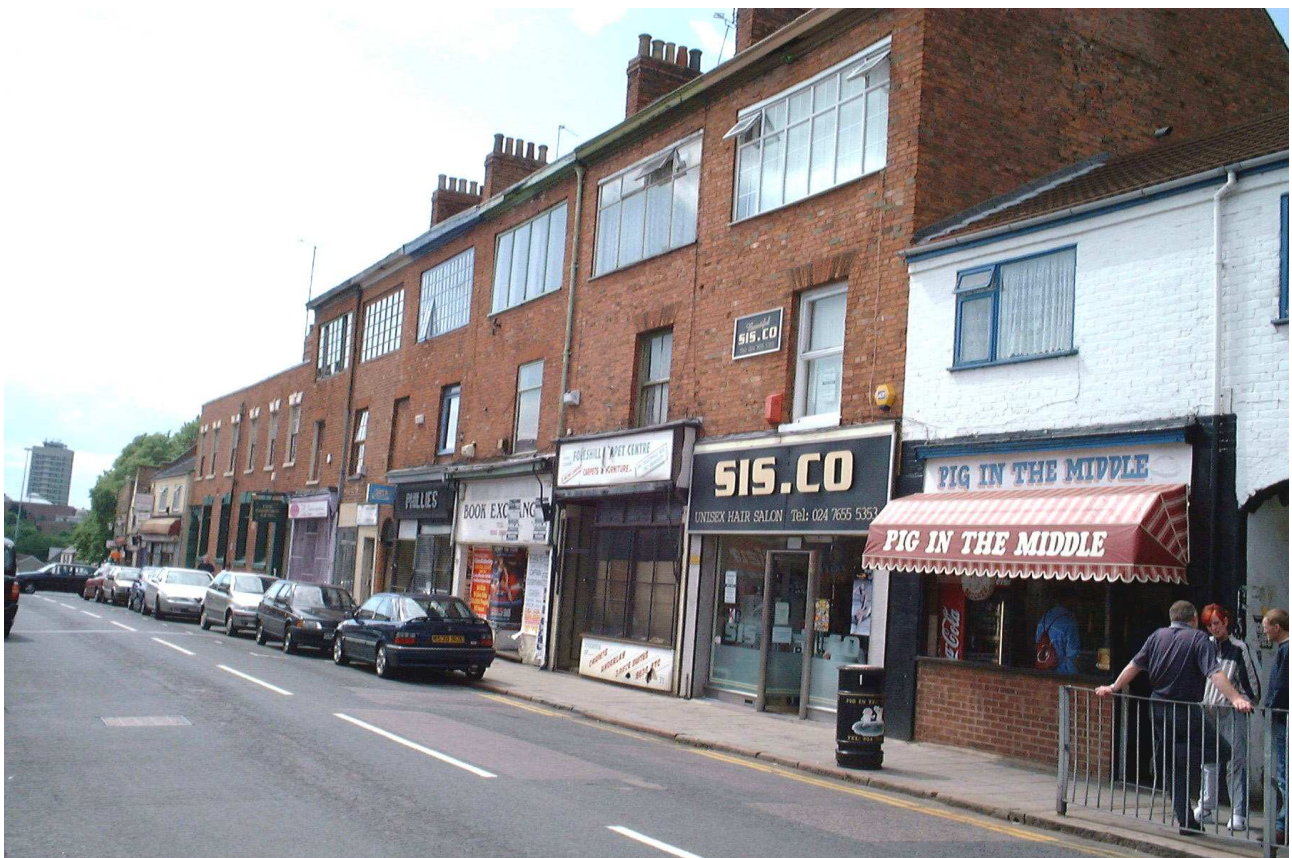
ABOVE: This view shows Nos 61-63 in 1991; Nos 61-62 have more recently been lost as a result of an arson attack. Despite alterations and the loss of their 'topshop' storey, these properties retained an historic 'feel'.
 BELOW: the grade II statutorily listed Nos 67-72 began life as weavers' houses with the 'topshops' above.

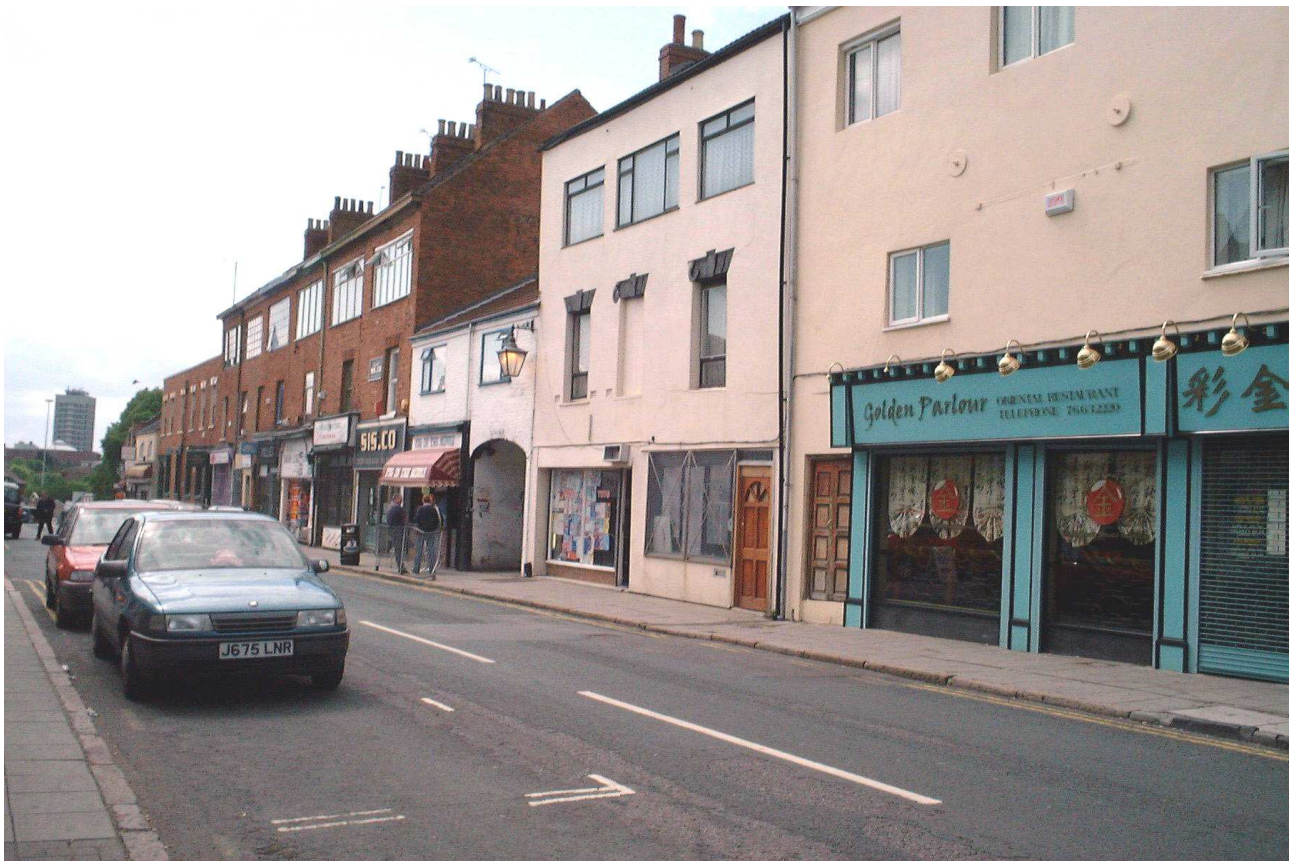
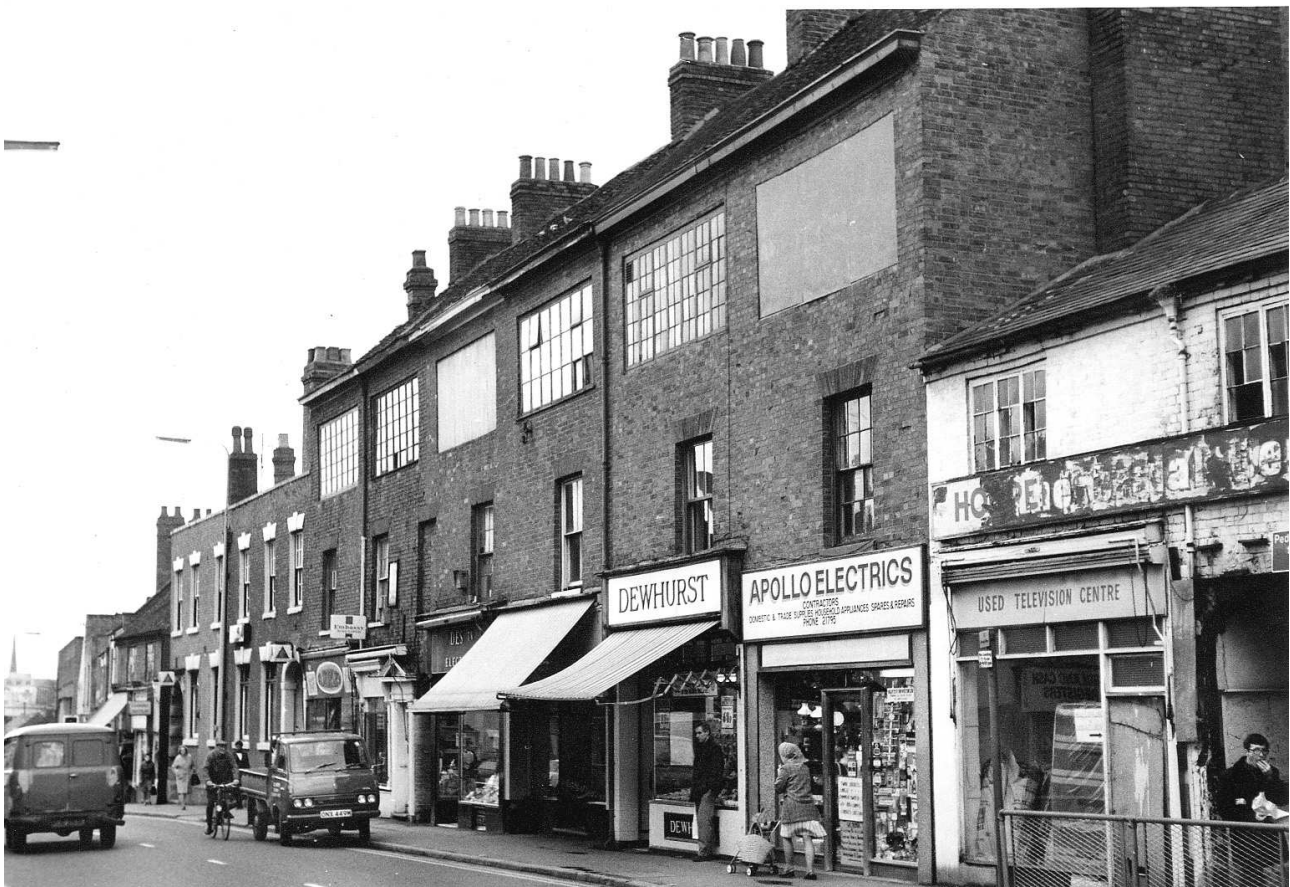
ABOVE: Nos 65-75 in a recent view, shortly after the refurbishment of Nos 75-76. Nos 74-76 also originated as weavers' 'topshops'. BELOW: Nos 67-72 as they appeared in the 1970s. Note the (lost) door surround at No 68.

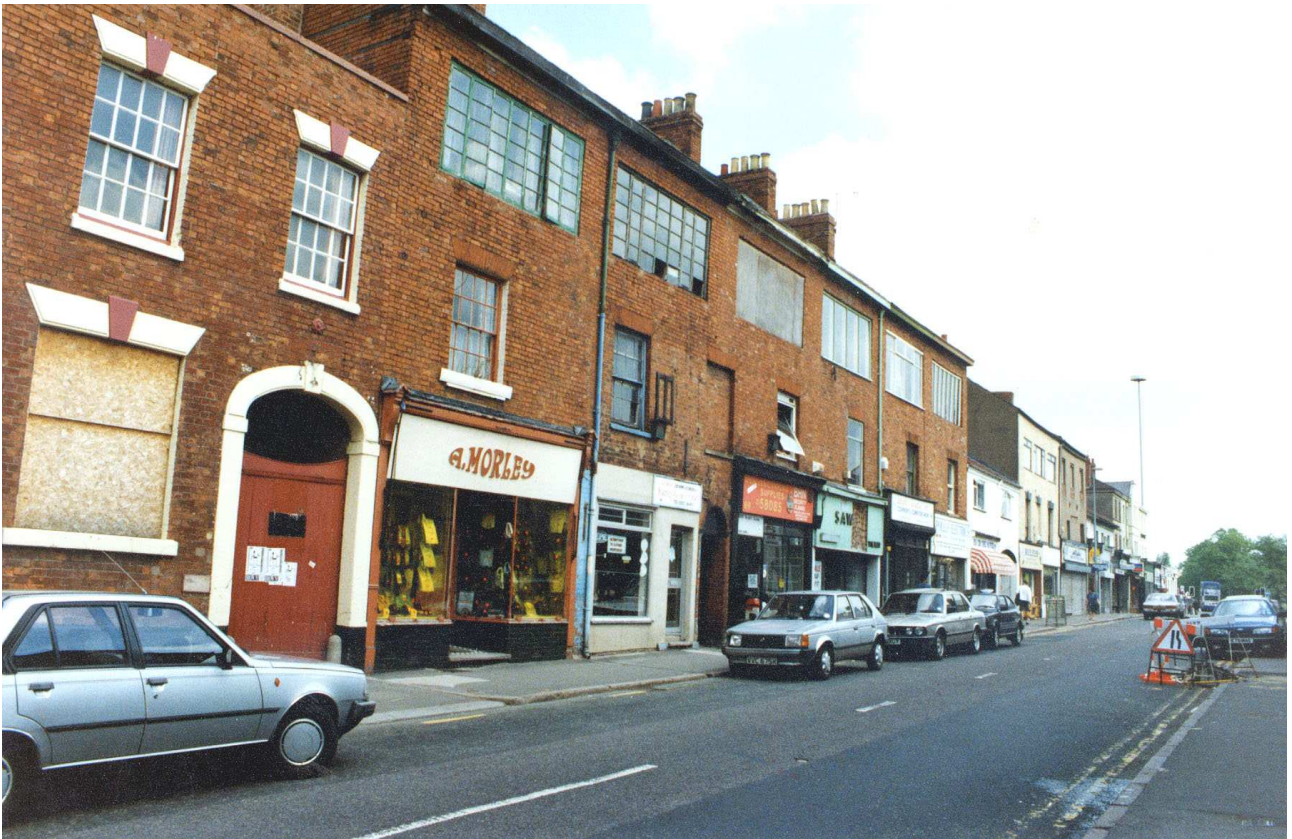
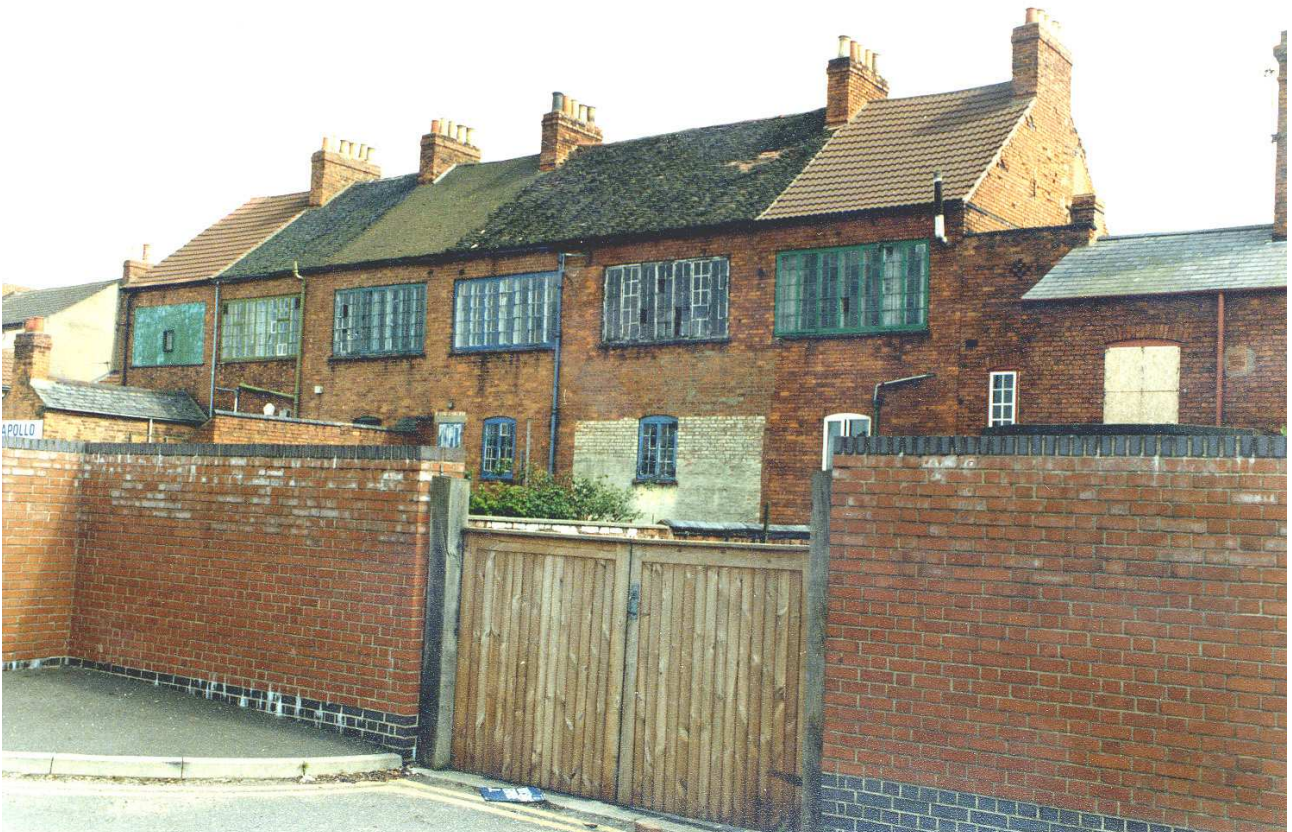
ABOVE: Another view of the row of 'topshops' at N^{os} 67-76 in the early 1990s. Note the frontage to N^o 67, largely unaltered since the early 20th century. BELOW: the rear elevation of N^{os} 67-72 around the same time. Most of the original 'topshop' and first floor windows still survived. It was important to have as much light as possible in the weaving workshops, so that the weavers could continue working at their looms for as long as the light lasted!

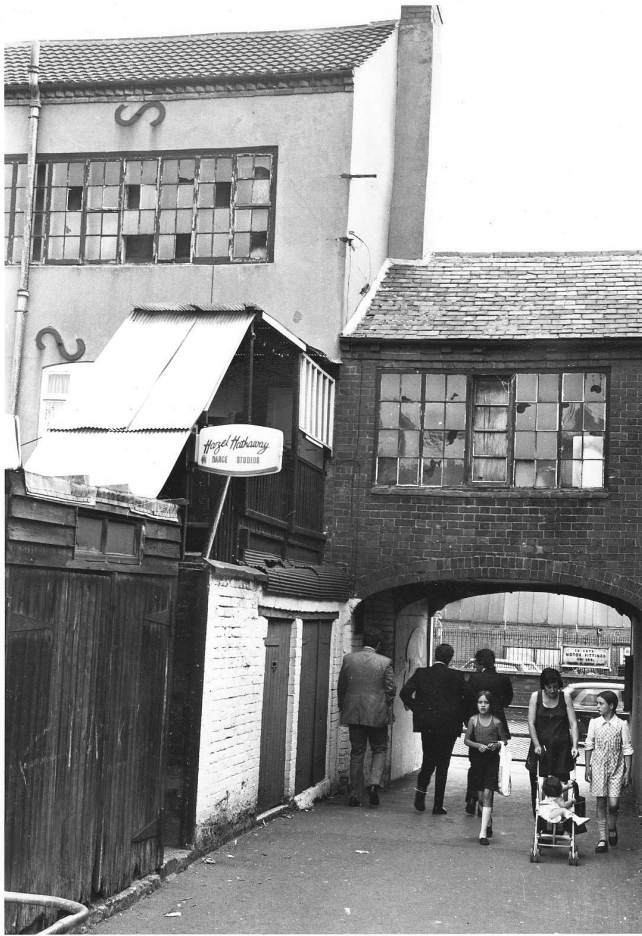
LEFT: This 1970s view of the rear of N^{os} 73 & 74 shows the original 'topshop' window at the back of N^o 74 (now covered or infilled) and a smaller version above the carriageway arch at N^o 73. The passage formerly led into Court N^o 11.

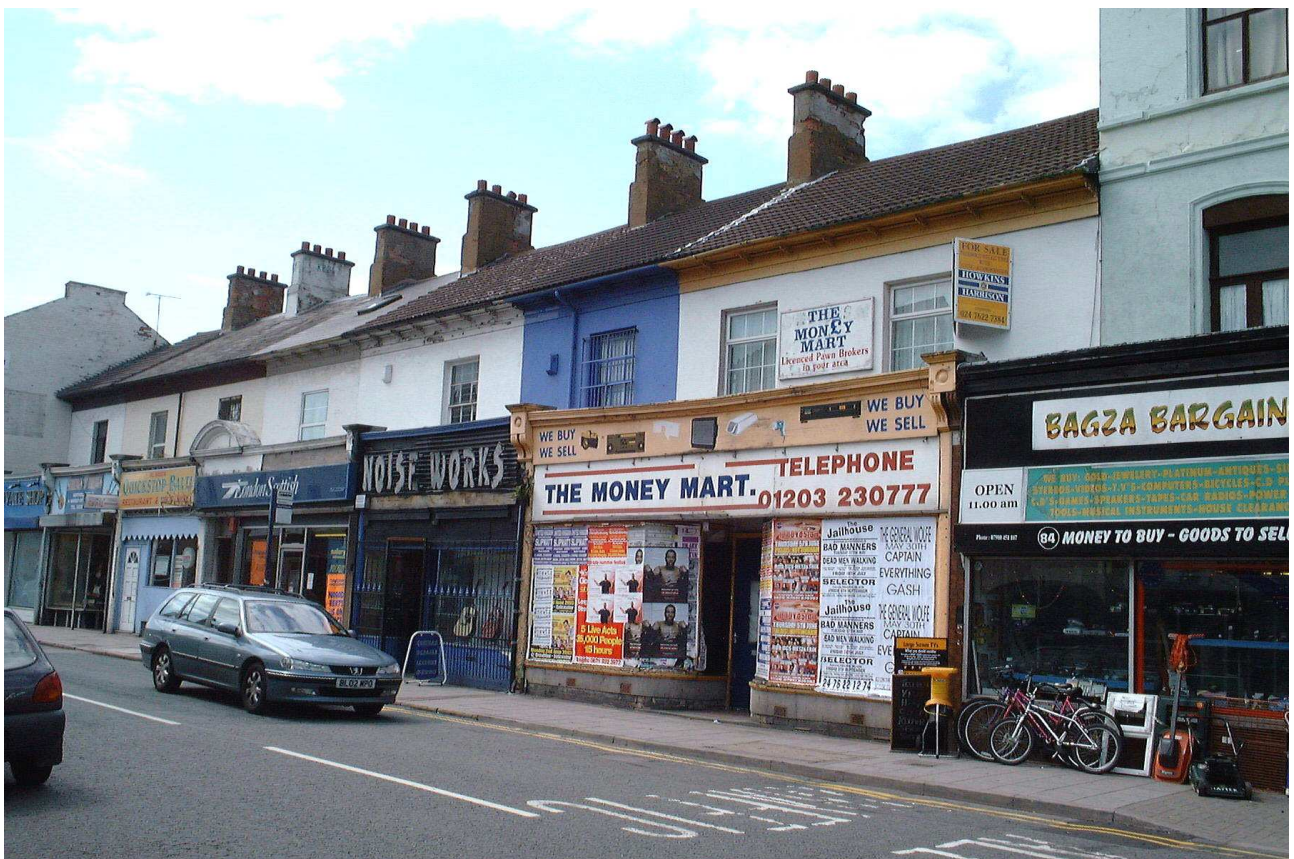
BELOW: A recent view of Ashville Terrace, showing the shops that were built over the front gardens of these former houses in the early 20th century. The original elegant uniformity of the shopfront fascias and pilasters has been compromised by the numerous alterations, in particular the use of new fascia boards of varying depth. Changes to window designs and roof coverings have also contributed to the decline.

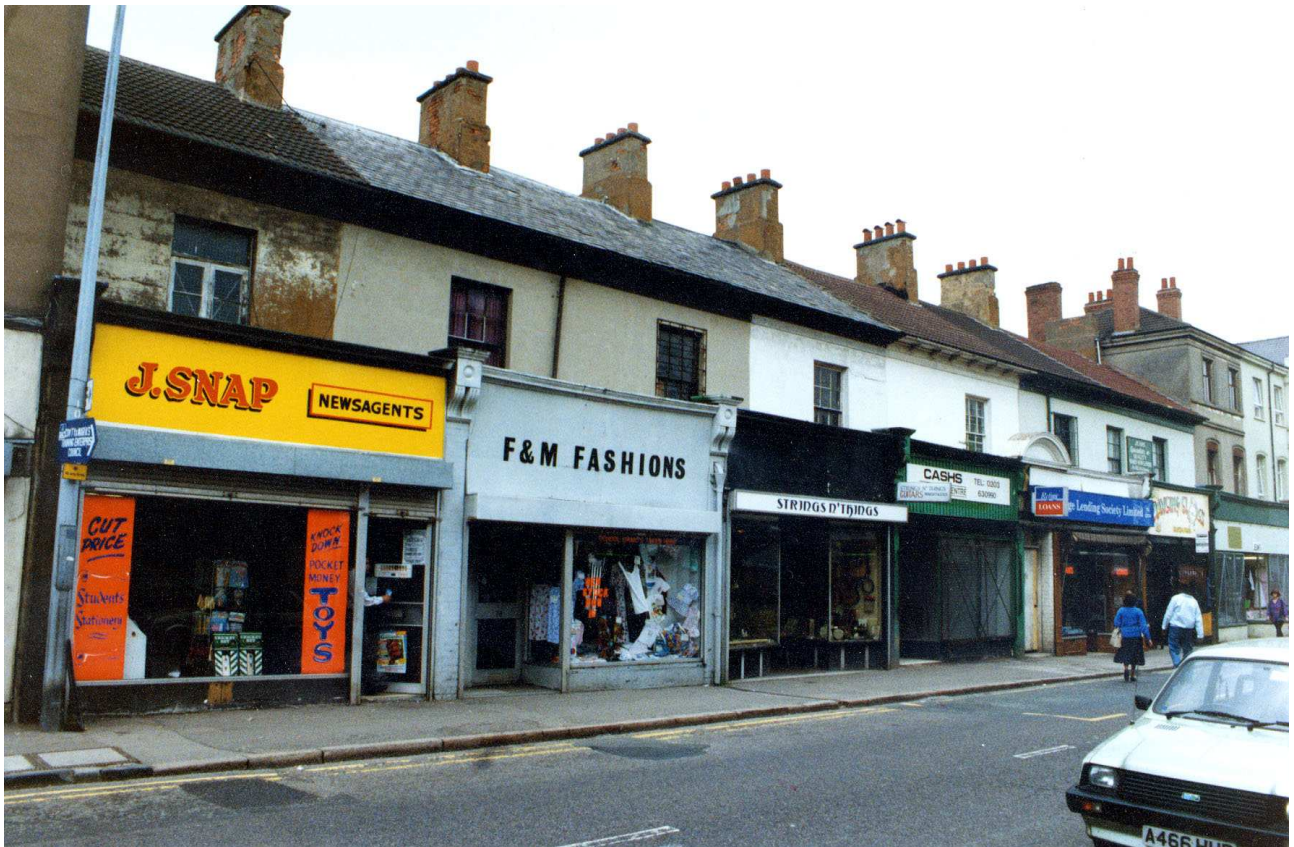
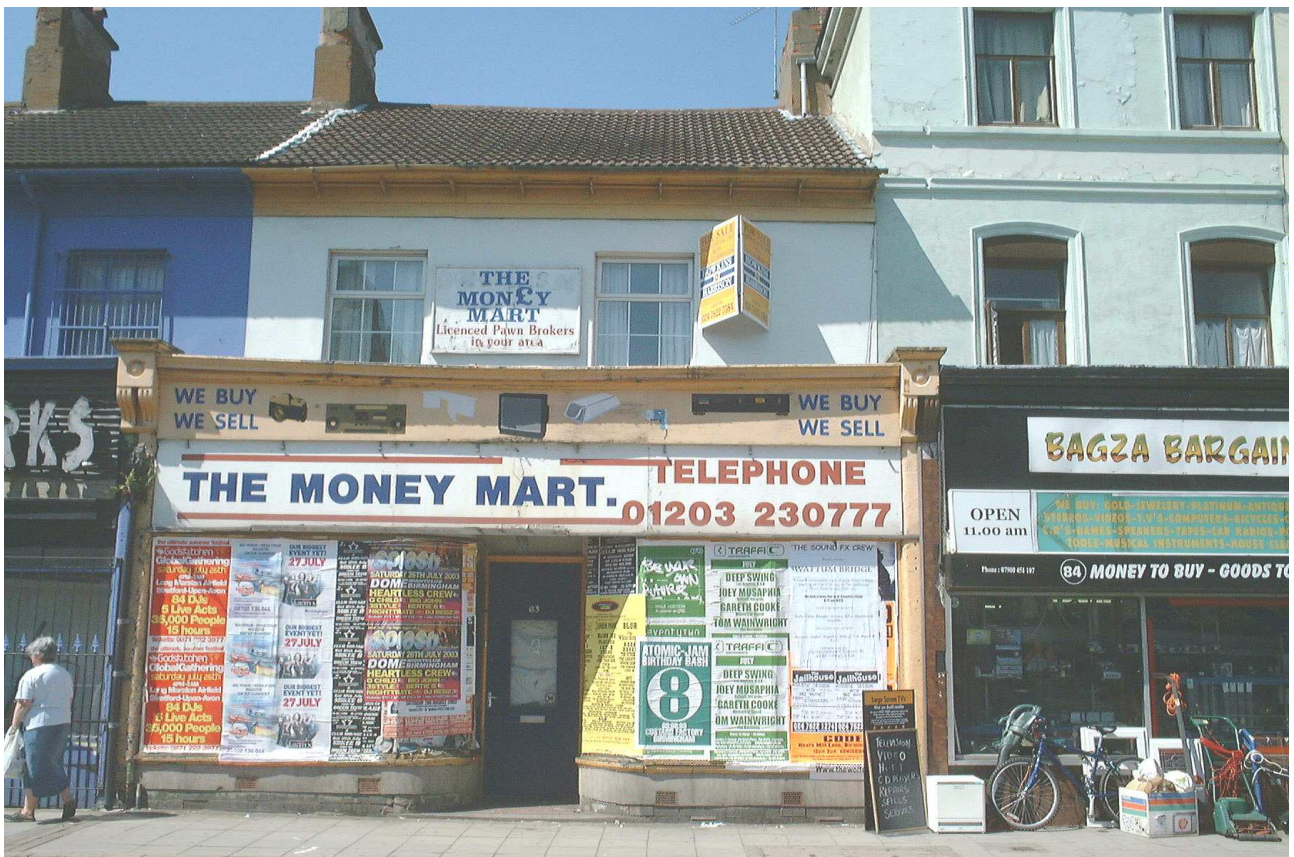
ABOVE: Another view of Ashville Terrace; BELOW: the traditional style shopfront at N^o 83, recently replaced similarly

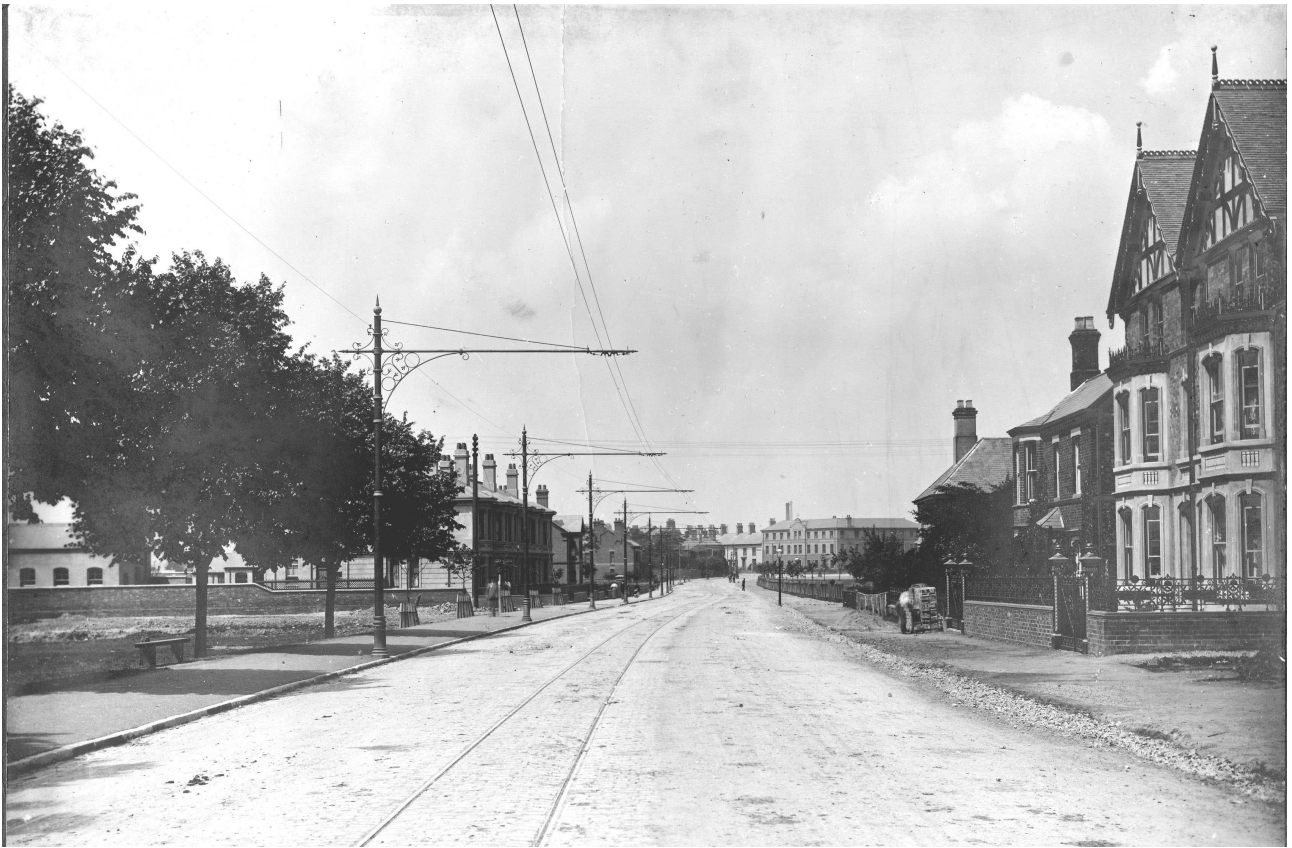
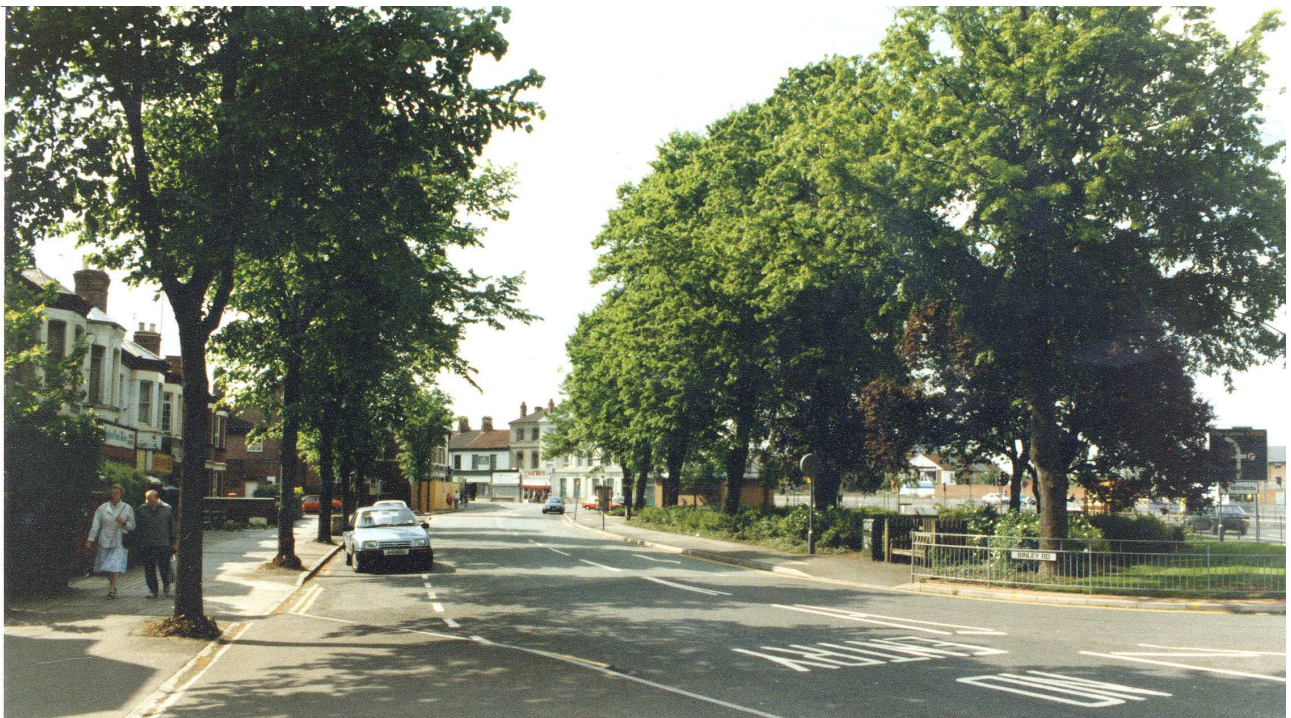
ABOVE & BELOW: These two views of c.1910 and 1991, looking from the old line of Binley Road westwards towards the eastern end of Far Gosford Street, were taken from roughly the same perspective, except that the top picture is taken from a point further back. The background detail is enlarged on the second plate after page 10. The most notable changes are the maturing of the young trees and the disappearance of the tram lines and poles! It is also notable that streetlamps did not extend very far into Binley Road in 1910!
