COVENTRY CITY COUNCIL CLIFFORD BRIDGE ROAD COVENTRY SECTION 7A CYCLE FACILITIES

STAGE 2 ROAD SAFETY AUDIT

SA 5011
July 2025

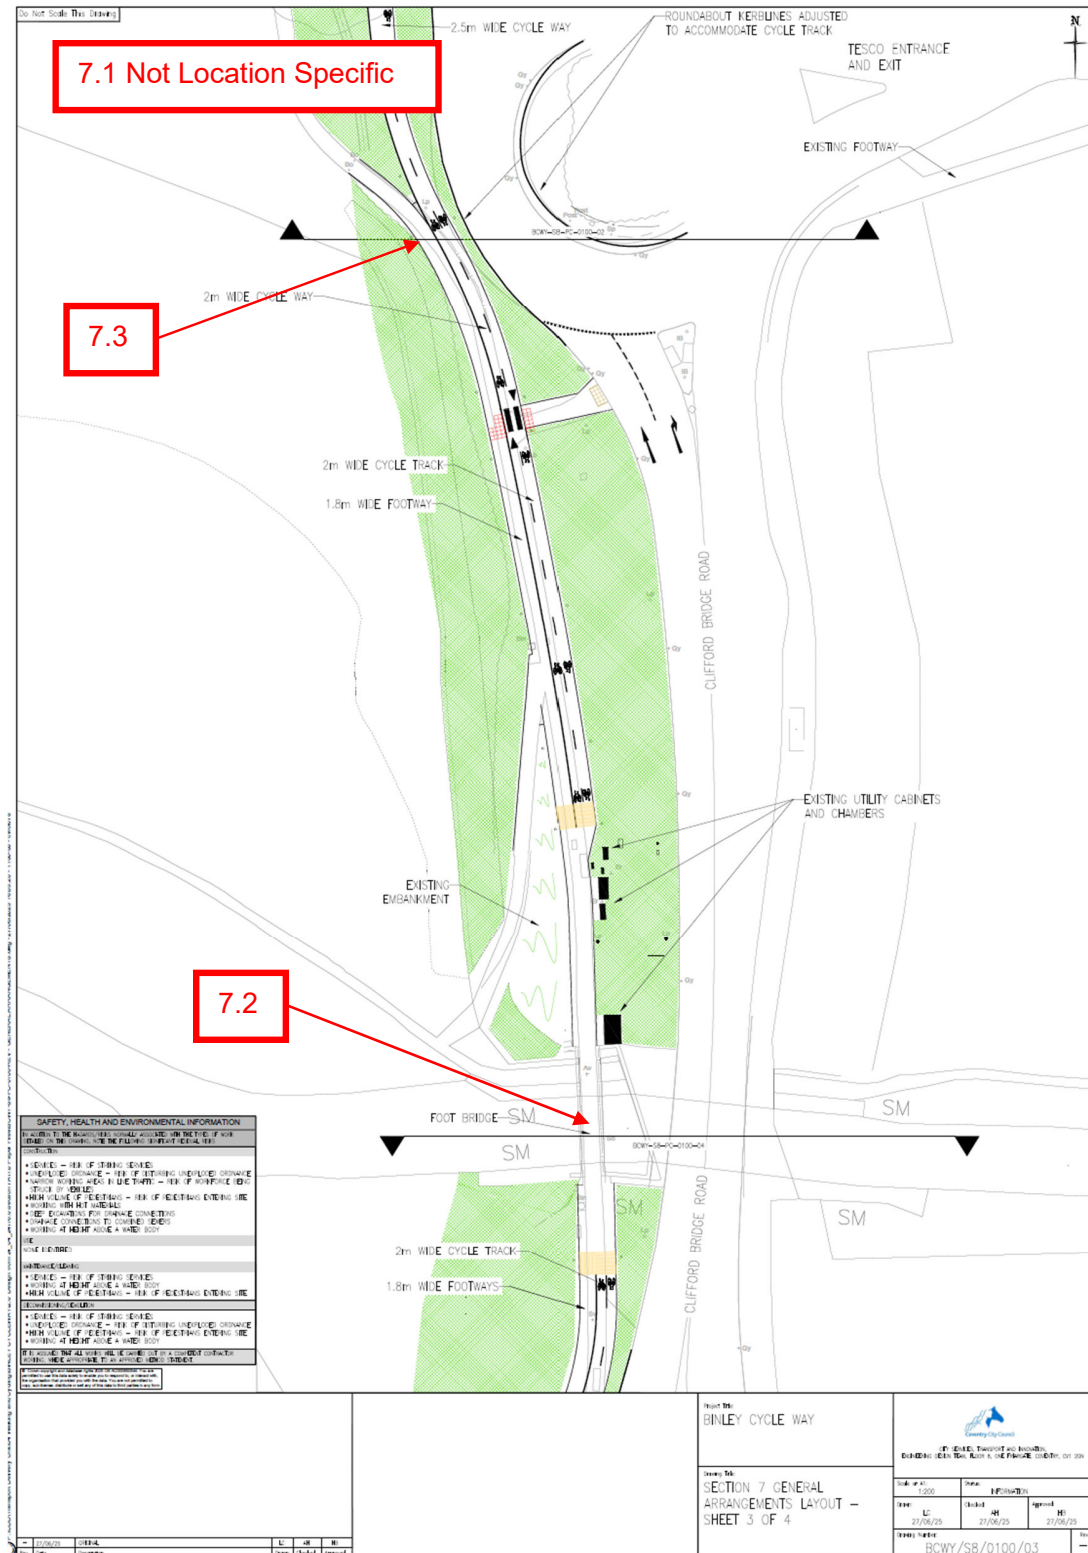
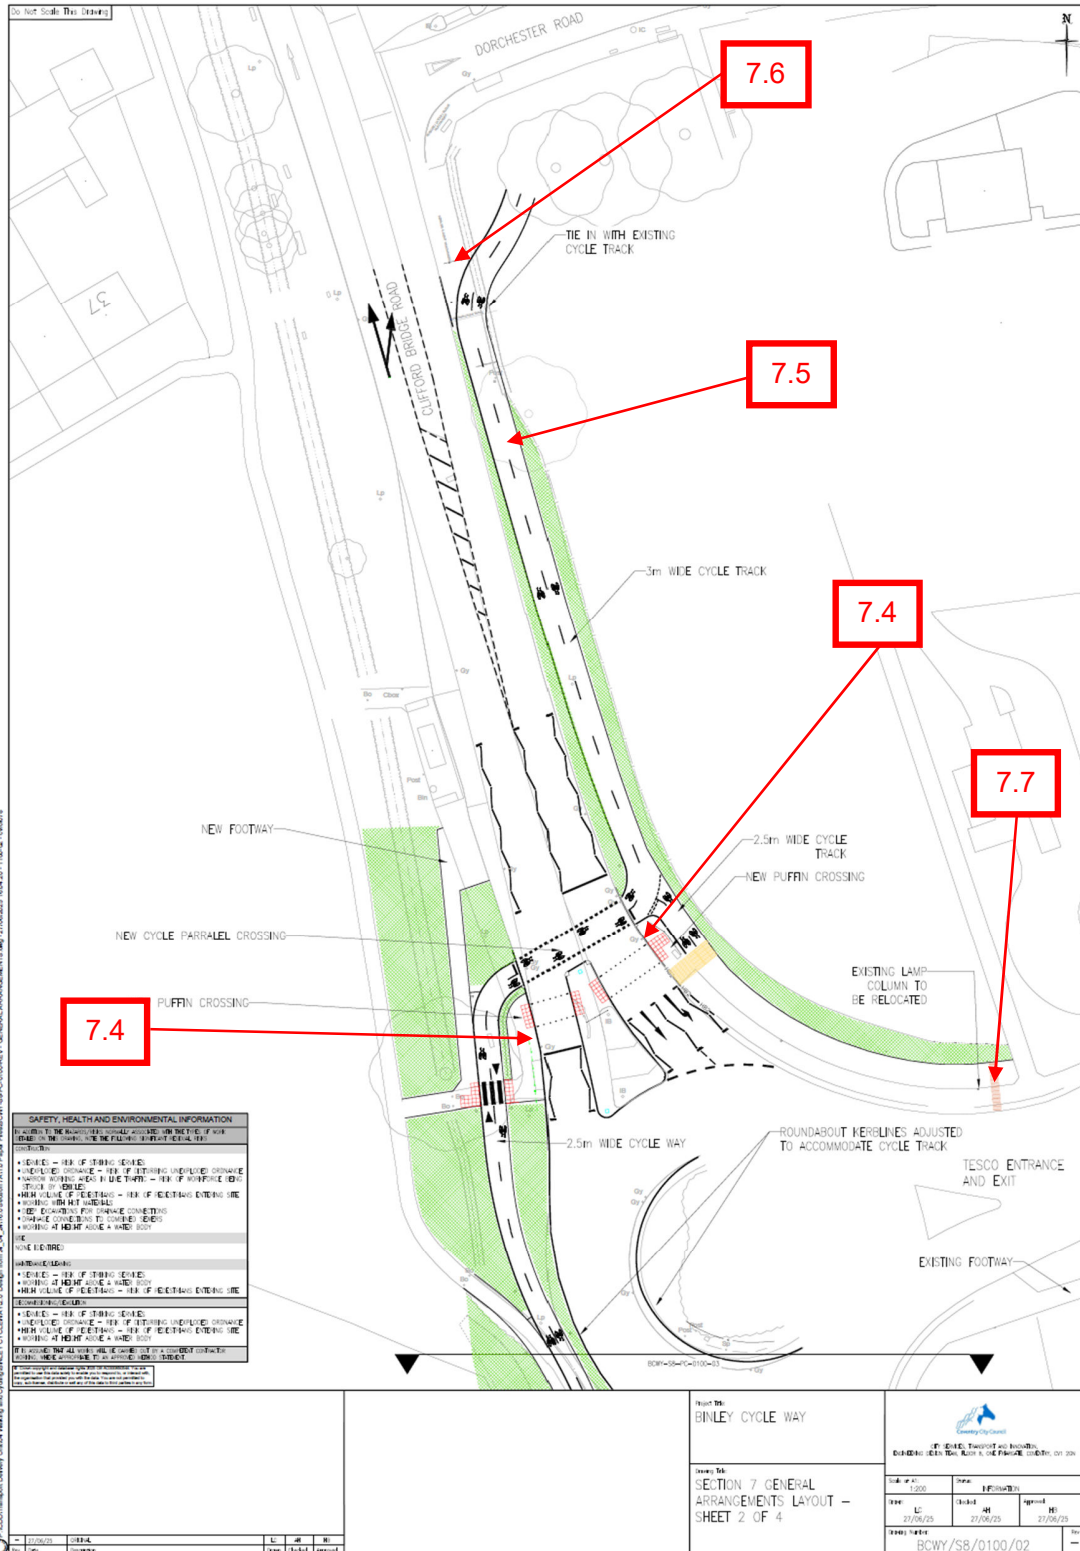
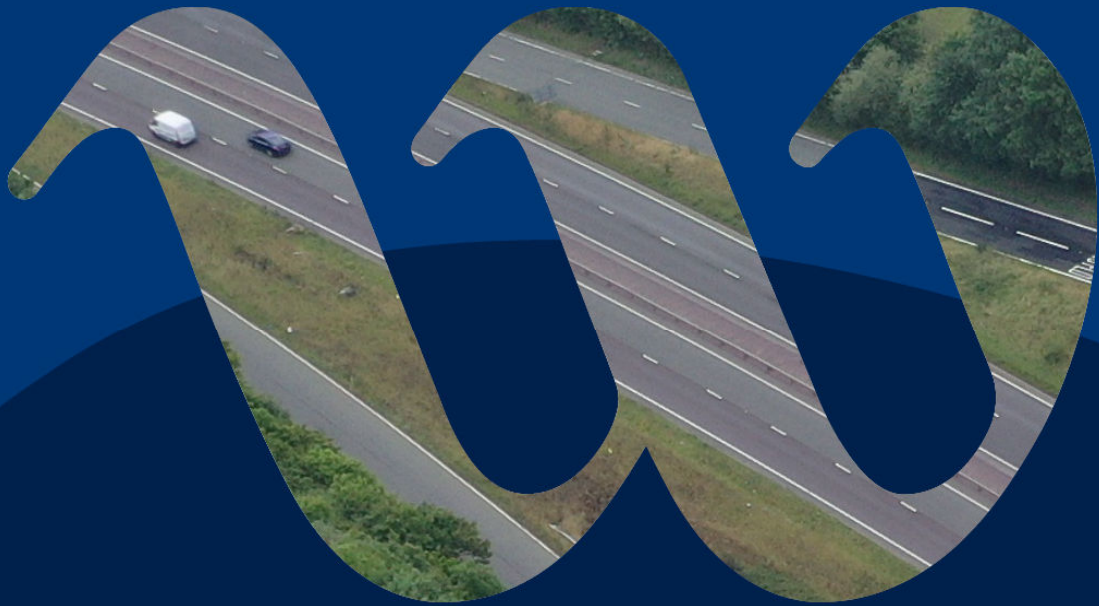
10.0 PROBLEM LOCATION PLAN

Location: Not Location Specific – Segregated two-way cycleway

Location: Clifford Bridge Road at foot bridge

Location: Clifford Bridge Road at Tesco roundabout

Location: Clifford Bridge Road north of Tesco roundabout

Location: Clifford Bridge Road south of Dorchester Way

Location: Tesco Access Road
