# London Road/Abbey Road— RSA Stage 2 Designer Response

For Coventry City Council

LRAR-RSA2-DOC-SM-0001-Rev-01

**STAGE 2 ROAD SAFETY AUDIT**  
**LONDON ROAD SIGNALISED JUNCTION**

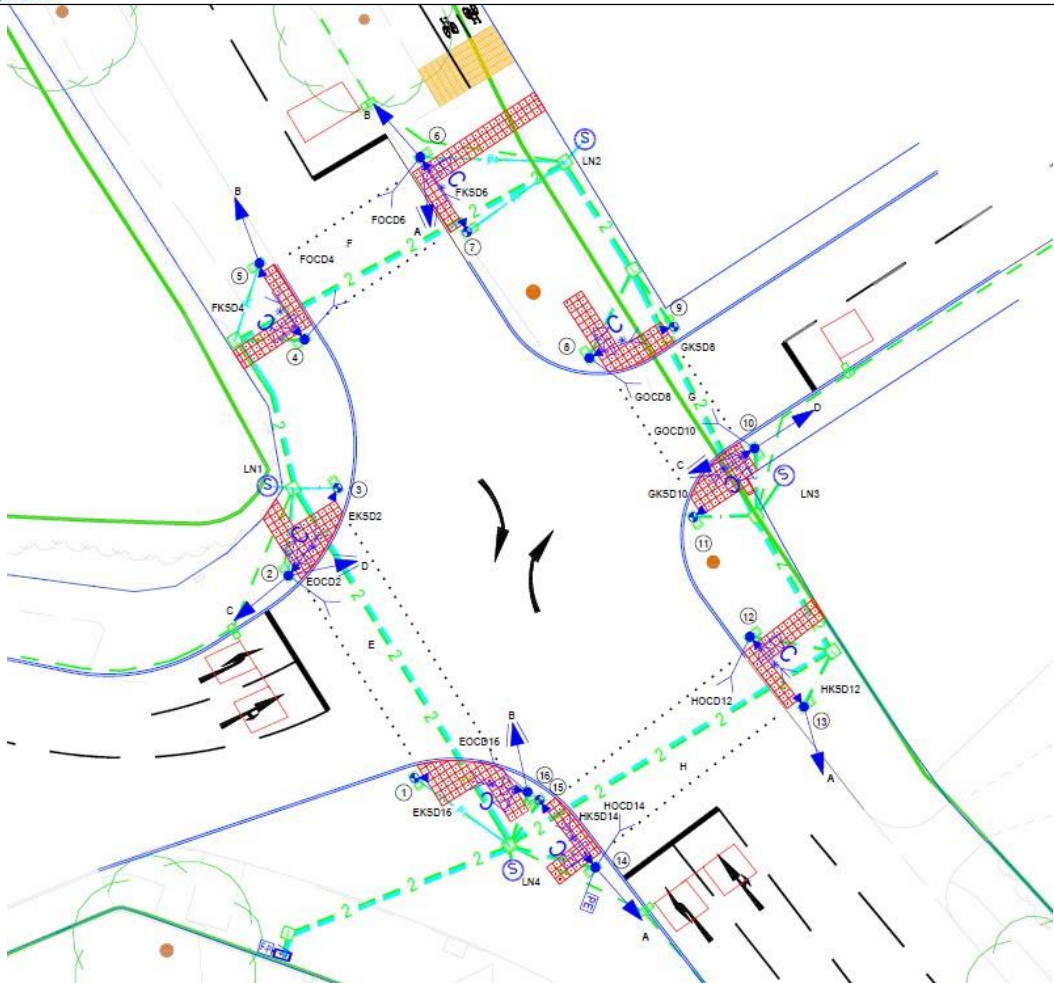
Fig 1 – Proposed Signal Layout

- 1) Yunex, who are the signal designers indicate that the signalisation design is in accordance with design guidance. Given the proximity of the bus stop, they provided 3 primary signals at numbers 5, 6 and 16 (as shown below). Therefore, their view is an additional mast is not appropriate. The designer has accepted this advice.

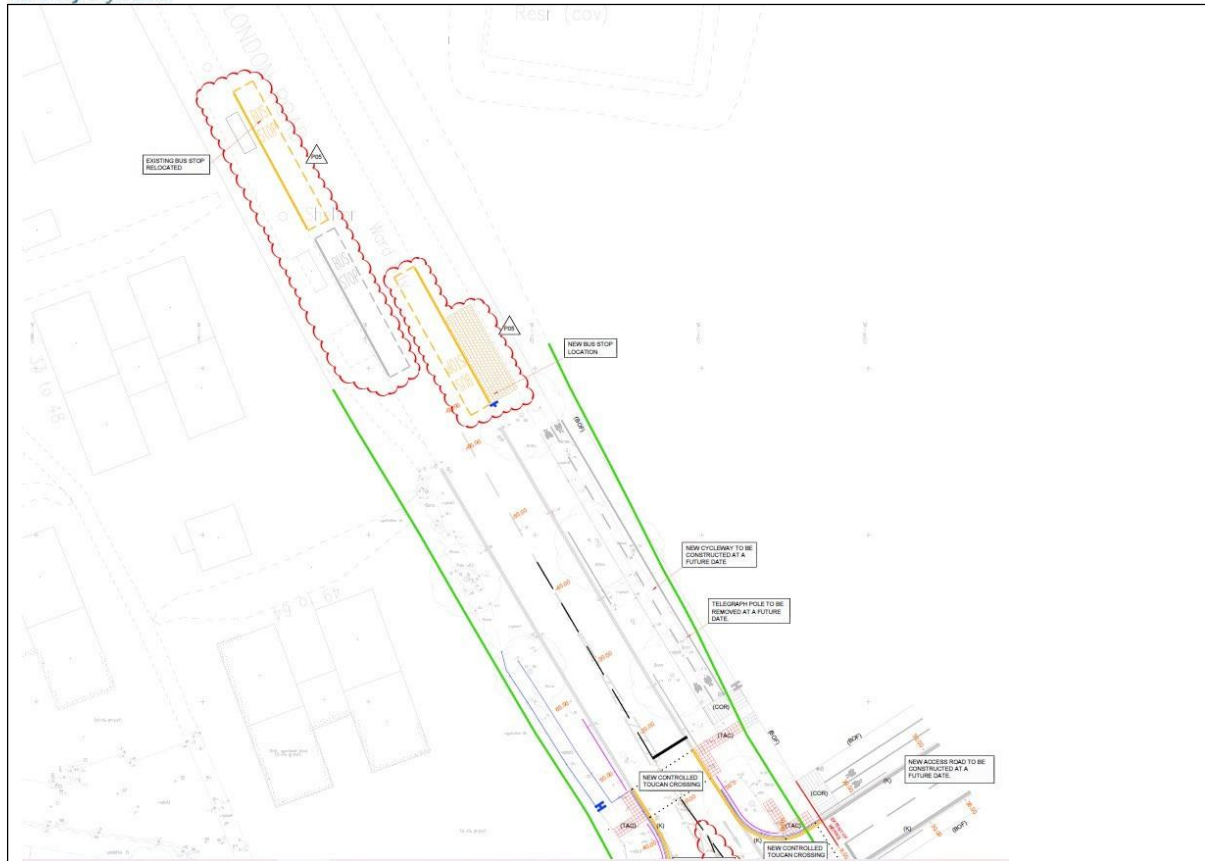
Fig 2 - New Bus stop location

- 2) The meeting with the safety team suggested a mast if the bus stop was located at 30m from the signal stop line, but also if it was located 40m from the signal stop line. As 1) the additional mast has been reviewed as discussed as the signal design follows current guidance. If the bus stop was located 40m from the stop line, then the adjacent bus stop serving northbound traffic should be relocated as well. There was also a location south of the current bus stop that was considered.
- 3) A further meeting with a representative of TfWM was held. They were happy with the 30m location currently shown. They did not consider the southern option suitable as visibility was not very good. The 40m was considered and TfWM would wish the opposing bus shelter to be relocated as well. The final layout agreed with TfWM is as shown below.

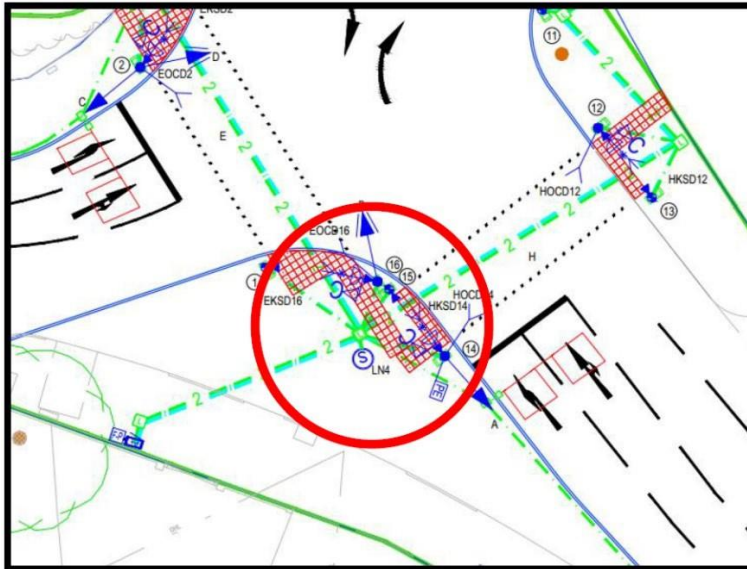
Confusing tactile paving – London Road

The submitted drawings are confusing as different drawings highlight different tactile paving layouts for the same locations. This may result in visually impaired pedestrians becoming confused and entering the highway at the wrong location; and this may result in pedestrian to vehicle type personal injury collisions.

If the above shows the proposed tactile layout, redesign the tactile paving so that the tactile paving is separated. This will significantly reduce pedestrian confusion and this will significantly reduce the likelihood of vehicle to pedestrian type personal injury collisions.

This comment has been accepted. The design has been co-ordinated with the signal designer. The current GA shows the design as below and will be passed to the signal designer for inclusion in

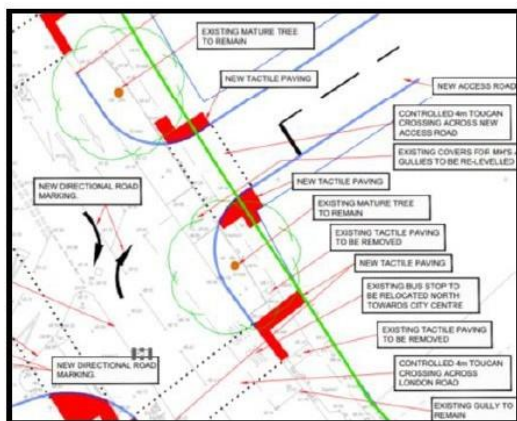
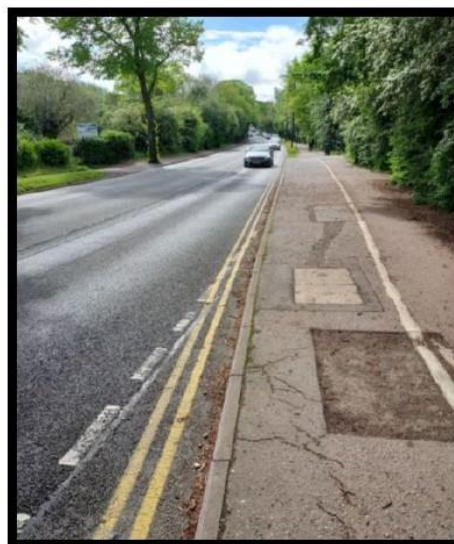
Service covers – throughout scheme & London Road junction with new access.

The existing covers are to be re-levelled but will remain in-situ. This location is where a high proportion of vehicles will be turning out of the new access into London Road. Having service covers at/on a corner increases the risk of vehicles skidding and also increases the likelihood of the service covers failing and becoming a maintenance issue. This increases the likelihood of vehicle to vehicle type personal injury collisions.

There are service covers on the proposed cycleway and the designs do not indicate that they will be made cycle friendly. Service covers can make cycling unsafe, particularly in adverse weather conditions; and significantly increases the likelihood of cyclist personal injury.

Examine existing service covers and make the service covers cycle friendly so they do not cause any road safety hazards.

There is a product called GripTop by Saint Gobain, see extract below. This product can be utilised on the covers. This option will be investigated further with the contractor and utility providers.

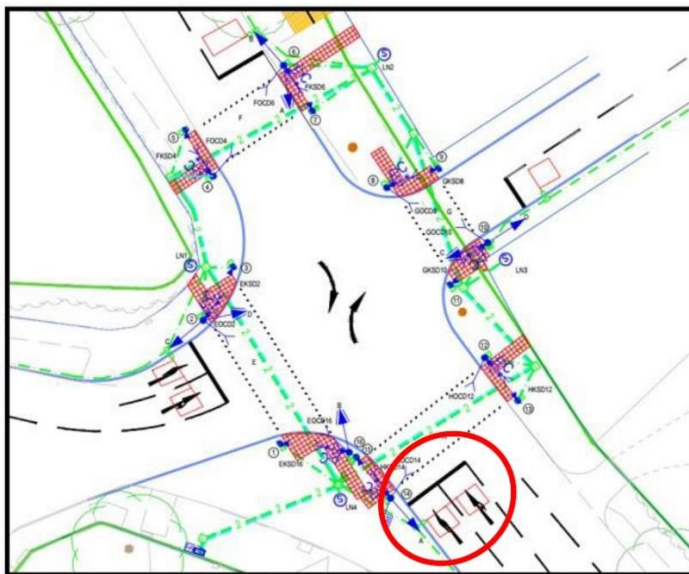
Driver frustration – London Road inbound approach to new junction

The proposed layout comprises a dedicated left-turn and straight on/right turn configuration on the London Road inbound approach to the new junction. London Road is a high traffic volume route into the city centre, and the proposed lane configuration can result in driver frustration due to traffic queuing behind right turners into the new access. This may result in drivers using the dedicated left-turn lane to manoeuvre through the junction, or try to bypass waiting right turn traffic, and this may result in drivers colliding with left turners and the footway on the north western side of the junction. This significantly increases the likelihood of personal injury collisions related to side swipe collisions and vehicle to pedestrian type collisions.

Redesign the junction layout to consider the impact of the driver frustration related to the lane layout and signal phasing. This will significantly reduce the likelihood of personal injury collisions related to the junction layout.

This comment has been accepted, but it is noted that the junction road markings and layout have not changed from the previous RSA2 and this was not picked up then. As a result, the junction has been reviewed and the proposed layout has been modified as shown below. A dedicated right turn has been included with a central ghost right turn markings to aim decision making prior to the arrival at the junction. Wicket signs will also display the proposed layout to help guide drivers. Additional Linsig modelling is to be undertaken to ensure the right turn capacity is adequate.

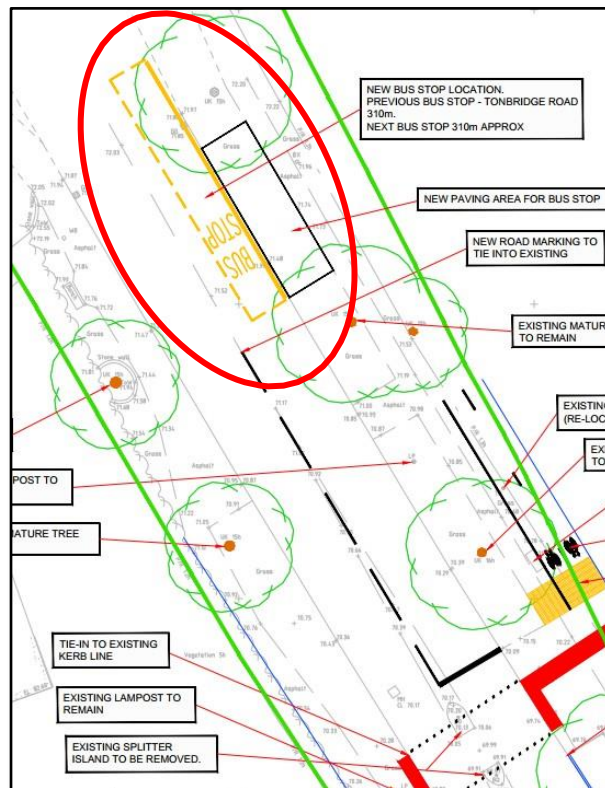
Location: London Road - see screen-print

*The bus stop relocation is on the approach to the proposed signalised junction, and in particular the signal heads. Buses waiting within the bus stop will significantly reduce the conspicuity of the signal heads (for vehicles on the approach from north-west to south-east) and this significantly increases the risk of vehicle to vehicle and vehicle to pedestrian type personal injury collisions.*

*The designer's response in regards to stopping distances is noted, however, the audit team still regard the location of the bus stop may result in conspicuity problems. Relocating the bus stop may significantly reduce the likelihood of vehicle-to-vehicle and vehicle to pedestrian type collisions.*

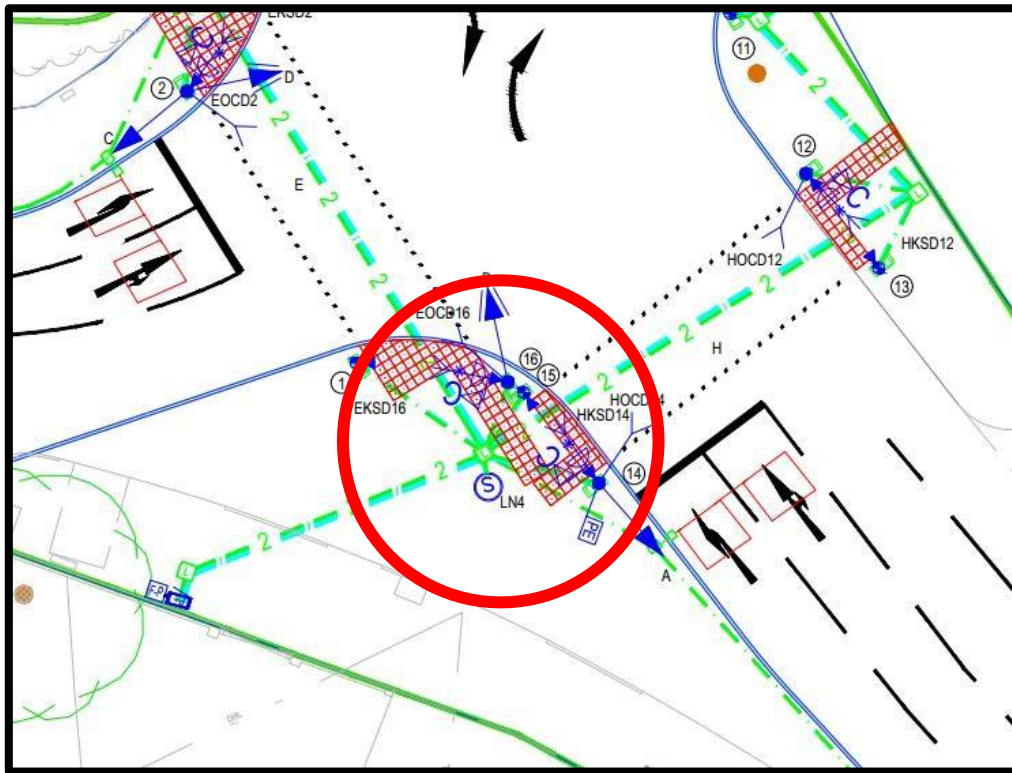
**Location** – See screen-print below

*The submitted drawings are confusing as different drawings highlight different tactile paving layouts for the same locations. As highlighted in the above drawing abstract, the tactile paving has been designed immediately adjacent to tactile paving that is advising pedestrians to travel in different directions. This may result in visually impaired pedestrians becoming confused and entering the highway at the wrong location; and this may result in pedestrian to vehicle type personal injury collisions.*

*If the above extract shows the proposed tactile layout, redesign the tactile paving so that the tactile paving is separated. This will significantly reduce pedestrian confusion and this will significantly reduce the likelihood of vehicle to pedestrian type personal injury collisions.*

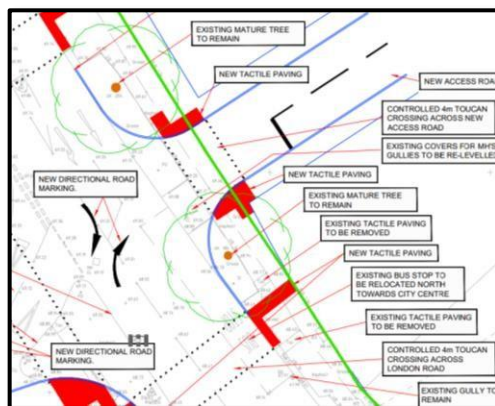
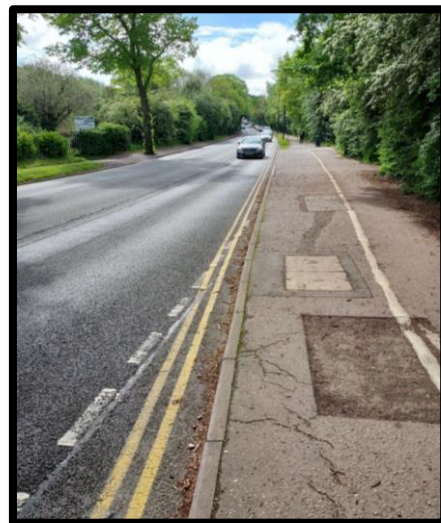
**Location** – London Road junction with new access

*The existing covers are to be re-levelled but will remain in situ. This location is where a high proportion of vehicles will be turning out of the new access into London Road. Having service covers at/on a corner increases the risk of vehicles skidding and also increases the likelihood of the service cover failing and becoming a maintenance issue. This increases the likelihood of vehicle to vehicle type personal injury collisions.*

*There are service covers on the proposed cycleway and the designs do not indicate that they will be made cycle friendly. Service covers can make cycling unsafe, particularly in adverse weather conditions; and significantly increases the likelihood of cyclist personal injury.*

*Examine existing service covers and make the service covers cycle friendly so they do not cause any road safety hazards.*

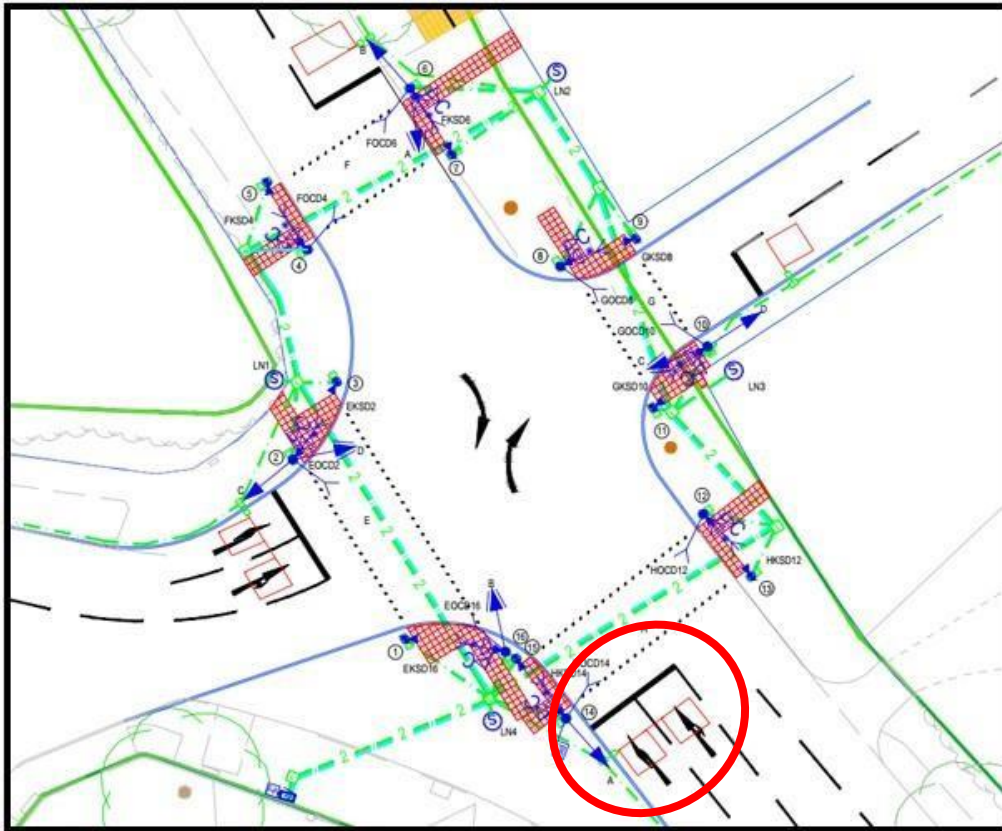
**Location** – London Road inbound approach to new junction

*The proposed layout comprises a dedicated left-turn and straight on/ right turn configuration on the London Road inbound approach to the new junction. London Road is a high traffic volume route into the city centre, and the proposed lane configuration can result in driver frustration due to traffic queueing behind right turners into the new access. This may result in drivers using the dedicated left-turn lane to manoeuvre through the junction, or try to bypass waiting right turn traffic and this may result in drivers colliding with left-turners and the footway on the north-western side of the junction. This significantly increases the likelihood of personal injury collisions related to side-swipe collisions and vehicle to pedestrian type collisions.*

*Redesign the junction layout to consider the impact of driver frustration related to the lane layout and signal phasing. This will significantly reduce the likelihood of personal injury collisions related to the junction layout*
