Asbestos Refurbishment Survey At Woodfield School, Stoneleigh Road Site, Coventry

Project No: W16-00408

Report Issue Date: 3 November 2016

Site: Woodfield School

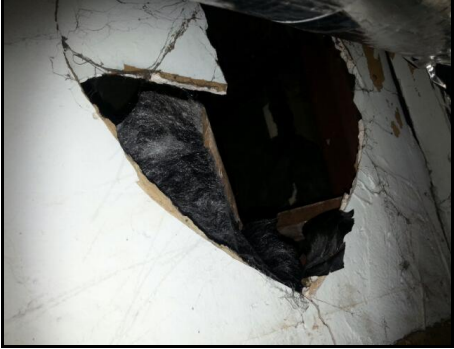
Building ID	Woodfield School
Sample No.	S0001
Floor	Ground Floor
Room No.	001
Room ID	Boiler Room

Item Description	Wall void
Material	Paper
Asbestos Type	No Asbestos Detected
Extent	-
Notes: Timber soffit. Plasterboard walls. Concrete floor. UPVC windows, doors and frame. MMMF insulation to pipework and internal replacement boiler. Limited access around boilers.	
Surveyor:	Paul Sidebotham
Recommendation:	-

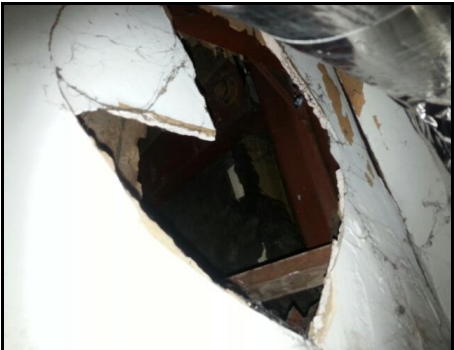
Building ID	Woodfield School
Sample No.	S0002
Floor	Ground Floor
Room No.	001
Room ID	Boiler Room

Item Description	Wall
Material	Insulating Board
Asbestos Type	No Asbestos Detected
Extent	-
Notes: Timber soffit. Plasterboard walls. Concrete floor. UPVC windows, doors and frame. MMMF insulation to pipework and internal replacement boiler. Limited access around boilers.	
Surveyor:	Paul Sidebotham
Recommendation:	-

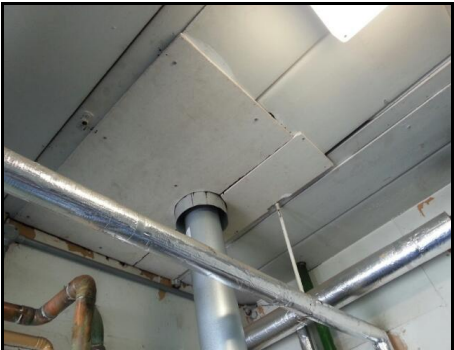
Building ID	Woodfield School
Sample No.	S0004
Floor	Ground Floor
Room No.	001
Room ID	Boiler Room

Item Description	Ceiling
Material	Insulating Board
Asbestos Type	No Asbestos Detected
Extent	-
Notes: Timber soffit. Plasterboard walls. Concrete floor. UPVC windows, doors and frame. MMMF insulation to pipework and internal replacement boiler. Limited access around boilers.	
Surveyor:	Paul Sidebotham
Recommendation:	-

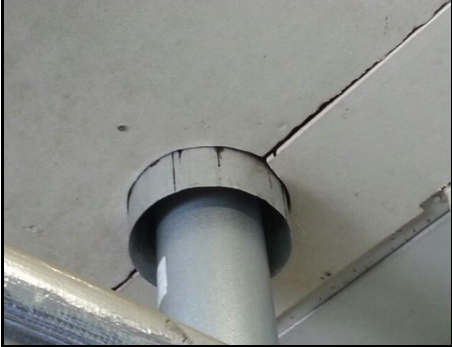
Building ID	Woodfield School
Sample No.	S0005
Floor	Ground Floor
Room No.	001
Room ID	Boiler Room

Item Description	Flue Pipe
Material	Bituminous Products
Asbestos Type	No Asbestos Detected
Extent	-
Notes: Timber soffit. Plasterboard walls. Concrete floor. UPVC windows, doors and frame. MMMF insulation to pipework and internal replacement boiler. Limited access around boilers.	
Surveyor:	Paul Sidebotham
Recommendation:	-

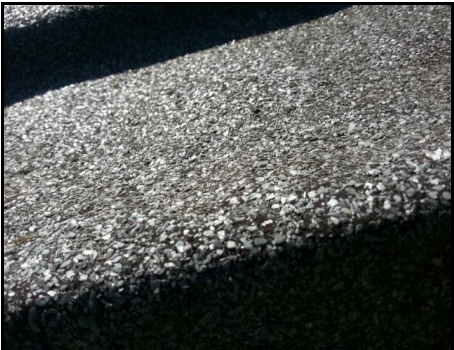
Building ID	Woodfield School	Item Description	Roof felt
Sample No.	S0008	Material	Roofing Felt
Floor	Ground Floor	Asbestos Type	No Asbestos Detected
Room No.	001	Extent	-
Room ID	Boiler Room	Notes:	Timber soffit. Plasterboard walls. Concrete floor. UPVC windows, doors and frame. MMMF insulation to pipework and internal replacement boiler. Limited access around boilers.
