Earlsdon

CONSERVATION AREA APPRAISAL

APPRAISAL

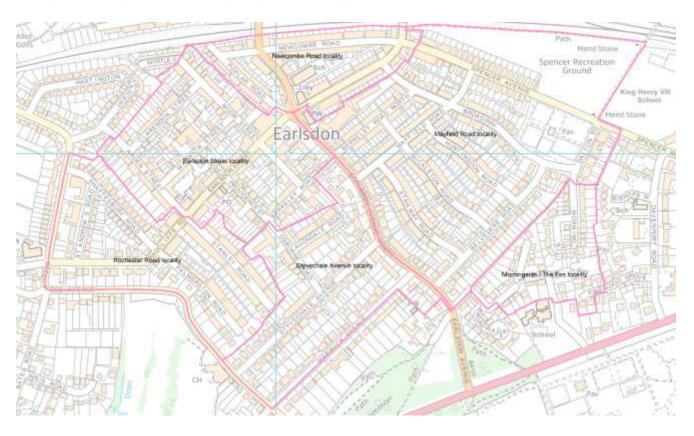
Fig 3.1. The localities

- 1. Earlsdon Street locality
- 2. Rochester Road locality
- 3. Styvechale Avenue locality
- 4. Newcombe Road locality
- 5. Mayfield Road locality
- 6. Morningside / The Firs locality

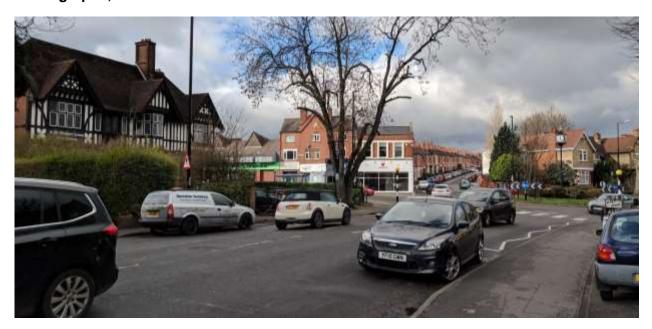
Fig 3.2. The junction of Earlsdon Street, Earlsdon Avenue South and Poplar Road, marked by the central clock, straddles three localities, and provides a significant nodal point and gateway in the area. The Earlsdon Street locality begins to the left of this view, marked by the visual presence of the decorative timber-framed interwar City Arms pub.

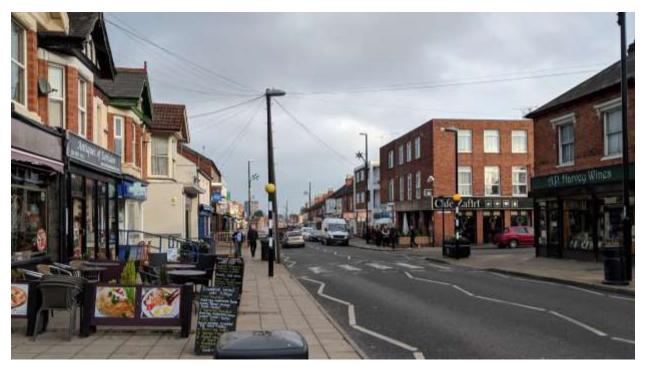
Fig 3.3. Earlsdon Street provides the bustling community focal point to the area which a mix of domestic and commercial premises. It has, however, been negatively impacted by modern signage, shopfronts, infilling, and street clutter

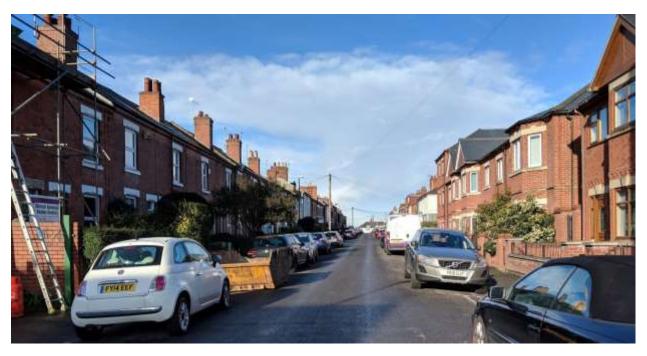
Fig 3.4. Arden Street is a residential road running away from Earlsdon Street. It has a particularly strong rhythmic group of smaller-scale red brick terraces with stone detailing above the windows, and chimneys.

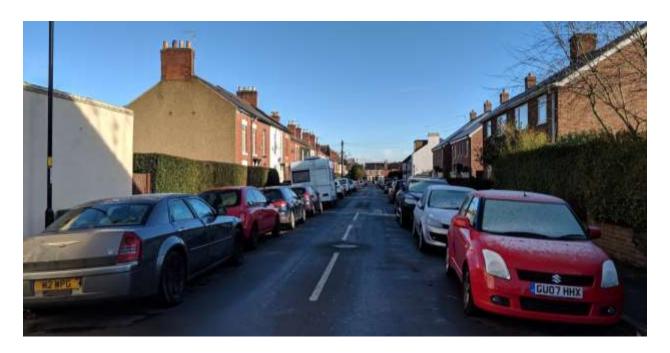
Fig 3.5. Clarendon Street has seen extensive redevelopment to the south side of the street (right), but retains a significant group of red brick and roughcast rendered terraces and semi-detached dwellings to the north side (left) incorporating decorative brickwork to eaves, stone window and door dressings and some decorative half timbered gables, though many historic windows have been lost.

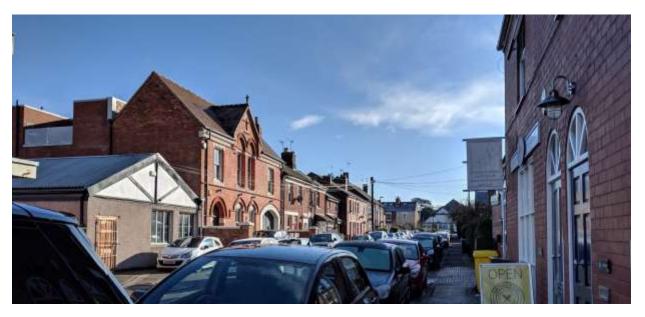
Fig 3.6. Moor Street incorporates a former nail factory, now converted to offices, alongside a series of terraces with some later infill. Key losses along this road include historic boundary treatments (rebuilt), and windows. At least one brick terrace has been inappropriately rendered. The Criterion Theatre, provides an important visual terminus to the road.

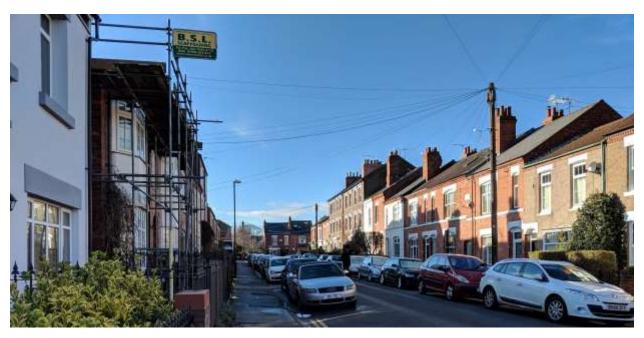
Fig 3.7. Berkeley Road South is a mix of terraces at varying scales, incorporating some semi-detached dwellings. These include larger-scale terraces with historic top light windows. Detailing includes decorative brick patterning to the eaves, stone window and door hoods, and chimneys.

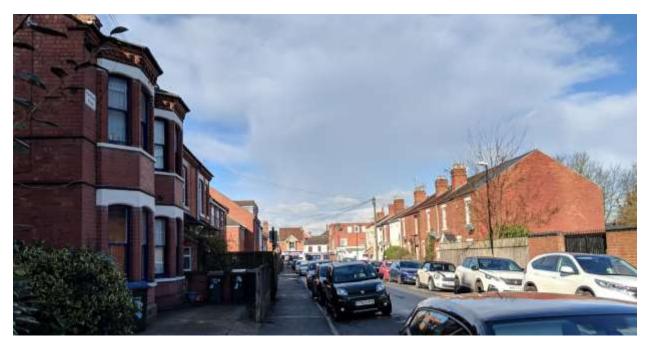
Fig 3.8. Providence Street provides important views down to Earlsdon St with a series of smaller-scale red brick terraces which are unfortunately impacted by infill and visual clutter to facades, including satellite dishes.

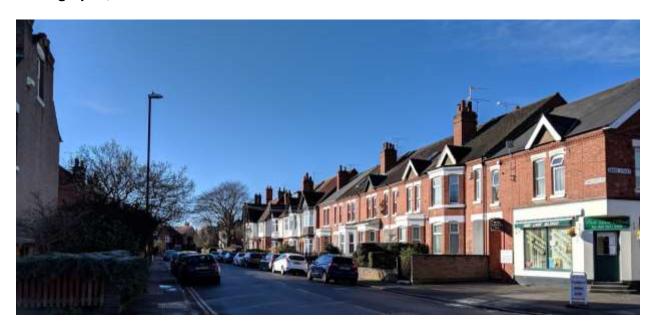
Fig 3.9. Radcliffe Road is a continuation of the central spine of Earlsdon Street, but becomes significantly more domestic in character. It has a strong rhythm of red brick terraces on both sides of the street, incorporating stone detailings to windows and doors, as well as a series of larger semi- properties with render to the upper storeys finished with decorative half-timbered gables

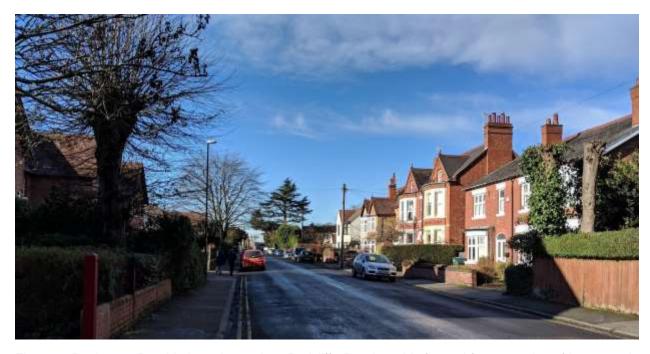
Fig 3.10. Rochester Road is less dense than Radcliffe Road, and is formed from a series of larger-scale detached and semi-detached dwellings finished in brick and render, incorporating key examples of stone and brick detailing, with visually prominent gables. The road is enhanced by soft landscaping from front gardens and boundary treatments, with a degree of setback from the road.

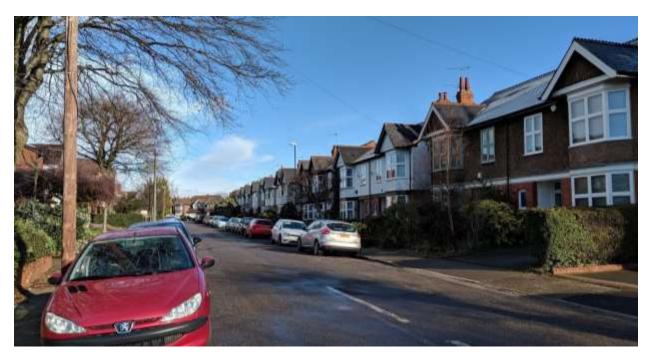
Fig 3.11. Despite the addition of a large late twentieth century apartment block, St Andrews Rd includes an important group of semi-detached dwellings finished in brick and render, with a strong rhythm of gables set back from the road.

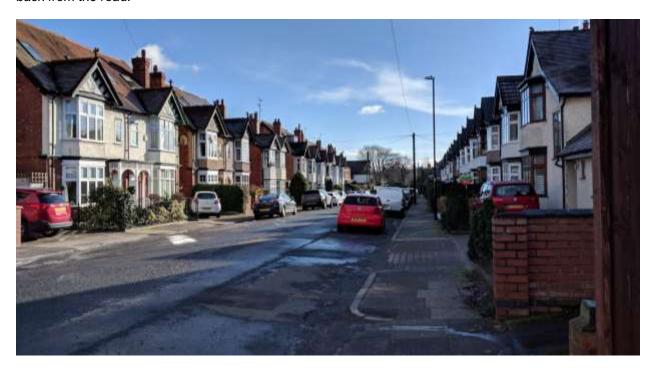
Fig 3.12. Shaftesbury Road is characterised by a surviving group of semi-detached brick and rendered dwellings, in a strong building line with a series of half timbered gables topped with roof finials. Some of these incorporate historic timber porches. There has been an evident loss of historic boundary treatments along this road.

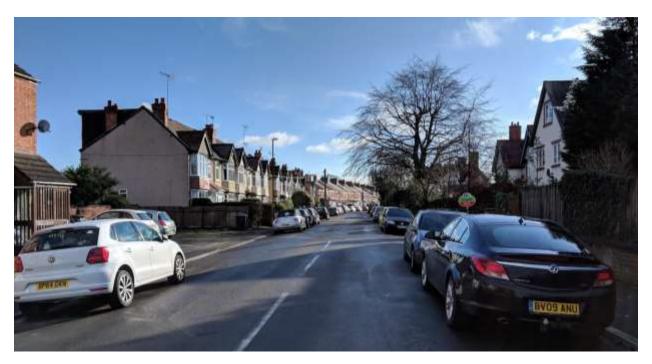
Fig 3.13. To the south side of Palmerston Road (right) there are a series of larger detached dwellings, including those incorporating decorative timberwork and substantial chimneys. To the north side (left), is a

surviving collection of rendered and red brick terraces. There has been some clear loss of historic boundary treatments along the road, and some vacant land detracting from the overall streetscene. There is also a degree of visual clutter, including substantial tv aerials, and large visible dormer windows.

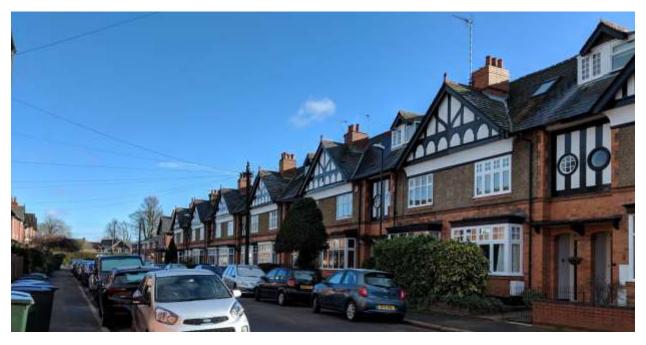
Fig 3.14. To the east side (right) of Avondale Road there is a terrace with a highly significant surviving decorative pattern incorporating half-timbered gables topped with roof finials, chimneys, bay windows, a contrast between brick and roughcast render (separated by brick banding) and round oculi windows. Whilst the terrace is enhanced by front boundary soft landscaping, there has been loss of historic boundary treatments and hard-standing/surface materials.

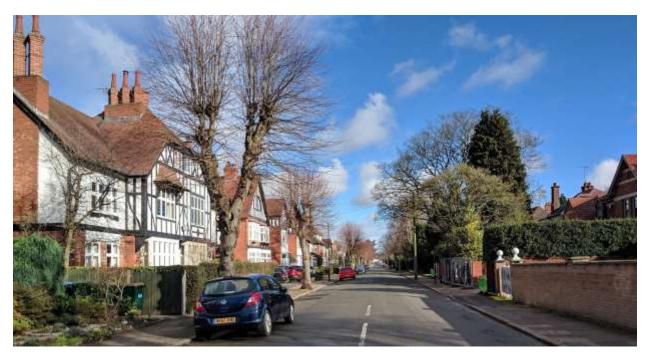
Fig 3.16. Warwick Avenue is characterised by a group of significant larger-scale detached and semidetached properties. To the east side of the street (right) this includes substantial setback behind front

garden plots and soft landscaping. To the west side (left) there remains a setback, though this is reduced, and a series of more visually prominent properties with timberwork and decorative brick chimneys. The sense of suburban seclusion is enhanced by periodic street trees, whilst evidence of early examples of private vehicle garaging are also of note.

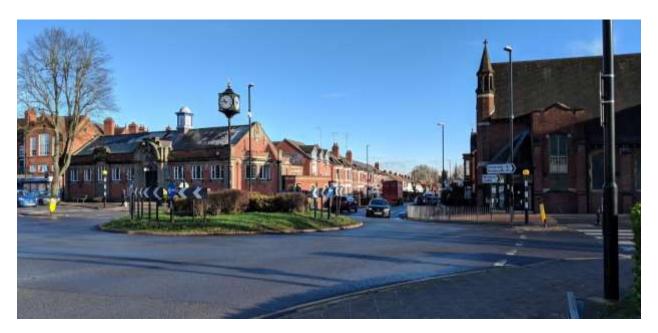
Fig 3.17 The junction of Earlsdon Street, Earlsdon Avenue South, and Poplar Road, marked by the central clock, straddles three localities, and provides a significant nodal point and gateway in the area. The significant grouping of the clock, Earlsdon Methodist Church and Earlsdon library provide an important focal point at the gateway into the Newcombe Road locality.

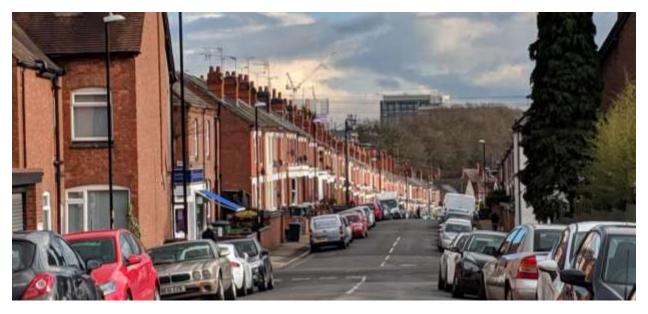
Fig 3.19. Newcombe Road provides views back to the City Centre. Despite a strong terrace rhythm with a run of smaller-scale red brick terraces incorporating chimneys and stone detailing enhanced by a curving street structure, the group has been undermined by visual clutter including satellite dishes, tv aerials, bins, as well as alterations to windows and front boundary treatments.

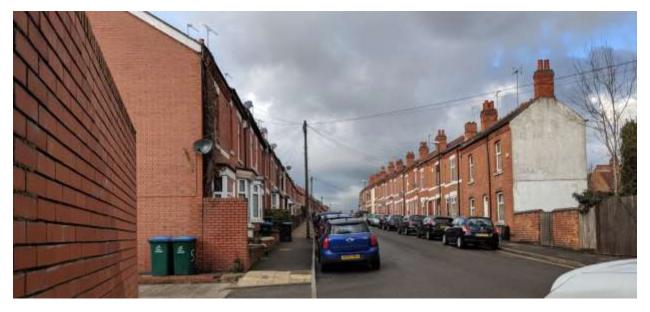
Fig 3.20. Poplar Road is characterised by a strong terrace rhythm, formed from smaller-scale red brick dwellings. These incorporate stone detailing around windows and doors, as well as brick patterning to eaves level. Despite this strong rhythm, the group value of the terrace has been undermined by the loss of historic boundary treatments, intermittent rendering of historic red brick houses, and general visual clutter including satellite dishes, as well as loss of historic windows.

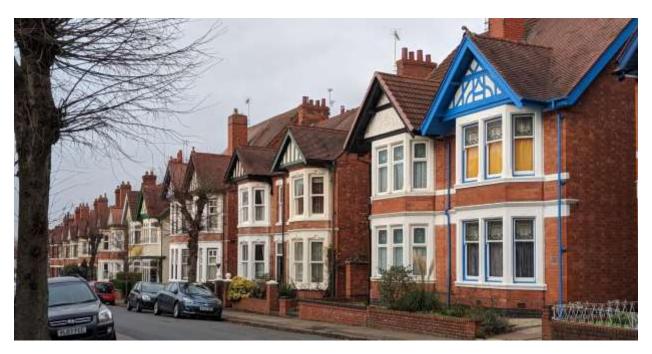
Fig 3.21. Spencer Avenue is characterised by a significant rhythm of red brick and roughcast render semidetached dwellings, enhanced by street trees and long range views to the landscaping of Spencer Park. The road incorporates examples of historic tiling to doorways and pathways, characteristic stone detailing around bay windows, and a strong rhythm of gable ends incorporating half-timbering. Despite a high level of surviving detailing, there are some examples where this timberwork has been replaced with uPVC panelling, and there has been general rebuilding of historic boundary treatments.

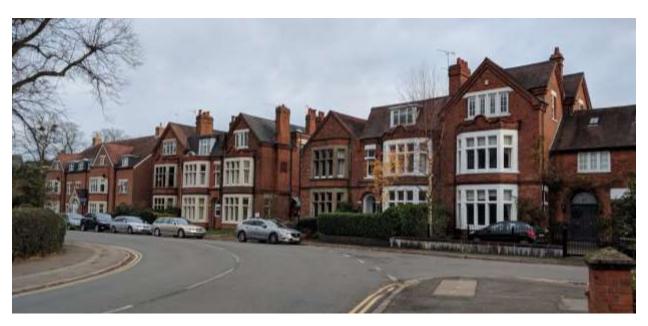
Fig 3.22. Dalton Road is characterised by large red brick dwellings with impressive stone surrounds to bay windows, they are enhanced by a curve in the road which frames views to the buildings as a group as well the boundary hedgerows to Spencer Park.

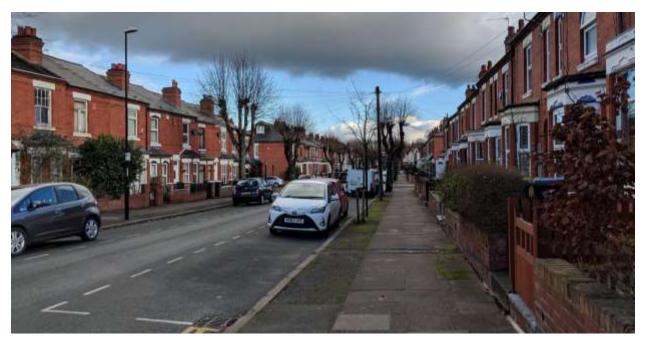
Fig 3.23. Mayfield Road provides an important spine in the locality, characterised by sets of grouped smaller-scale red brick terraces with decorative brickwork to eaves and stone window hoods. Whilst some

traditional sash windows remain, many have been replaced with uPVC top hung windows and traditional boundary treatments have been rebuilt.

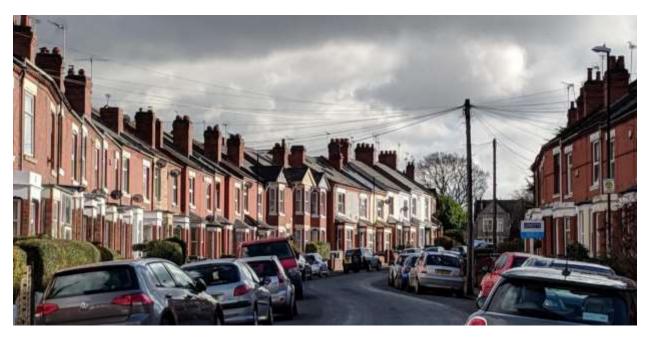
Fig 3.24. Huntington Road is characterised by strong groups of both red brick and roughcast rendered terraced properties. The curve of the street provides interesting views up and down the street, enhanced by unifying features such as chimneys. Along the road, however, many traditional windows have been lost,

historic boundaries rebuilt and in some areas visual clutter (e.g. satellite dishes and aerials) have encroached onto the facade with some placed on chimneys.

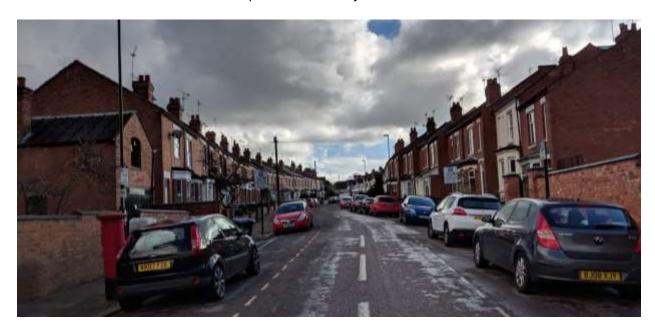
Fig 2.25. Mickleton Road has, on both sides of the street, significant groupings of red brick and roughcast rendered terraces, enhanced by a curve in the road which provides interesting long range views. Roughcast rendered terraces incorporate detailing such as half-timbered gables, whereas brick properties generally include stone window hoods. Despite the strong terrace rhythm many historic windows have been lost, boundaries rebuilt, and general clutter (satellite dishes and aerials) has encroached on the facade and chimneys.

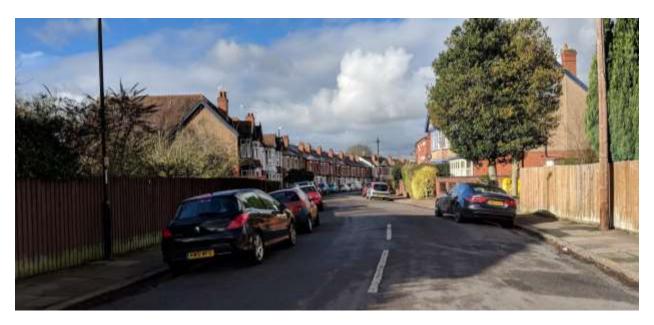
Fig 2.26. Stanway Road is characterised by a close grouping of red brick and roughcast rendered terraces and semi-detached dwellings. The properties incorporate decorative painted half-timbered gables, brick detailing to eaves, and stone window hoods. The curvature of the road creates interesting views of the properties. Despite a strong terrace rhythm many historic windows have been lost.

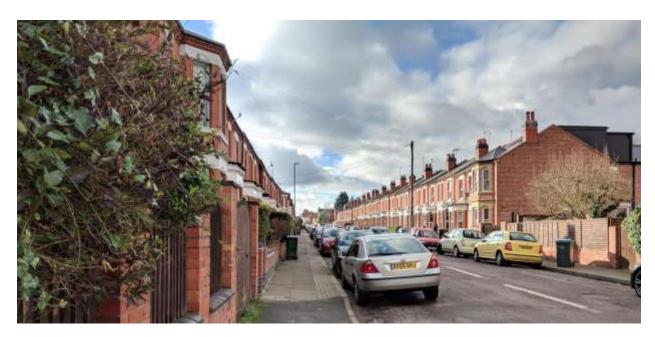
Fig 3.27. Berkeley Road North is characterised by significant groups of red brick terraces (with some examples of roughcast render) incorporating stone banding and hoods around windows and doors some of which incorporate a pattern, as well as key features such as chimneys which provide a strong rhythm to the road. Despite a strong terrace rhythm many historic windows have been lost, boundaries rebuilt and at least one example of a red brick facade being inappropriately rendered.

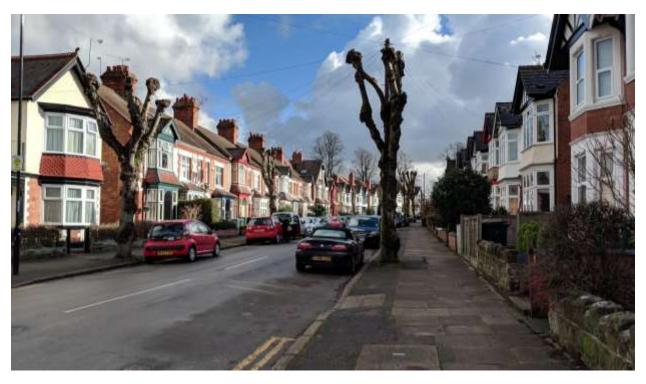
Fig 3.28. Broadway is characterised by a group of semi-detached dwellings, predominantly roughcast rendered, incorporating features such as painted decorative half-timbered gables, large bay windows, and stone/brick detailing. The eastern part of the street is enhanced by the open space of Spencer Park which provides a formal landscaped boundary as the road curves into Dalton Road.

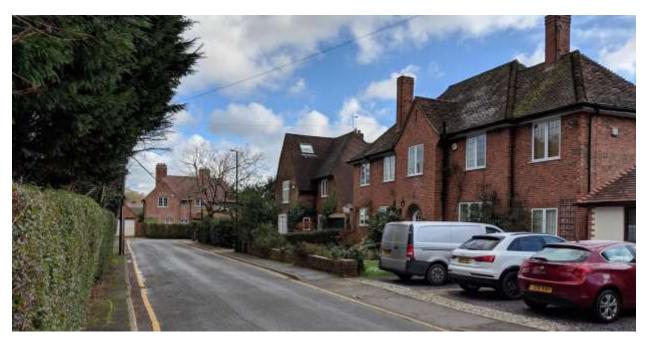
Fig 3.29. The northern section of the Firs is predominantly late 20th century. However, progressing south towards Kenilworth Road there is an interesting collection of larger, brick, detached dwellings dating from the interwar period, enhanced by strong boundary landscaping along the street frontage. The area feels secluded, and a significant different character to the dense terraces of much of Earlsdon.

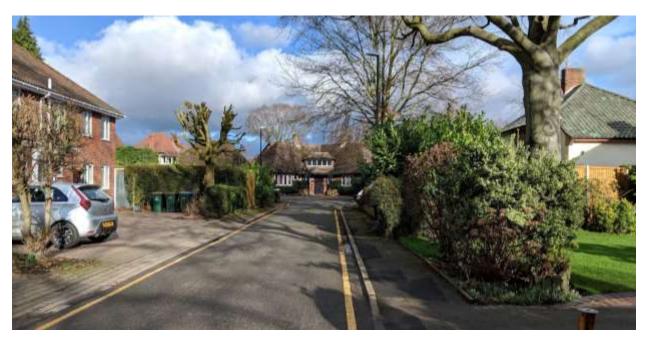
Fig 3.30. The northern offshoot of the Firs terminates in an interesting interwar property.

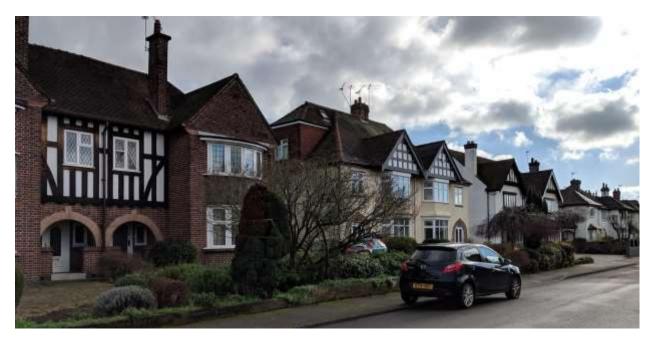
Fig 3.31. Morningside is characterised by a significant surviving group of interwar semi-detached dwellings. They draw on the precedent elsewhere in Earlsdon, and more broadly, for decorative timber-framing. The road is enhanced by setbacks, and landscaped front boundary treatments where they remain.

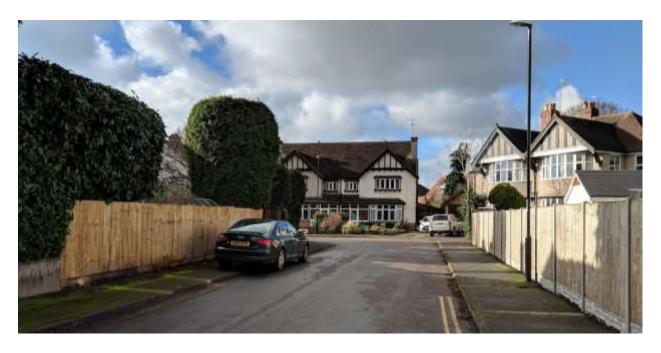
Fig 3.32. Morningside provides a winding suburban set of properties, with reveals created around strong corners. Some of the soft landscaping has been lost in favour of close board fencing.

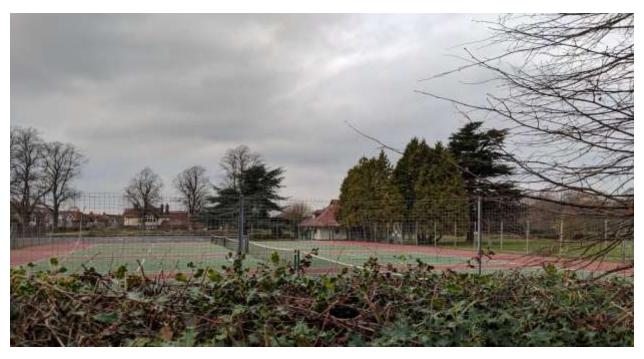
Fig 3.34. South of Spencer Avenue, this part of the park is a more formal designed landscape, complete with communal amenities such as tennis courts and a decorative bandstand. Its neat hedgerows and trees provide an important setting for the surrounding built form (particularly Dalton Rd, Broadway, and Spencer Avenue) as well as providing a sense of relief within the area.

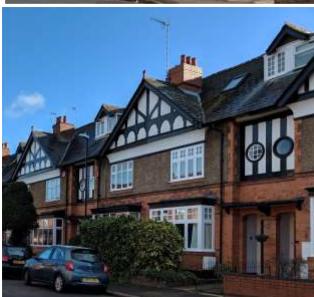
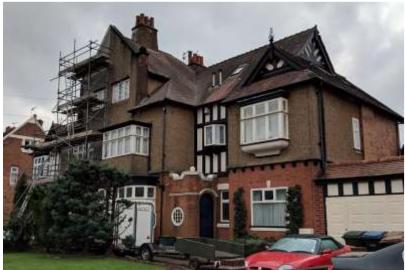
Fig 3.36. Indicative example of building types, styles, and materials

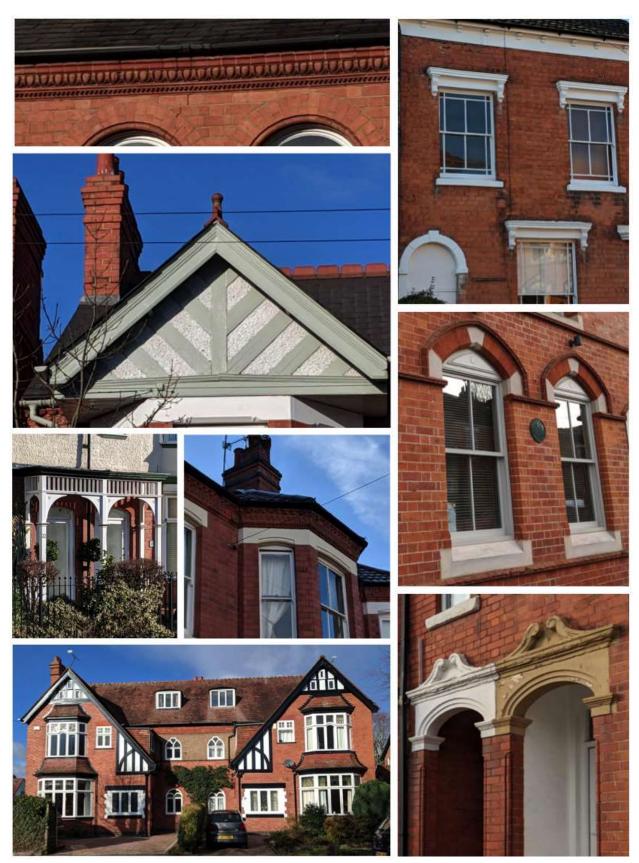
Fig 3.36. Indicate example architectural detailing
